# Preliminary Information

## PIP5584 Dynamic Fuel System DTC

Brand:	Model:	Model Years:	VIN:		Engine:	Transmissions:
			from	to		
Chevrolet	Silverado 1500 (new Model)	2019	All	All	5.3L 6.2L, L84, L87	All
GMC	Sierra 1500 (new Model)	2019	All	All	5.3L 6.2L, L84, L87	All

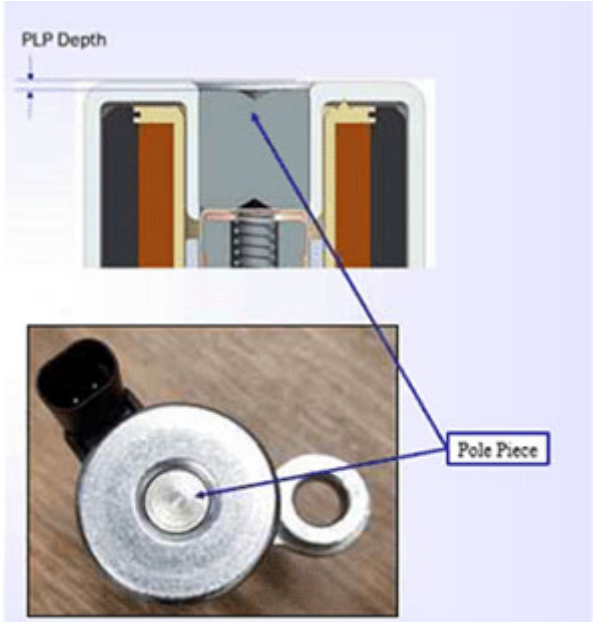
Inspect the rest of the solenoids for pole piece standing proud as seen below.

If the pole piece is sticking out (above the surface) the solenoid will also need to be replaced.

Replace the OCV for the cylinder with the concern.

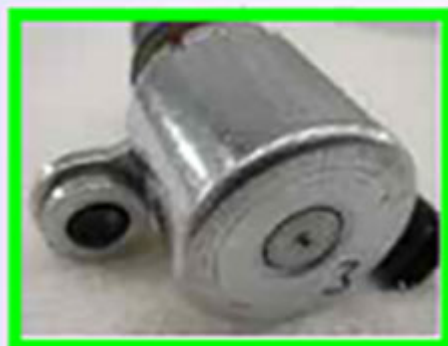
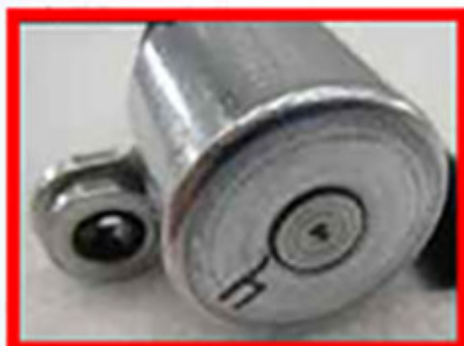
> 0.4mm = Good

< 0.4mm = NOK

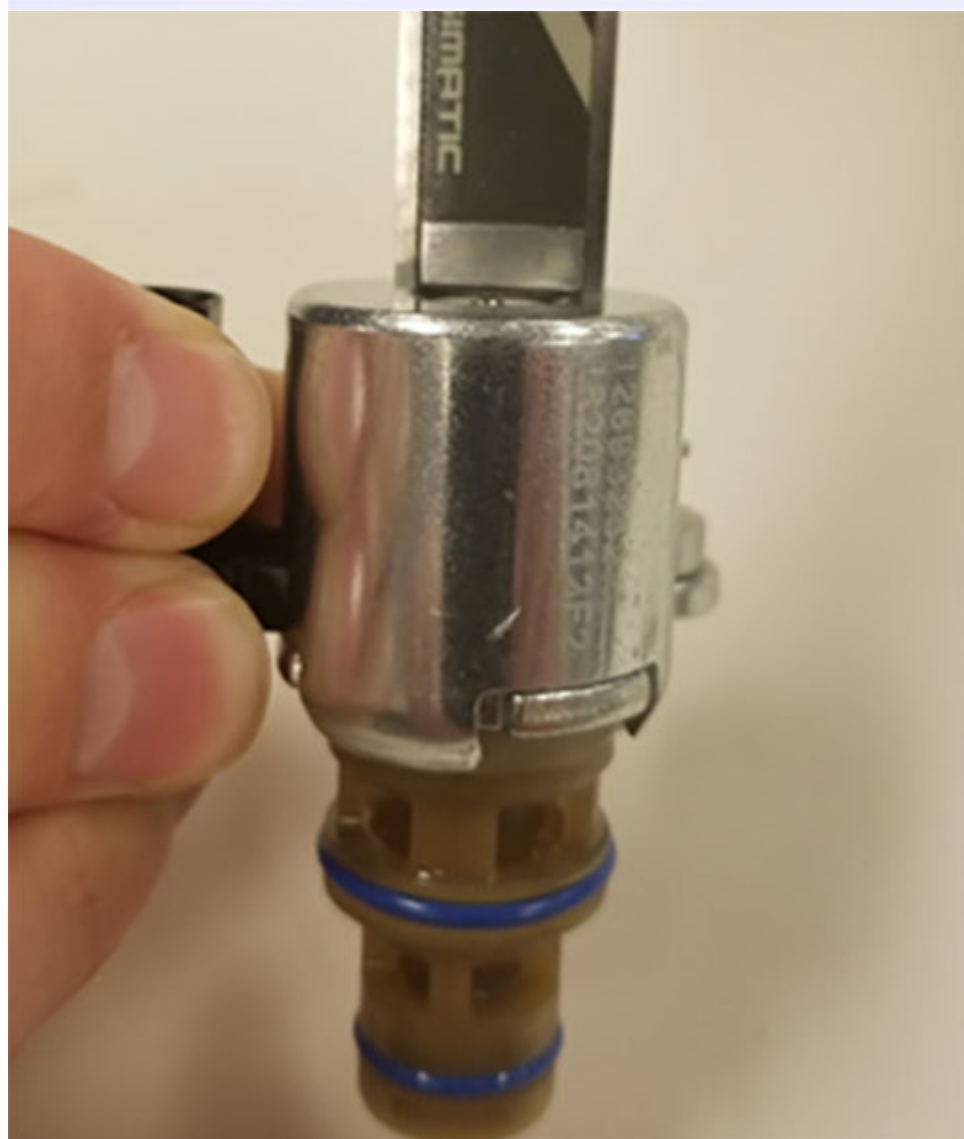
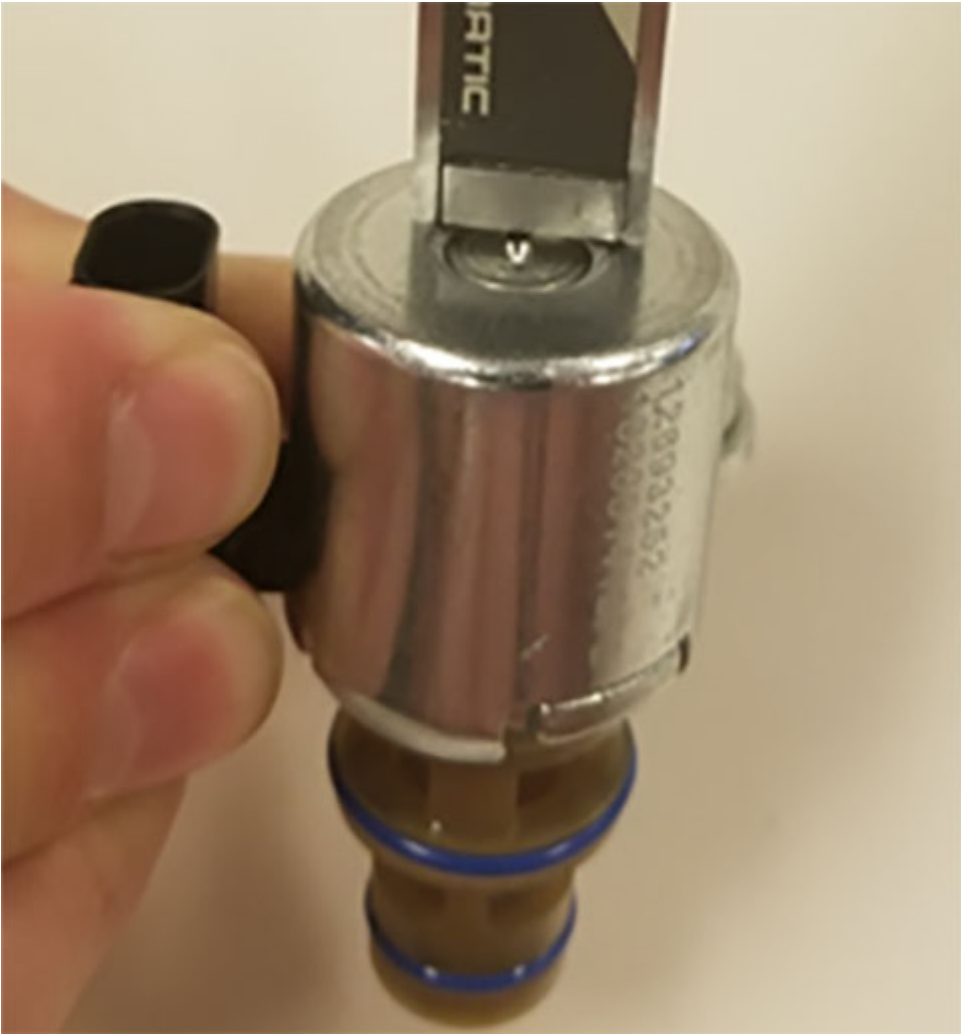
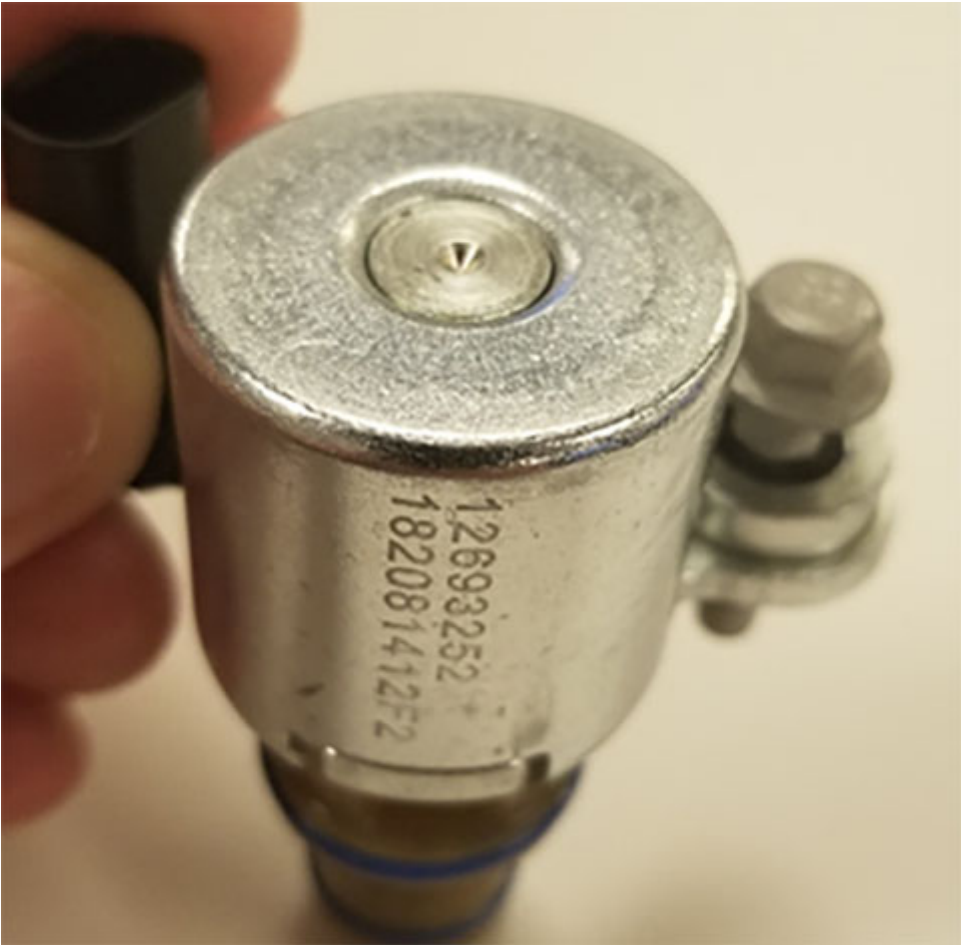
3 Images above show measuring the plunger of the OCV. (It should be checked in the vehicle)
