### PIP5495E Check Engine Light On With P0299 Or P0234

#### Models

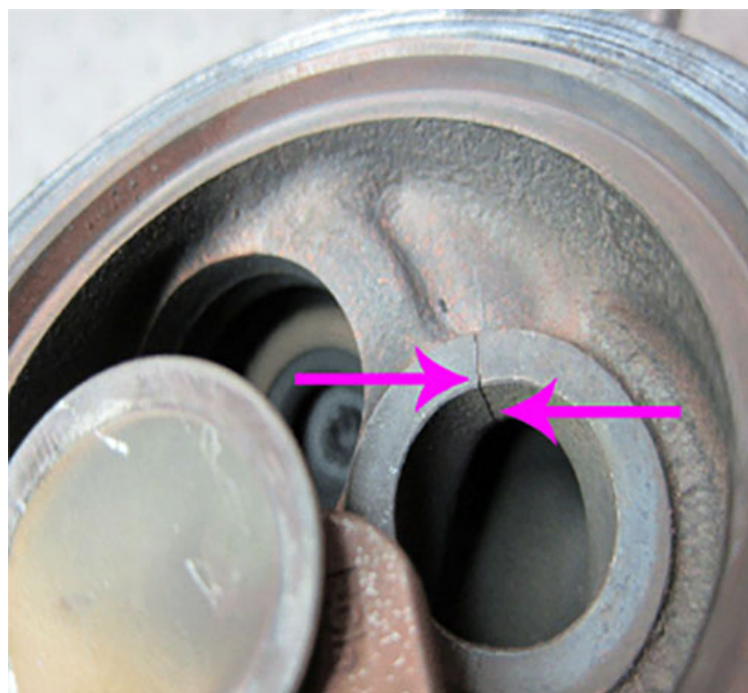
Crack(s) at the wastegate valve port (this is normal and does not affect performance)

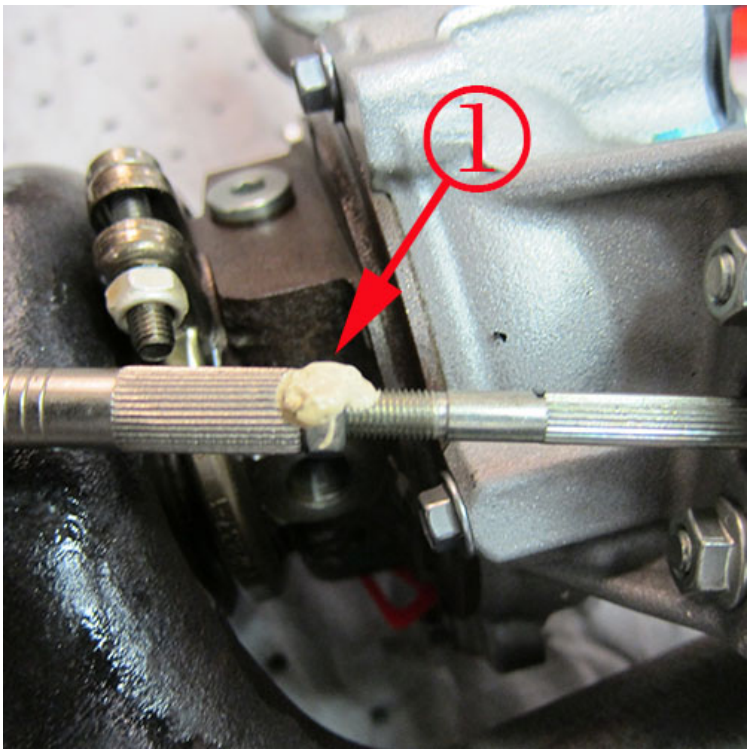
If the tamper paint seal is broken or missing, check the vehicle for any additional sign of modification to the induction, exhaust, or engine calibrations as this may indicate an attempt to adjust the wastegate arm to modify the powertrain operation.

If found, review the powertrain warranty status with your service manager prior to performing repairs.

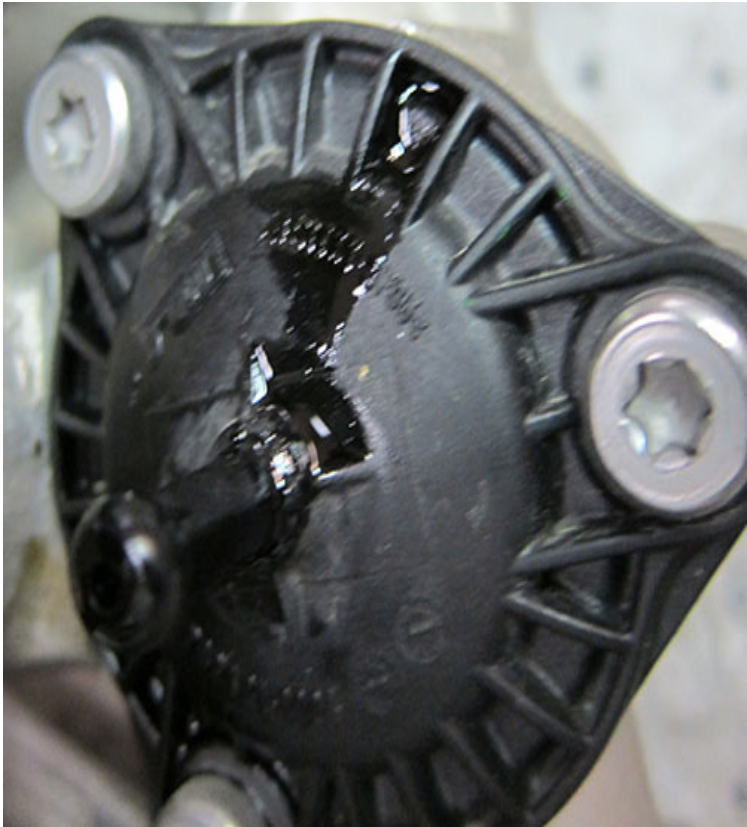
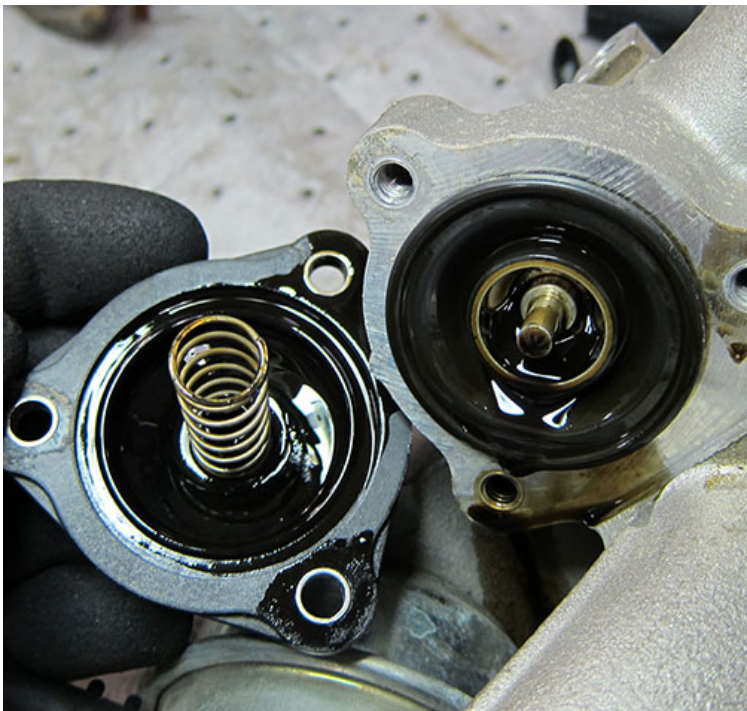
Bypass (recirculation) valve cover port broken or water/oil found inside the valve (clean the components, if necessary replace bypass (recirculation) valve assembly - released for service)

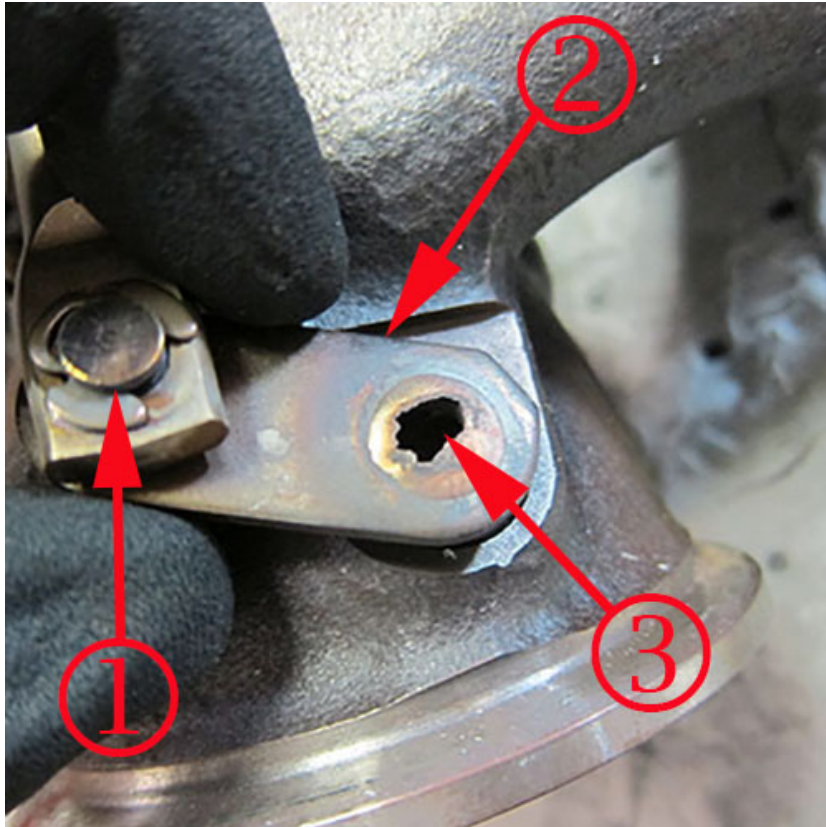
Disconnected wastegate lever arm (crank) (2) from the shaft (3).

Disconnected wastegate lever arm pin (1) from the lever arm (crank) (2).

Replace the turbocharger if P0299 is set and at least one of the following is present:

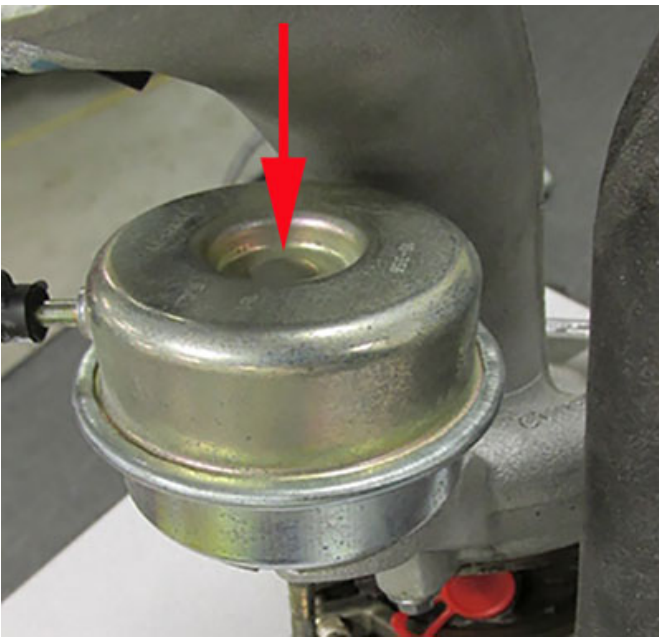
The original equipment wastegate actuator found on 2011 and 2012 model years shown below, has a recessed stop at the head of the actuator.

Original equipment actuator is found on 2011 and 2012 model years.

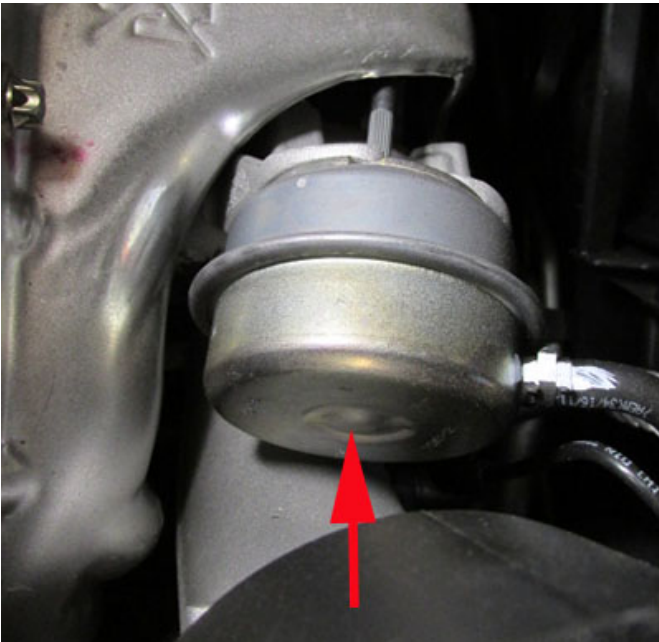
The updated design actuator show below has a stop that is not recessed and allows 5mm more travel in the closed direction.

With this updated design, it is very unlikely that an insufficient preload issue exists.

Updated design.

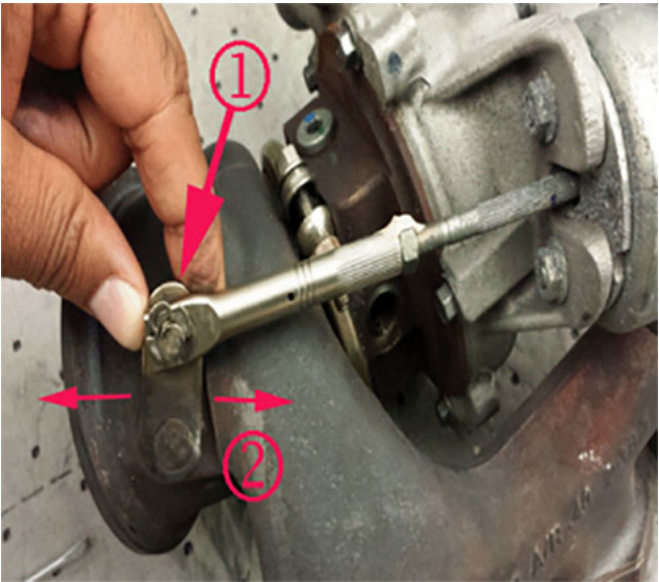
Wastegate Preload Inspection.

Wastegate lever arm (1) moves with little effort in the direction as shown (2) while the actuator rod remains static, see picture below "Wastegate Preload Inspection".

If the lever wiggles with little effort while the actuator rod remains static, the pre-load is insufficient and the turbocharger must be replaced.

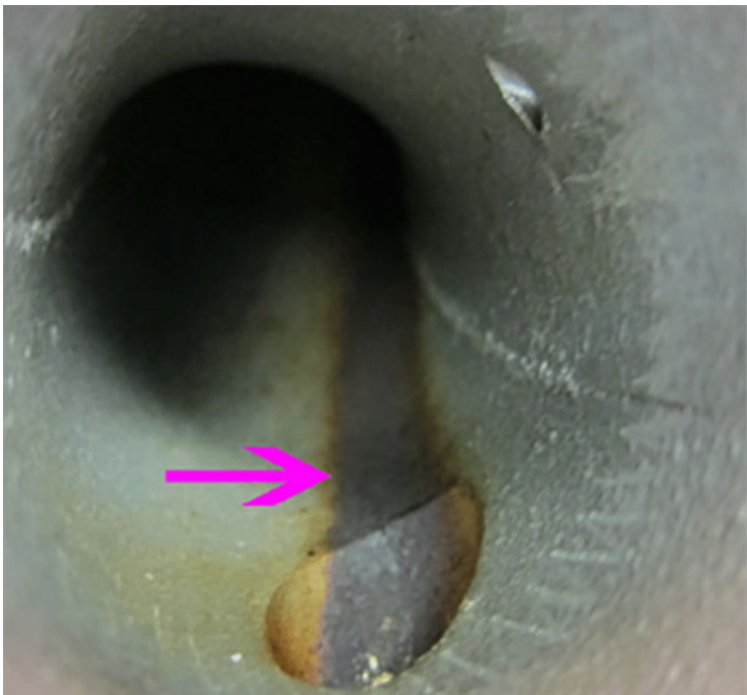
Notice: The view shown below indicates NORMAL oil staining in the turbocharger outside air inlet. This dry stain does not represent an oil leak.

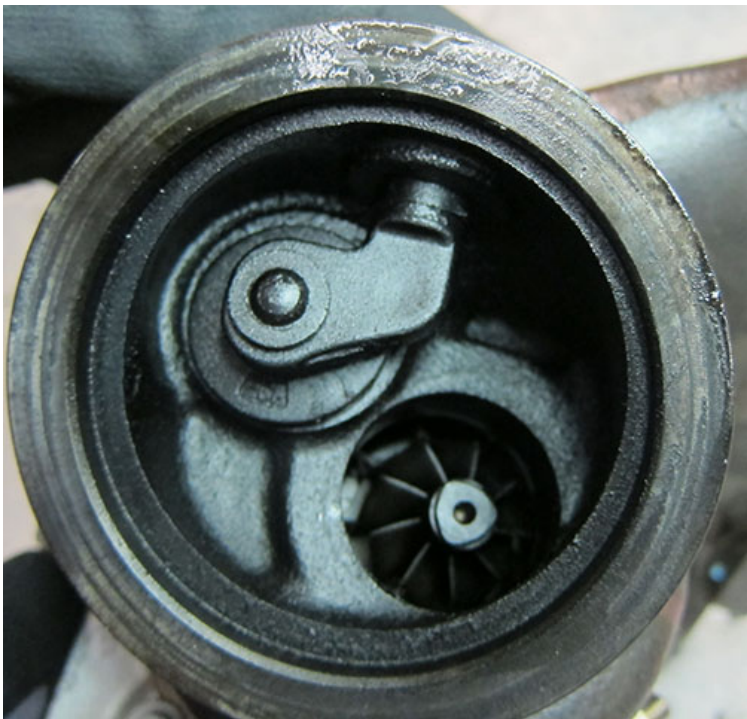
Inspect for the presence of oil in the exhaust system.

If oil is present in the exhaust system, then inspect the turbocharger turbine and compressor wheels to be sure that they are not broken off.

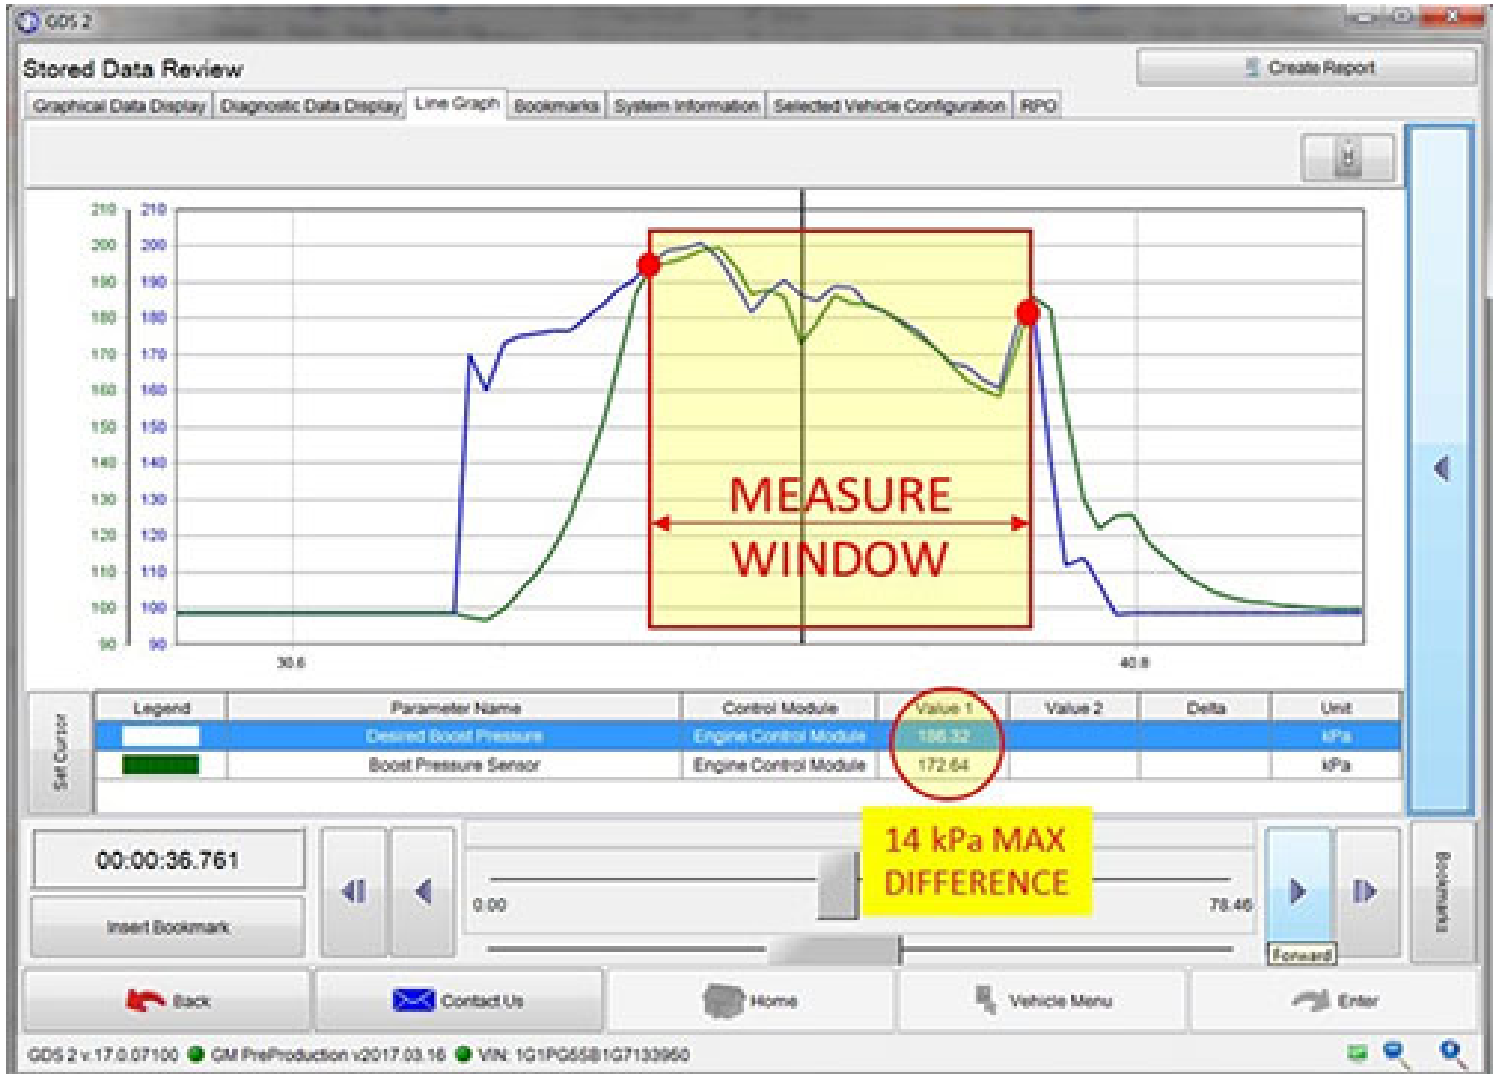
Example of normal turbocharger wastegate operation:

In this example, notice that the measure window begins once the Boost Pressure Sensor reading (Green) meets the Desired Boost Pressure reading (Blue) and ends when the APP is released per the testing instructions.

The Boost Pressure Sensor reading (Green) closely tracks the Desired Boost Pressure reading (Blue) indicating normal Turbocharger
