Bulletin No.: PIT5576B

### PIT5576B Hood Ajar Message

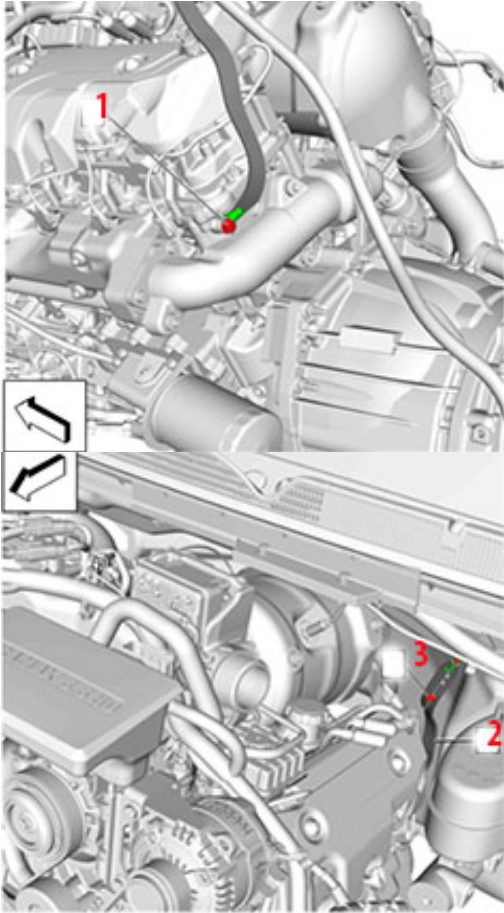
<b>Involved Region or Country</b>	<b>North America</b>
<b>Additional Options (RPO)</b>	N/A
<b>Condition</b>	<p><b>Some customers may comment of an intermittent "Hood Ajar" message being displayed, even though the hood is not ajar. This concern may be more noticeable when certain electrical loads are operated, such as:</b></p> <ul style="list-style-type: none"> <li>- Power windows</li> <li>- HVAC blower</li> <li>- A/C compressor</li> <li>- Power seats</li> <li>- Shifting in and out of park</li> </ul>
<b>Cause</b>	<p><b>This condition can be caused by a poor body ground connection at either:</b></p> <ol style="list-style-type: none"> <li><b>1. G218</b></li> <li><b>2. The braided ground strap (2) that connects the left rear cylinder head (1) to the body cowl/front of dash (3), shown below.</b></li> </ol>

**1. Inspect G218 for the nut being loose, cross threaded and/or missing. Also, grasp the ground eyelet and verify that it does not rotate on the stud. If any issues are found, perform the necessary repairs.**

**2. Inspect the body ground strap to ensure it is connected in the proper locations and that the strap eyelet connections are tight and free of any paint or corrosion. In most cases, connection issues with the braided ground strap are caused by poor workmanship during a previous repair. Examples of such repairs include: removing the body, cylinder head, engine, etc. It is important to make sure the braided ground strap is connected in the proper locations. During some of these repairs, the braided ground strap was not reattached at all, or it was reattached to the incorrect location, such as a valve cover. The valve cover is not a proper ground as it is insulated from the main engine block by the gasket and bolt retainers. If any issues are found with the braided ground strap, repair them as necessary.**
