EC18-029

September 11, 2018

2018 QX80; MIL ON WITH DTC P0138 AND/OR P0158

APPLIED VEHICLES: 2018 QX80 (Z62)

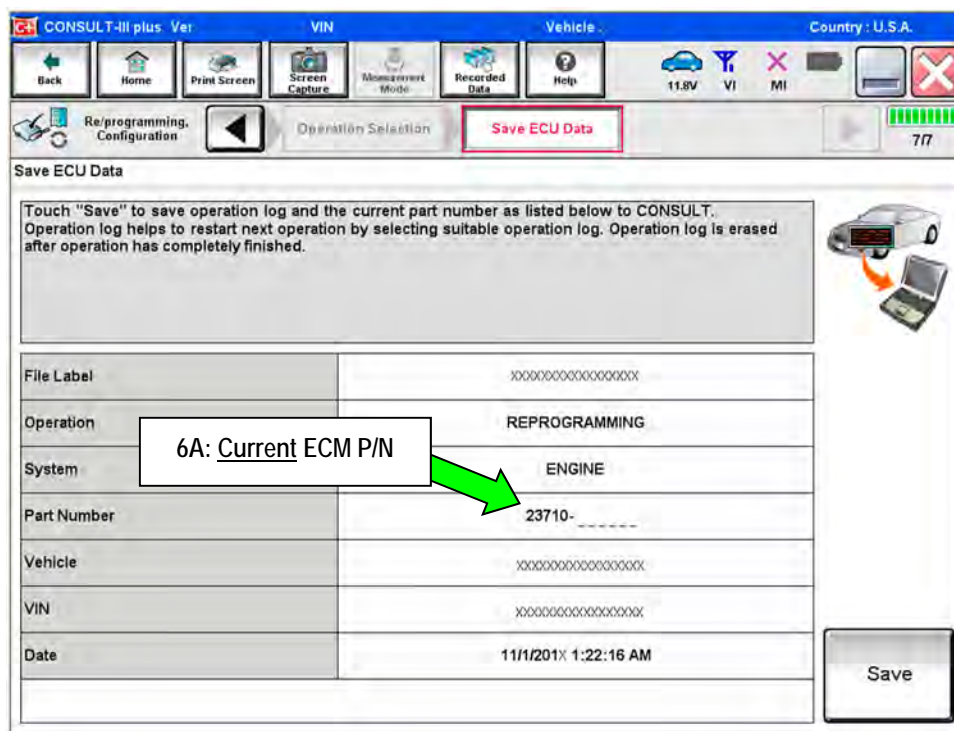
Figure 2

6. When you get to the screen shown in Figure 2, confirm this bulletin applies as follows.

A. Find the ECM **Part Number** and write it on the repair order.

NOTE: This is the current ECM Part Number (P/N).

B. Compare the P/N you wrote down to the numbers in the **Current ECM Part Number** column in **Table A** below.

- If there is a match, this bulletin applies. Continue with the reprogramming procedure.
- If there is not a match, reprogramming does not apply. Refer to ASIST for further diagnosis.

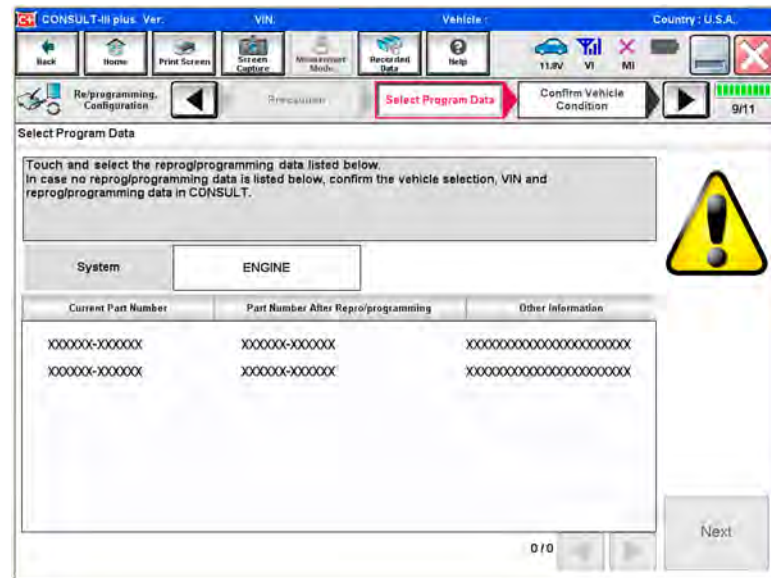
- In some cases, more than one new P/N for reprogramming is available.
 - In this case, the screen in Figure 3 displays.
 - Select and use the reprogramming option that **does not** have the message “Caution! Use ONLY with ITBXX-XXX”.
- If you get this screen and it is blank (no reprogramming listed), it means there is no reprogramming available for this vehicle. Close C-III plus and refer back to ASIST for further diagnosis.

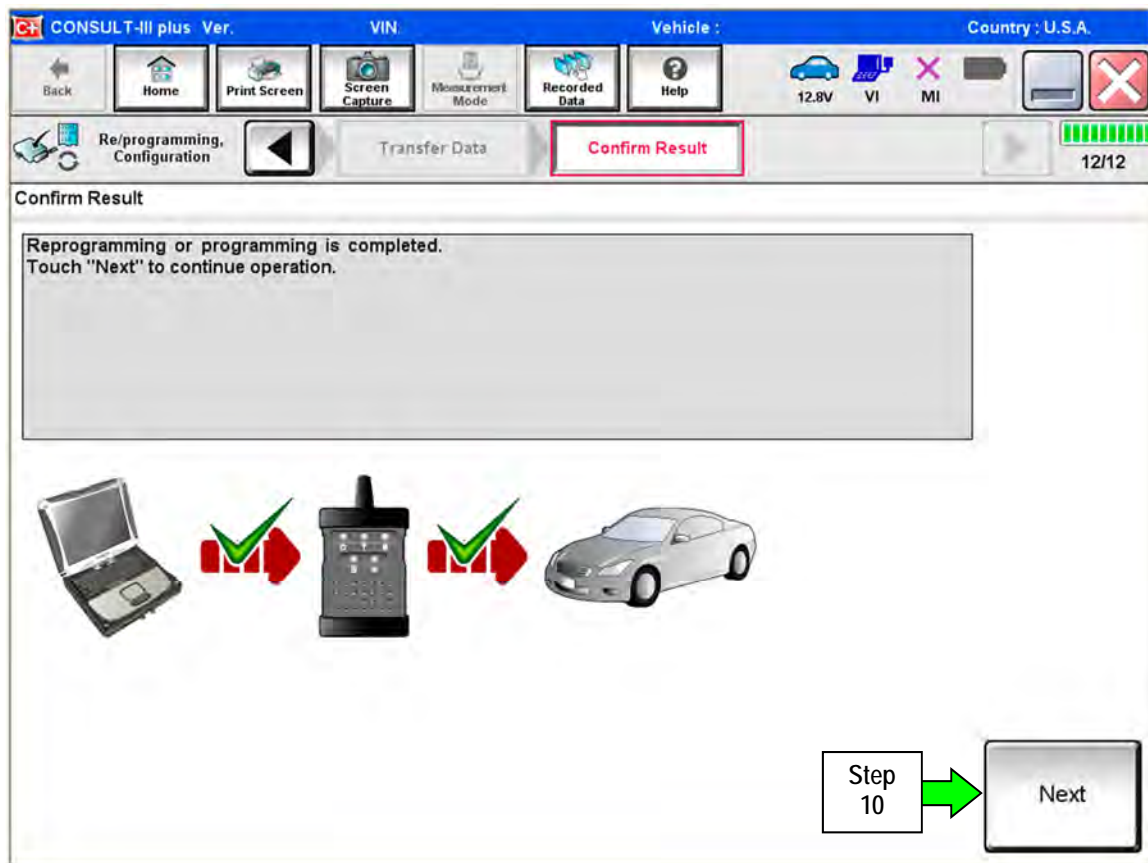
8. When the screen in Figure 5 displays, reprogramming is complete.

NOTE: If the screen in Figure 5 does not display (reprogramming does not complete), refer to the information on page 7.

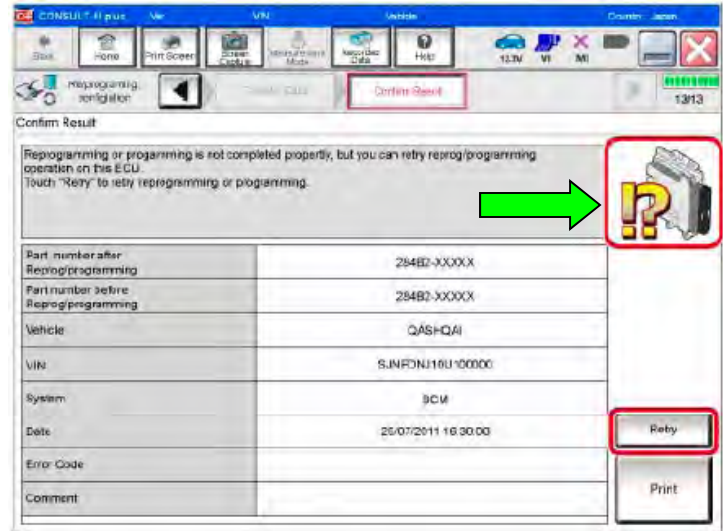
Figure 6

If reprogramming does not complete and the “!?” icon displays as shown in Figure 6:

- Check battery voltage (12.0 - 15.5 V).
- Ignition is ON, engine OFF.
- External Bluetooth® devices are OFF.
- All electrical loads are OFF.
- **Select retry and follow the on screen instructions.**
- “Retry” may not go through on first attempt and can be selected more than once.

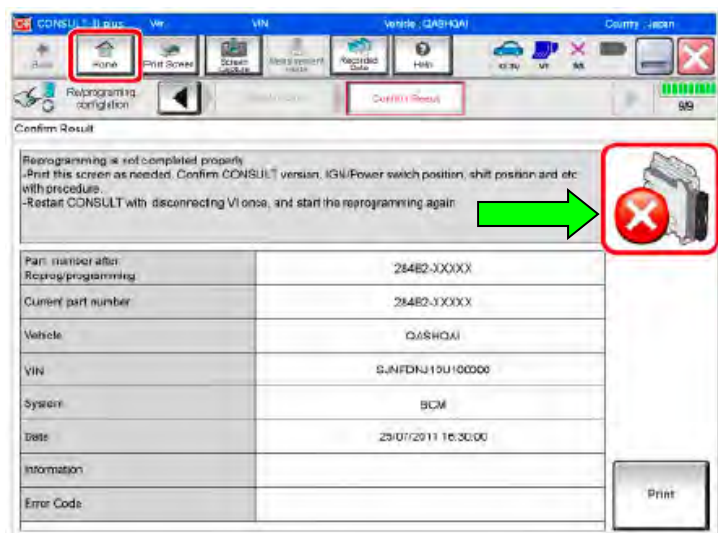
Figure 7

If reprogramming does not complete and the “X” icon displays as shown in Figure 7:

- Check battery voltage (12.0 - 15.5 V).
- CONSULT A/C adapter is plugged in.
- Ignition is ON, engine OFF.
- Transmission is in Park.
- All C-III plus / VI cables are securely connected.
- All C-III plus updates are installed.
- **Select Home, and restart the reprogram procedure from the beginning.**

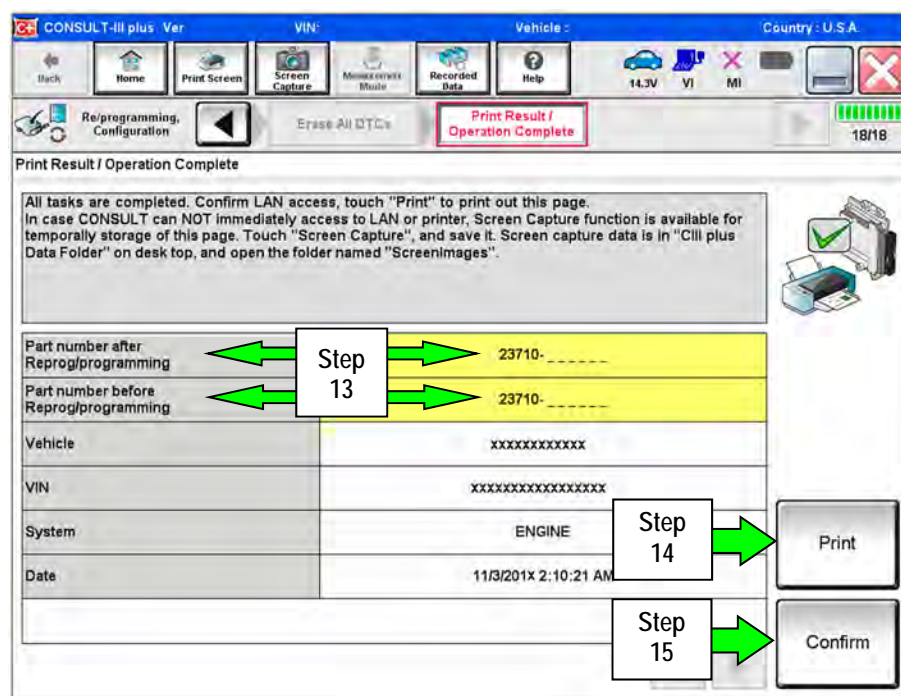
12. When the entire reprogramming process is complete, the screen in Figure 8 will display.
13. Verify the before and after part numbers are different.
14. Print a copy of this screen (Figure 8) and attach it to the repair order for warranty documentation.
15. Select **Confirm**.
