Remote Key Batteries Are Prematurely Discharged

Model	Model Year	Model Type	VIN Range	Vehicle-Specific Equipment
Panamera	2017-2018	971	N/A	N/A

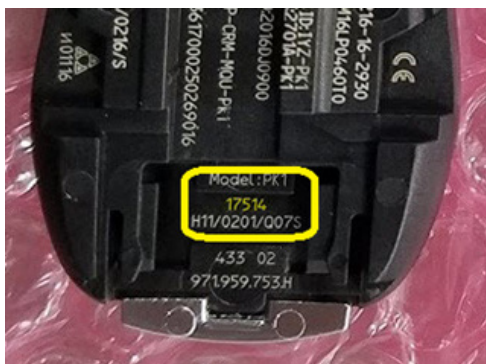
Figure 1

The manufacturing process was modified and no longer damages the key. Keys produced after 8/25/2017 are not affected by this defect. Unaffected keys will have a five digit production date code '17345' or higher. (See figure 1.)

The first two digits are the year: **17** = 2017
The next two digits are the calendar week: **34** = calendar week 34
The last digit is the day of the week: **5** = Friday

The key itself must be replaced. Ensure the following:

1. The part to be replaced was produced before the countermeasure date of 8/25/2017. (The five digit production date code is lower than 17345.)
2. The replacement part was produced after the countermeasure date of 8/25/2017. (The five digit production date code is 17345 or higher.)
