LTB01198NAS2

TECHNICAL BULLETIN

501-03: Body Closures

Gesture Tailgate Unintentionally Opening

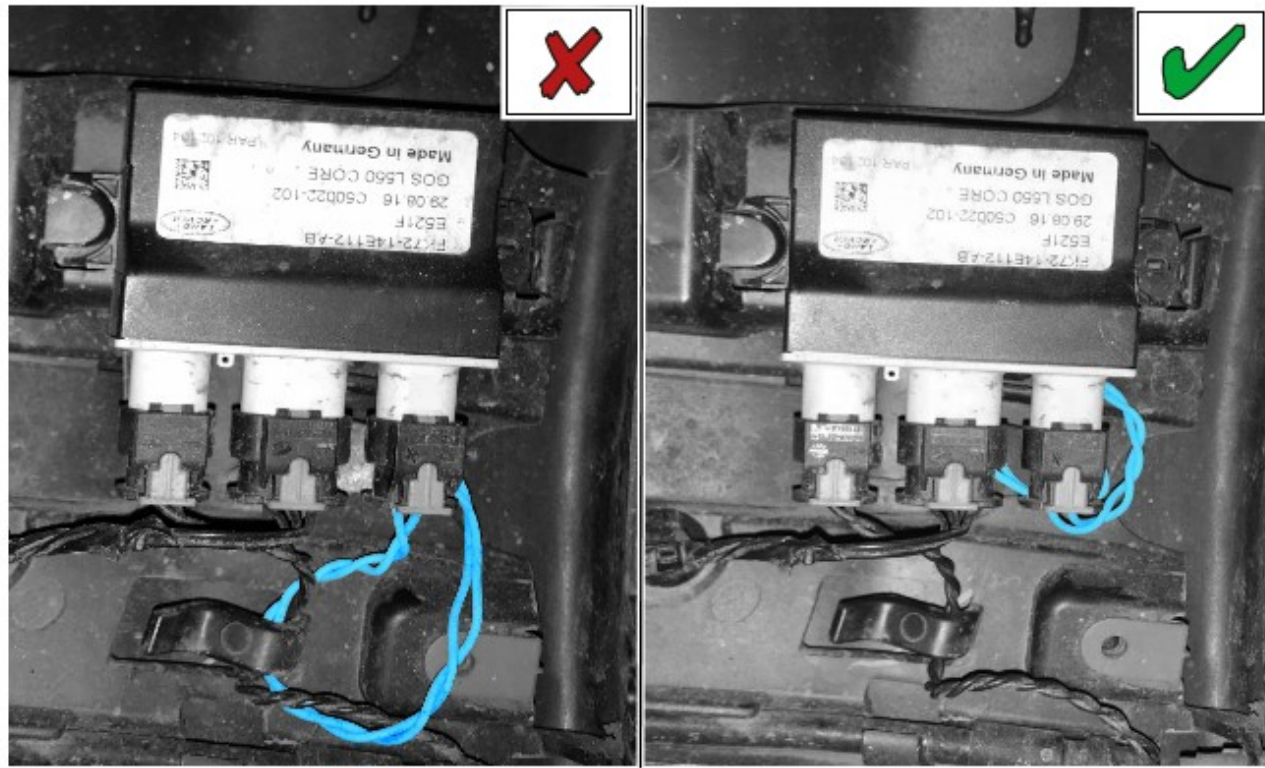
E226705

Inspect the left Hands-Free Tailgate module wiring.

- If the wiring is routed correctly [✓] as shown, go to Step 7.
- If the wiring is not routed correctly [✗] as shown, go to Step 5.
