N076NAS3

# TECHNICAL BULLETIN

502-00: Uni-Body, Subframe and Mounting System

Service Action: Deployable Side Step Fitment Location Rework

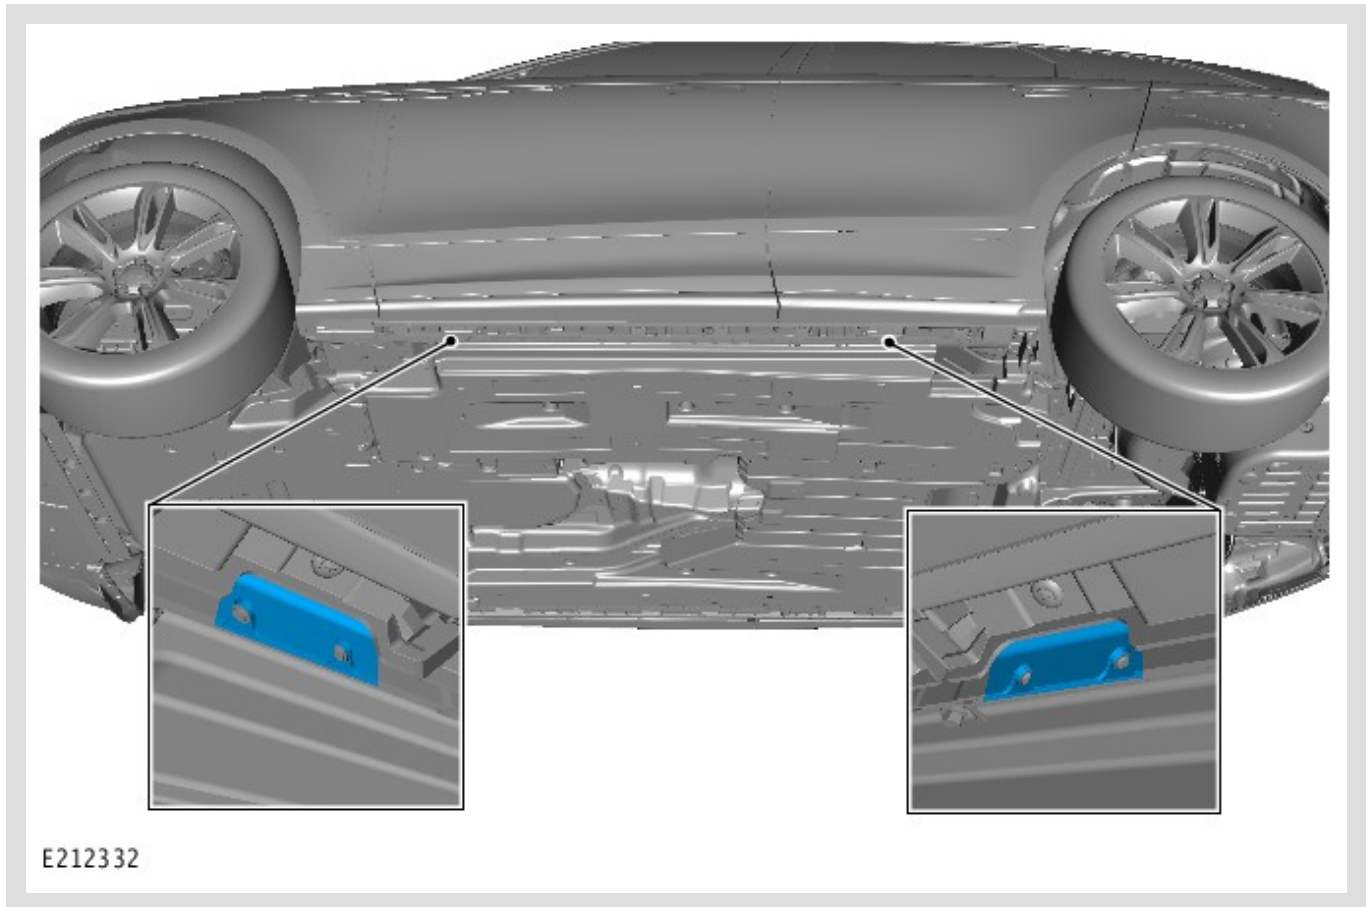
1

Location of the deployable side step mounting holes.

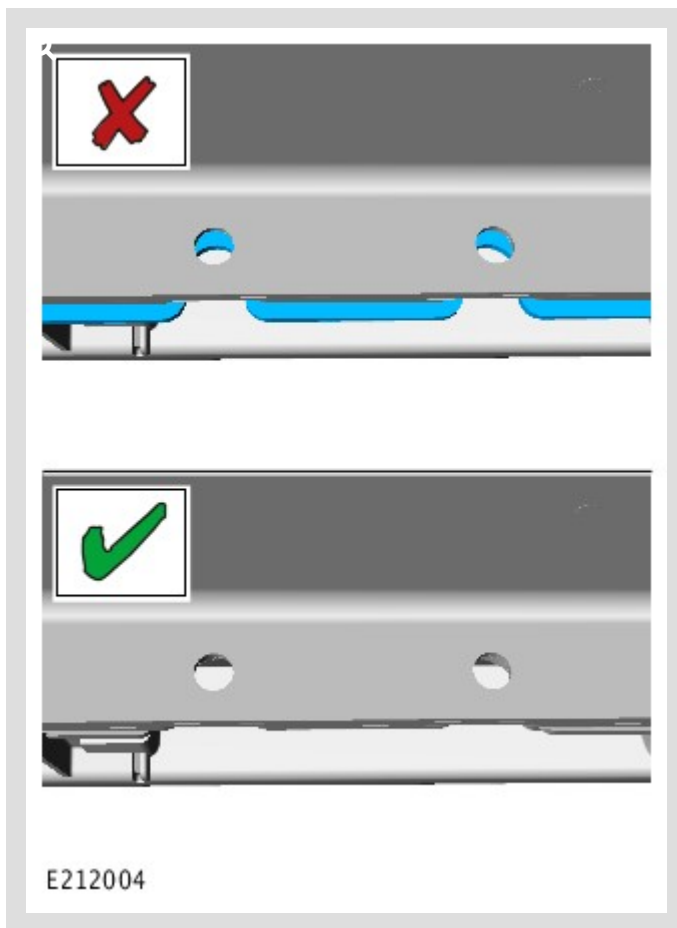
1

Inspect the deployable side step mounting location.

- If the mounting holes are aligned as shown (✓), no modification is necessary.
  - Continue with deployable side step installation.
- If the mounting holes are not aligned as shown (✗), go to Step 2.
