Technical Service Bulletin

34 Oil leak from the ATF sump area

34 18 36 2050215/3 July 10, 2018. Supersedes Technical Service Bulletin Group 34 number 18-29 dated February 16, 2018 for reasons listed below.

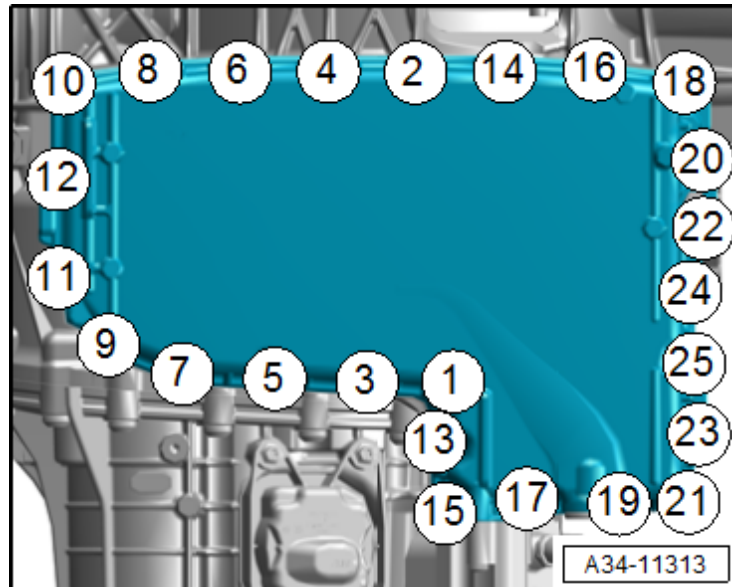
Figure 1. Tightening sequence.

1. Take photos of the actual condition and attach to the Repair Order.
2. Retighten the ATF sump bolts with a torque of 5 Nm. Make sure to follow the correct tightening sequence (Figure 1).

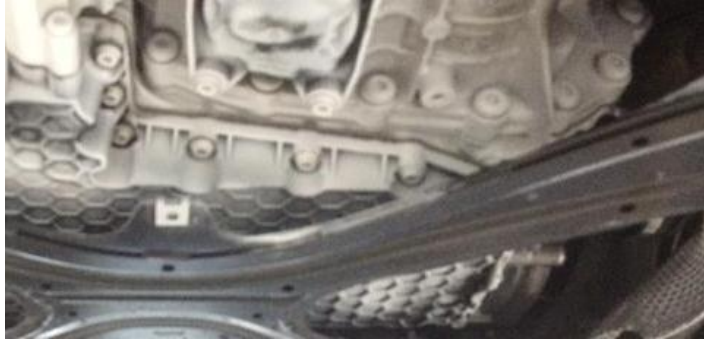
Figure 2: Transmission with oil leak detection spray applied.

4. Apply oil leak detection spray (Part # G 001 900 A1 or a locally available talcum based oil leak detection spray equivalent) to the sealing area of the sump, ATF cooler, drain plug, and the case half seam (Figure 2).

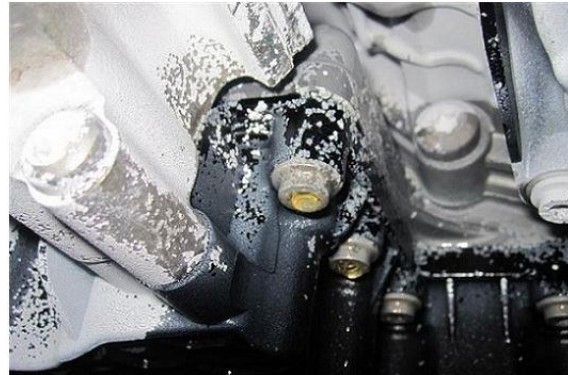
Tip: If there are drips after the test drive as shown (Figure 3) you should be able to determine if the leak is from the ATF sump gasket or if the leak is from elsewhere. Make sure to check for leaks above the sump gasket. Check the seam of the transmission case split and the weep hole of the double seal (Figure 4). Both of these leaks can be confused for an ATF sump gasket leak.

Figure 3. Oil leak.

Tip: If the ATF sump has been diagnosed to be leaking after all the above checks, replace the ATF sump according to the Repair Manual and recheck for leaks. Use Warranty Table 2 if the ATF sump is replaced. If the repair manual is followed using the special tools, the required wheel alignment should not be necessary.

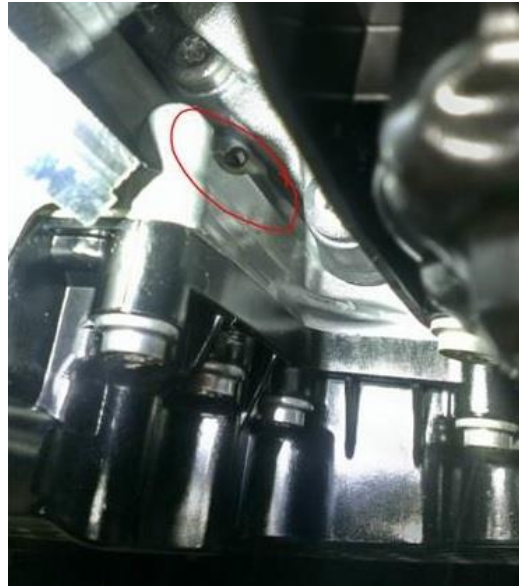
Figure 4. Double seal weep hole location.
