Technical Service Bulletin

55 Rear lid gesture-controlled operation does not work, DTC U115200 stored in comfort control module

55 18 43 2051804/1 July 17, 2018.

Model(s)	Year	VIN Range	Vehicle-Specific Equipment
A4	2017 - 2018	All	With advanced key (hands free trunk opening)
A5, Q5	2018	All	With advanced key (hands free trunk opening)

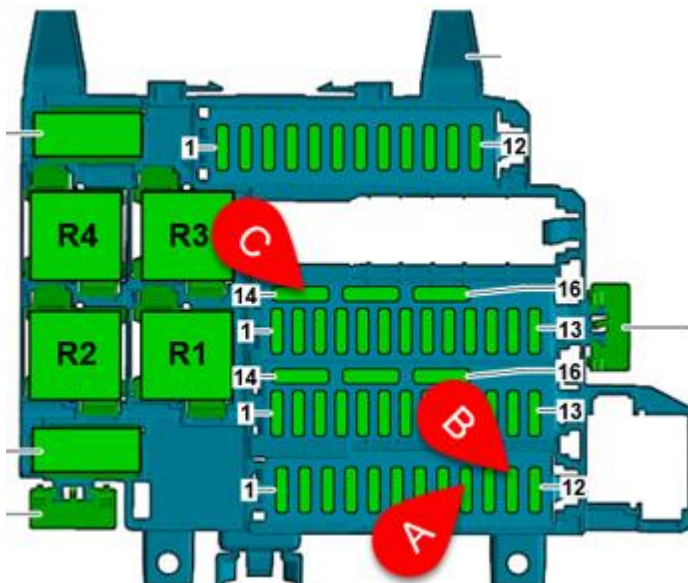
Figure 1. Q5 (FY) Fuse Locations: A: ST1-SF9. B: ST1-SF11. C: ST3-SF14.

- Verify the condition listed above.
- Perform a reset of the comfort control module 0046 by removing the following fuses from the Relay and fuse carrier 2 (SR2), located in the left rear of the vehicle.

3. Wait 30 seconds with all three fuses removed.
4. Reinstall the three fuses.
5. Perform an ignition cycle.
6. If the functionality of the gesture controlled rear lid is restored, no further repairs can be made. This TSB will be updated once software is available to resolve the condition.
7. In the event that functionality is not restored, continue diagnostics with ODIS Guided Fault Finding.

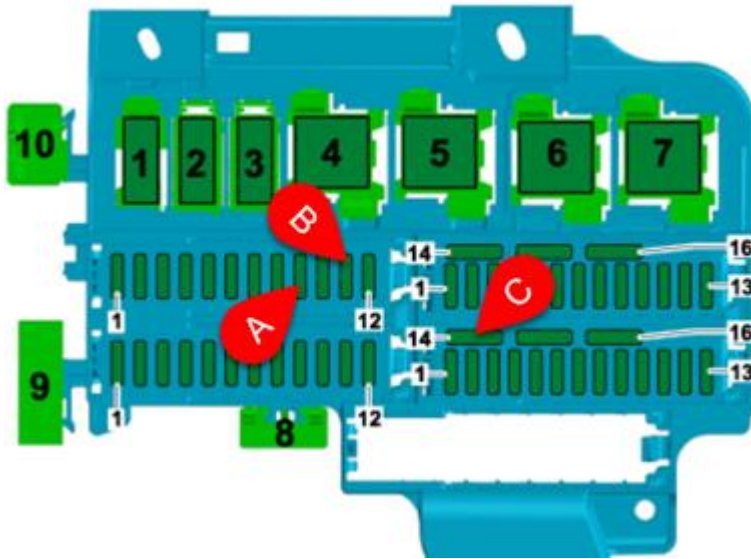
Figure 2. A5 Cabriolet Fuse Locations: A: ST1-SF9. B: ST1-SF11. C:ST3-SF14

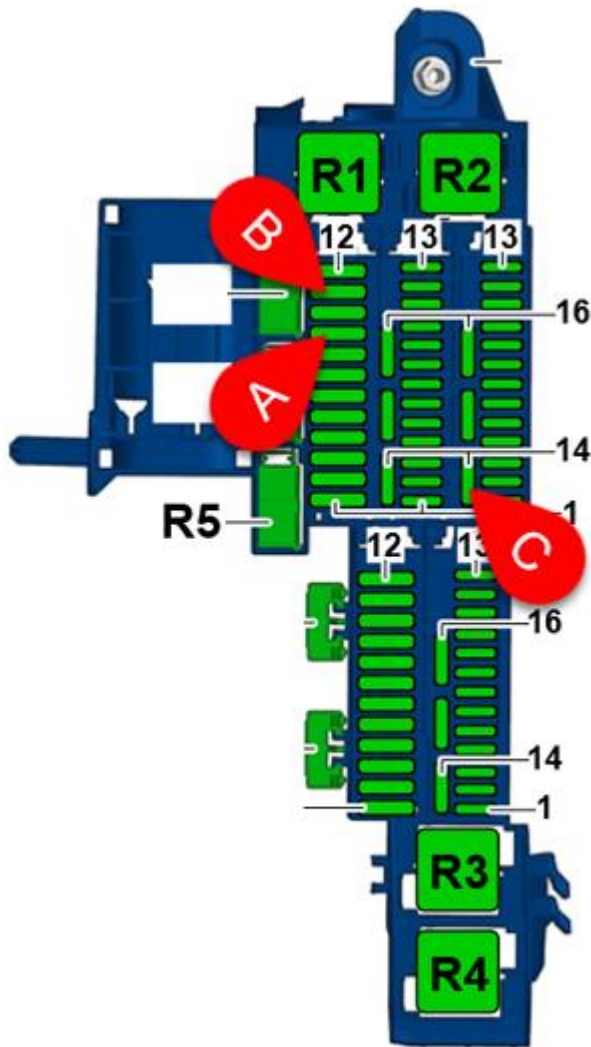
Figure 3. A4, A5 Coupe, and A5 Sportback Fuse Locations: A: ST1-SF9. B: ST1-SF11. C: ST3-SF14.
