74 Front seat side trim loose or broken

74 18 24 2042470/3 July 12, 2018. Supersedes Technical Service Bulletin Group 74 number 17-23 dated March 30, 2017 for reasons listed below.

Model(s)	Year	VIN Range	Vehicle-Specific Equipment	
TT	2016 - 2017	All	Not Applicable	
TT roadster	2016	All	Not Applicable

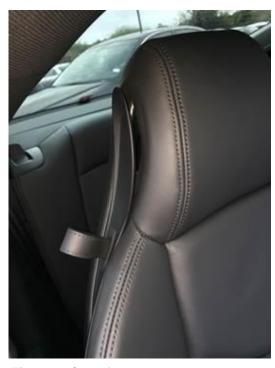
If the customer comes in with concern of seat trim loose and trim is just slightly loose (As shown in Figure 1, Figure 2, and Figure 3), please try to postpone the repair. If the trim is completely loose or falling off, you may move forward with the replacement. You will have to replace the side airbag and airbag guide plate repair kit as well. There is the possibility of a significant delay on those parts at this time.

Figure 1. Outer front seat side trim loose.

The material used in the construction of the trim pieces is of insufficient strength and can break under normal use.

Replace loose or broken trim strips with replacement parts along with the side airbag and airbag guide plate repair kit, following the instructions in Elsa. As noted above, TT roadsters are not eligible to receive the updated ABS outer pieces so no airbag replacement is necessary on the roadster.

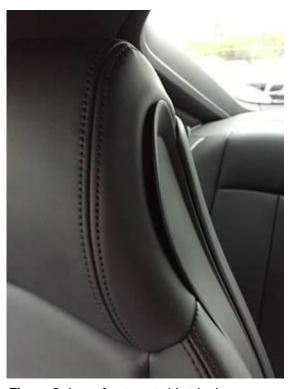
Figure 2. Inner front seat side trim loose.

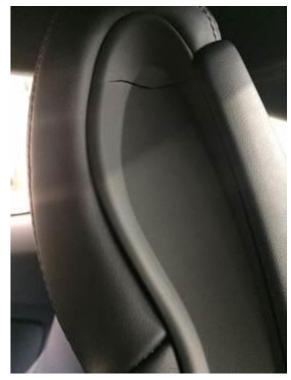
Figure 3. Front seat side trim cracked.

If a piece of trim has broken off, locate and remove the broken piece before reassembly. If the broken piece is not removed, it may cause a rattle noise.
