Technical Service Bulletin

90 Instrument cluster: trip recorder, short, and long-term memory in on-board computer intermittently reset

90 18 93 2051735/1 July 6, 2018.

Model(s)	Year	VIN Range	Vehicle-Specific Equipment
A6, A7	2017 - 2018	All	With multifunction display/trip computer

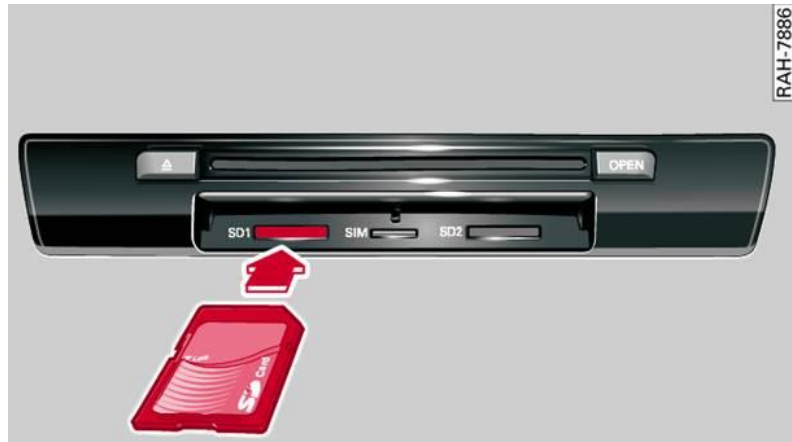
Figure 1. Infotainment control unit (example) position of the SD card for the update.

4. **A.** If the message: "...please insert the Update CD with following part number ..." appears, insert the specified SD card into the infotainment control unit (Figure 1). The infotainment control unit is located in the center console.

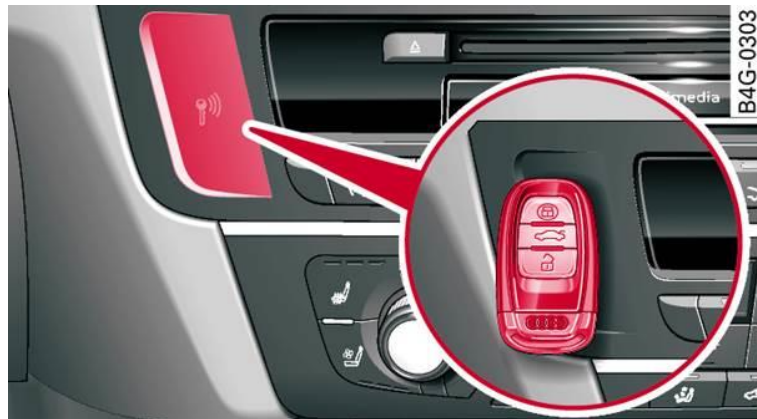
Figure 2. Center console with a location for the vehicle key (example).

4. **B.** If the message: "...hold the vehicle key on the transponder..." appears, hold the vehicle key fully on the provided mark of the center console (Figure 2), until the update starts in the instrument cluster and keep the key in this position until the update is completed.

Tip: It is recommended to affix the vehicle key in this position with an adhesive tape that can be removed without leaving any residue.
