Technical Service Bulletin

94 Rear lights do not switch from bumper to hatchgate after closing

94 18 00 2050234/2 July 17, 2018. Supersedes Technical Service Bulletin Group 94 number 18-96 dated January 30, 2018 for reasons listed below.

Model(s)	Year	VIN Range	Vehicle-Specific Equipment
Q5	2018	All	Not Applicable

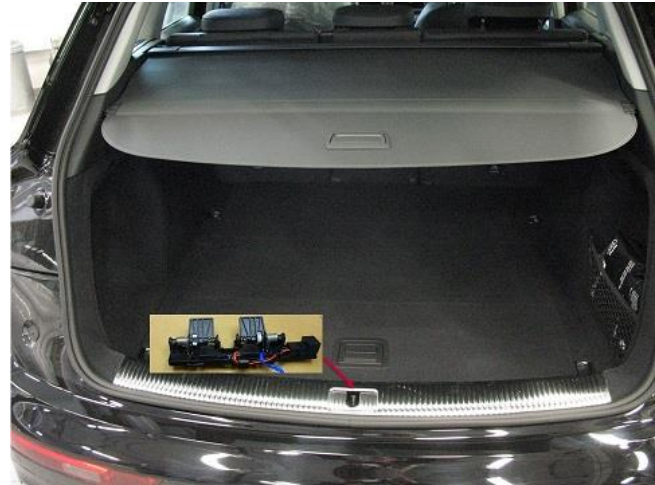
1. The paddle on the micro switch was broken due to adjustment of the rear hatch or the striker in production.
2. Dirt can block one/both paddles on the micro switch, which is fastened on the striker of the rear lid.

Figure 1. Rear lid closed sensor.

1. Replace the rear lid closed sensor if found broken (Figure 1).
2. Blow out any debris that might be causing an obstruction with compressed air (Figure 2).

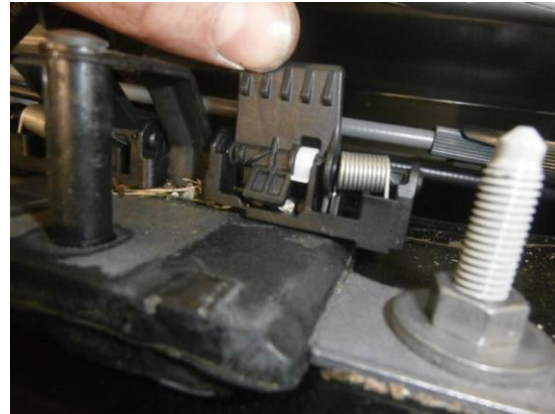
Figure 2. Debris trapped in the rear lid closed sensor.
