SERVICE BULLETIN

Technical Service Bulletin: 51-0692

DOMETIC HEATING FURNACES

Furnace Limit Switch Service Bulletin

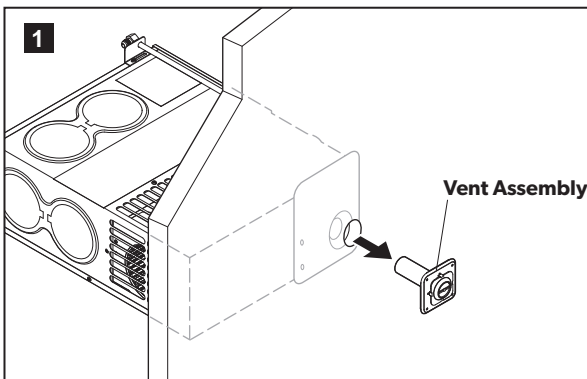
1.1 Removing the vent assembly

The cause of this nuisance issue is a mistaken omission of a plastic wire tie to suspend the heat exchanger limit switch wires up and away from the exhaust tube vent terminal. The omission of this component allows the limit switch wires to potentially melt on the vent terminal, shorting to ground, and causing either the fuse or circuit breaker in the circuit to blow, or the sail switch to become inoperative. **In ALL cases the safety devices in the system are performing as designed and prevent the furnace from operating.**

1 SLEEVING THE EXHAUST TUBE
