# SERVICE BULLETIN

Technical Service Bulletin: 51-0780

## EN Absorption Refrigerators Door Latch Strike Covers Service Kit Installation

**Absorption Refrigerators**  
Service Bulletin

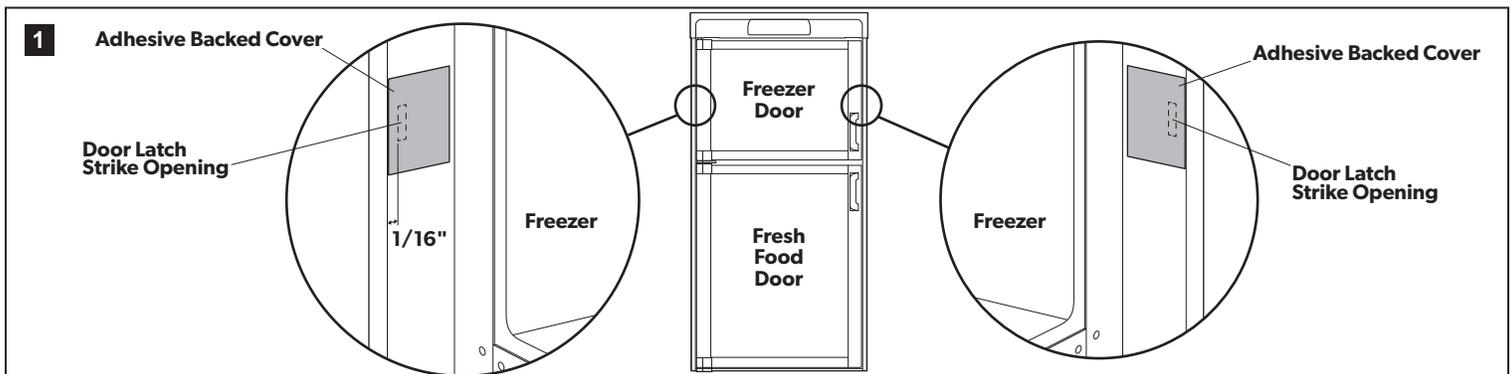
The visual cosmetic defect is that extra door latch strike openings have been punched in the refrigerator frame, and during the assembly process the extra door latch strikes were not installed (please see the illustrations below.) The foam sealing strip, required by ANSI/NFPA 1192 and ANSI Z21.19, is provided to seal the refrigerator against the cabinetry when it is installed into the RV. Although the omission of the door latch strikes leaves small cosmetic openings that can be seen visually, the foam sealing strip located behind the door latch strike openings at the freezer provides a seal to maintain complete separation of the combustion system from the interior atmosphere of the recreational vehicle, as stated in ANSI/NFPA 1192.

- Remove one adhesive backed cover from the paper backing and install the cover over one of the door latch strike openings using the following guidelines:
  - The area in which the adhesive backed cover will be applied must be clean and free of any residue that will impact the ability of the cover to adhere properly.
  - The adhesive backed cover must completely cover the door latch strike opening and extend towards the front edge of the refrigerator frame by at least 1/16".
  - The adhesive backed cover must be centered vertically over the door latch strike opening.
- Once the cover is in place, apply light pressure across the surface of the cover to ensure that the cover firmly adheres to the refrigerator frame.

**i** Extra adhesive backed covers are included. If for any reason the adhesive backed cover is installed improperly, remove the cover and install a new adhesive backed cover. The adhesive backing on the cover is intended for a one-time application only.

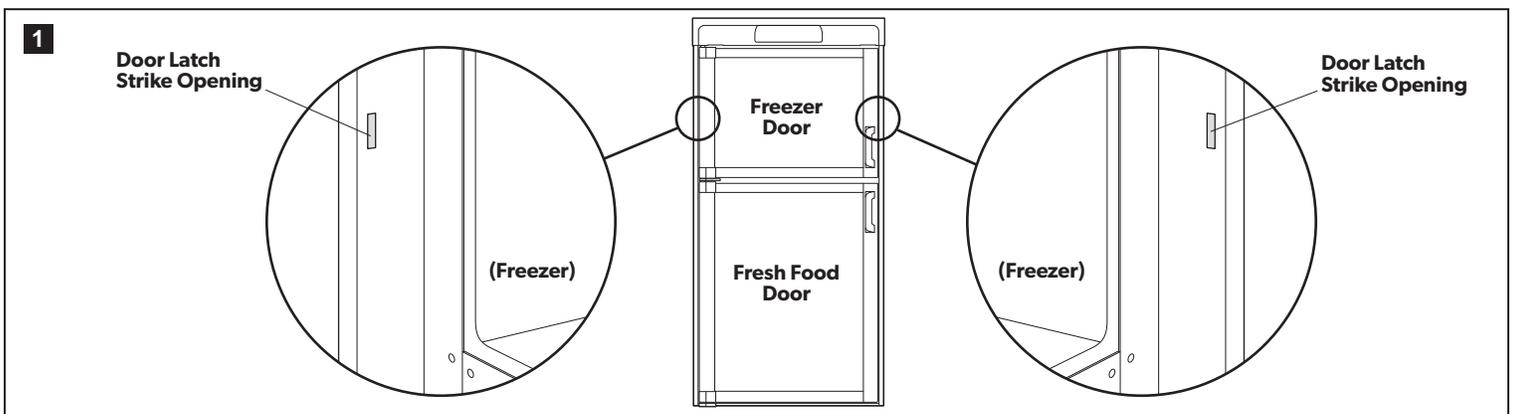
### Identifying the door latch strike openings

The visual cosmetic defect is that extra door latch strike openings have been punched in the refrigerator frame, and during the assembly process the extra door latch strikes were not installed (please see the illustrations below.) The foam sealing strip, required by ANSI/NFPA 1192 and ANSI Z21.19, is provided to seal the refrigerator against the cabinetry when it is installed into the RV. Although the omission of the door latch strikes leaves small cosmetic openings that can be seen visually, the foam sealing strip located behind the door latch strike openings at the freezer provides a seal to maintain complete separation of the combustion system from the interior atmosphere of the recreational vehicle, as stated in ANSI/NFPA 1192.

The openings in the refrigerator frame from the missing door latch strikes at the freezer are located at a height far above the external refrigerator sidewall vent openings in the refrigerator ventilation and combustion compartment. Any combustion products produced by the refrigerator will exit to the outside of the RV through those vent openings, and prevent any build-up of combustion particles to the level of the extra door latch strike openings. Therefore, this visual cosmetic defect does not result in a safety risk to any occupant of the interior atmosphere of the recreational vehicle.

The repair that will be made on the refrigerator is to install an adhesive backed cover over the two door latch strike openings. The repair kit will be single packed (3316893.990) as one kit or bulk packed (3316893.991) in a quantity of twenty five kits. One kit will consist of an instruction sheet and four adhesive backed covers. There are two extra adhesive backed covers provided in case of an improper application.
