**Title:** Batt2 Load Shed Relay Failure

**Applies To:** LT's Without 16UZZL

This document will guide the user through identifying a failed relay and possibly a spread terminal resulting in loss of power to the sleeper.

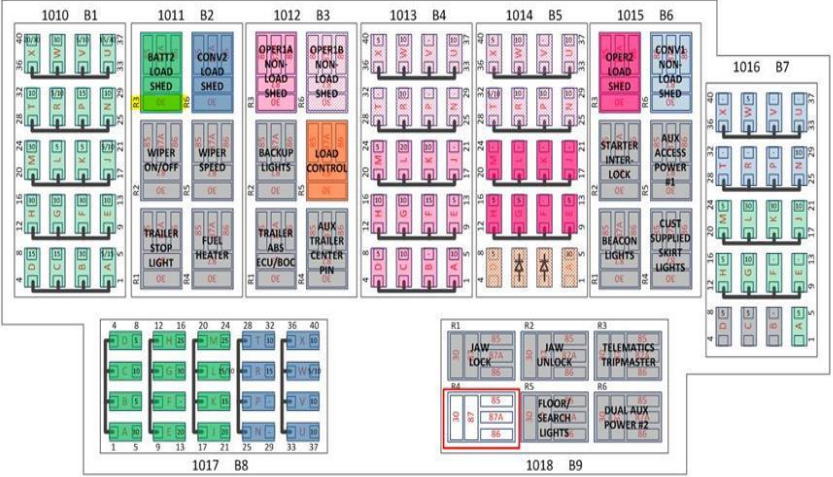
| Step | Action | Decision |
|---|---|---|
| 2 | Current LT Series IP Fuse Block Layout<br> | <ol style="list-style-type: none"> <li>1. Gain access to the PDM located on the passenger side of the unit.</li> <li>2. Locate the batt2 load shed relay in the PDM.</li> <li>3. Proceed to next step</li> </ol> |

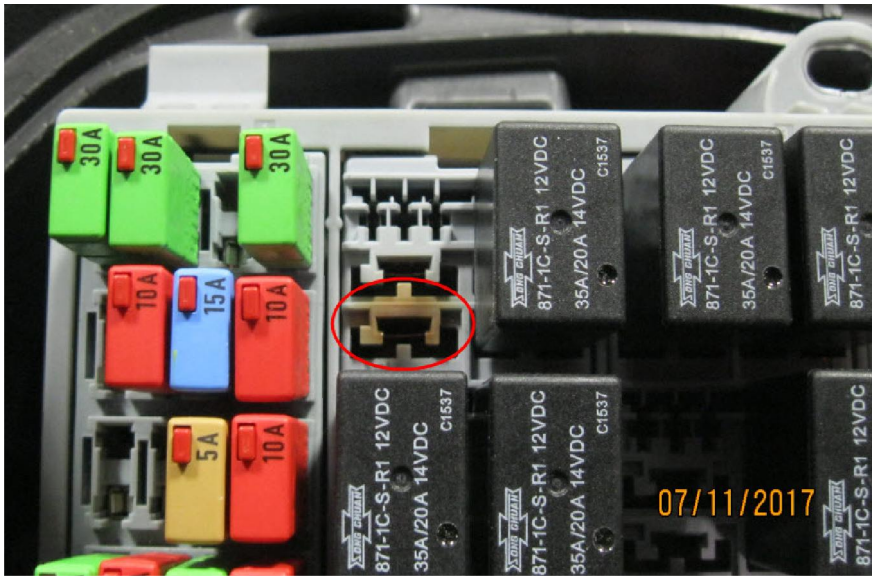
| Step | Action | Decision |
|---|---|---|
| 3 | | <ol style="list-style-type: none"> <li>1. Remove relay and inspect for signs of discoloration in the PDM like the photo. Apply power to pin 85 of the relay and ground to pin 86 and listen for a click. Replace the relay if no audible noise heard.</li> <li>2. Inspect the terminal for signs of spreading or damage from heat.</li> <li>3. Remove the wire at pin 87 (A14N) - proceed to next step.</li> </ol> |
