| <b>Countries:</b> | CANADA, UNITED STATES | <b>Document ID:</b> | IK1600227 |

**Title:** Loose, Missing, or Damaged Glass in the LT Hood Mounted Mirror

**Applies To:** LT

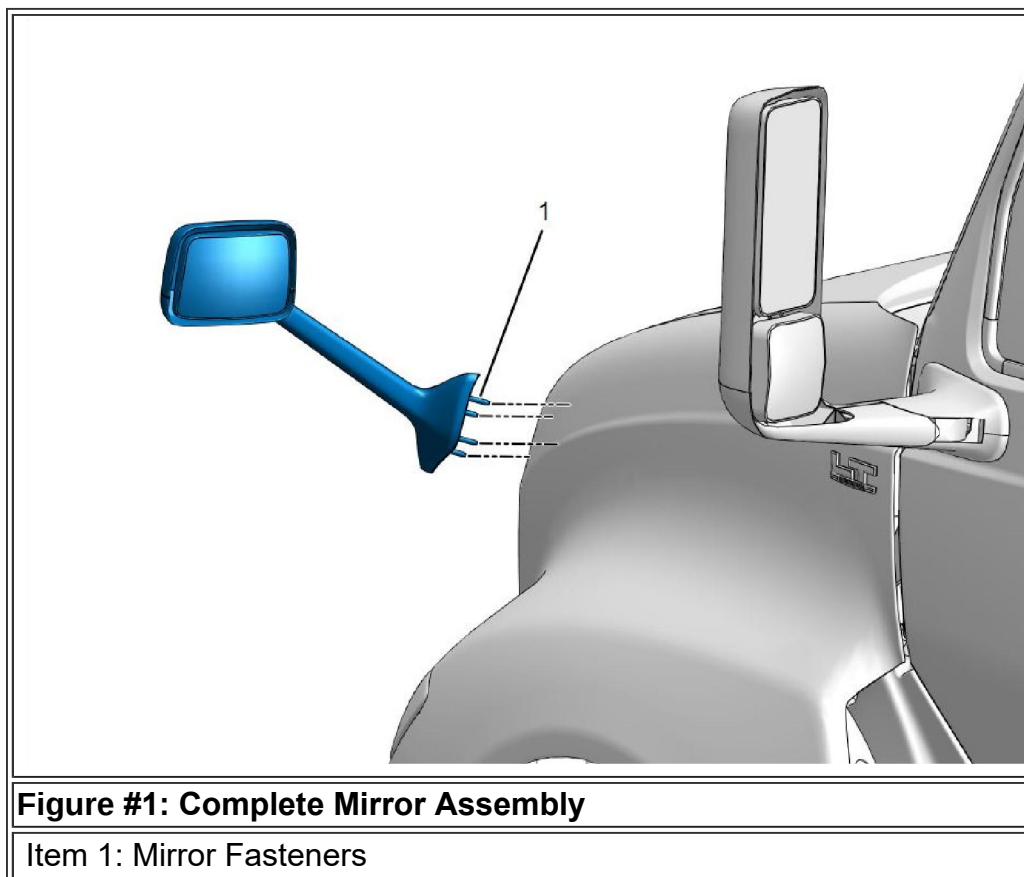
Inspect the condition of the mirror assembly. If the mirror is either loose or missing, the complete mirror assembly (Head & Arm) will need to be replaced.

1. Open hood to gain access to the the mirror assembly mounting hardware.
2. Remove 4 fasteners (Figure 1, item 1).

3. Remove complete mirror assembly from vehicle taking care not to damage top coat paint.
4. Reinstall new mirror and torque fasteners to 9-12 ft-lb (12.2 - 16.2 Nm)
5. Close and relatch hood. Readjust mirror glass as needed.
