**Document ID:** IK1900256

**Title:** ISB AC Compressor Radial mount failure

**Applies To:** Workstar

This document will guide the user through correcting ISB Radial mount AC compressor failure.

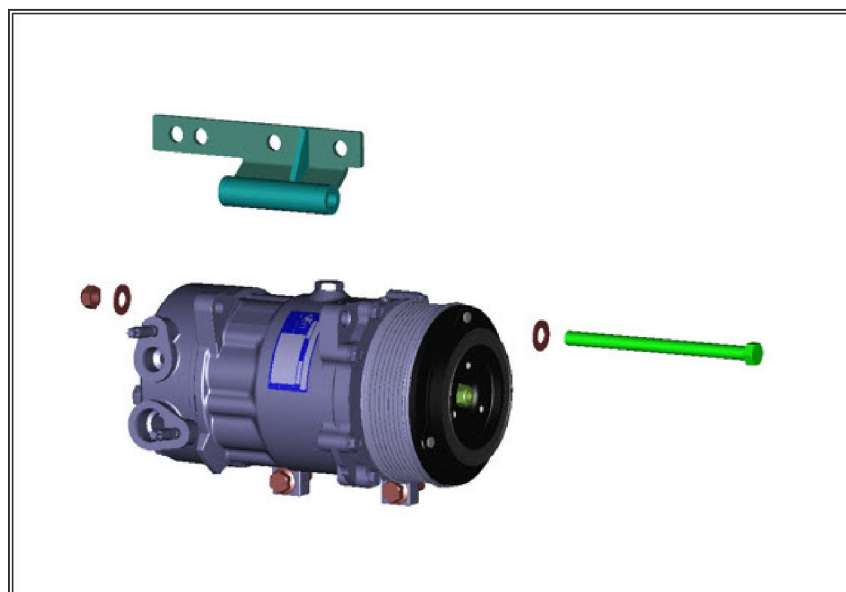
Failed AC compressor with cracked/broken mounting mounting points.

If the compressor is found failed, and cracks are found in the mounting tabs for RADIAL mounts, you will need to add two washers in order to correctly fasten to the AC Compressor to the Radial mount. Add washer part number 120394 under head of bolt 25684R1, also under nut 9413979 as shown in the below figure.
