Engine Idle Surge With Steering Input

Service Category Engine/Hybrid System

Section Engine Control

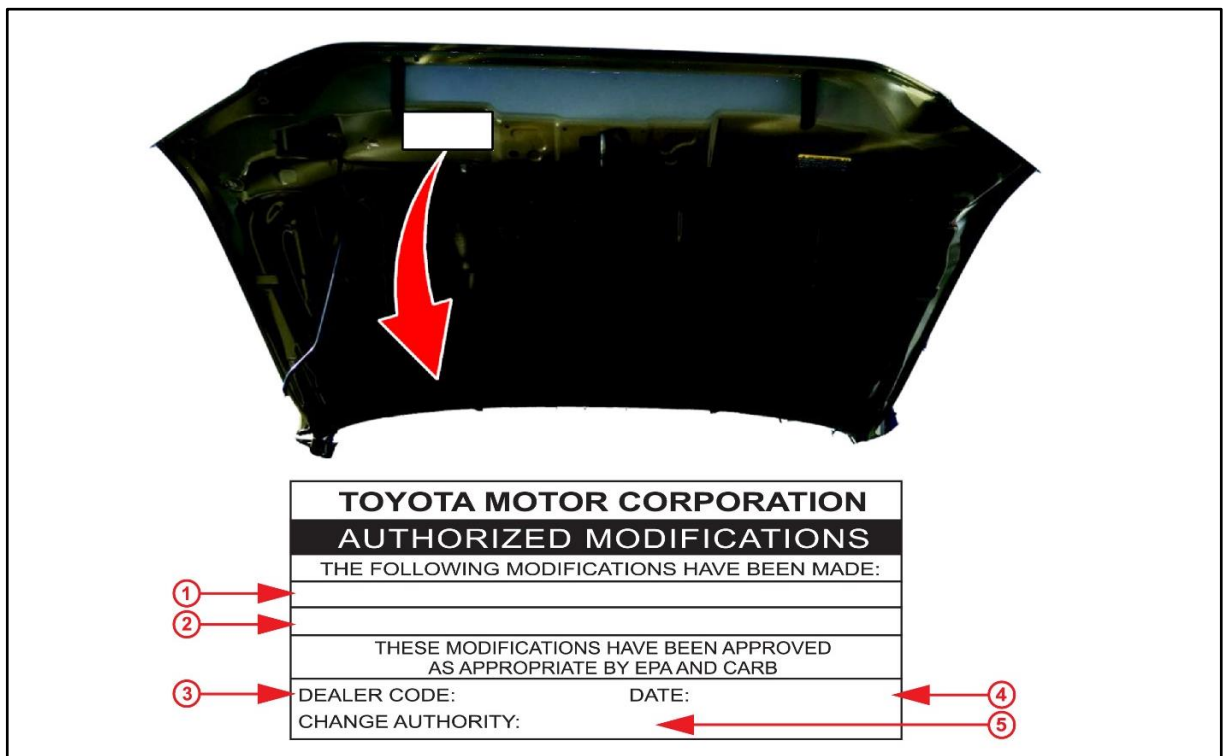
Figure 1. Location of Authorized Modifications Label for 2016–2017 Tacoma

- Check for the Authorized Modifications Label affixed to the vehicle in the location shown below. Confirm if the ECM (PCM) calibration has been updated.

- Prepare and install the Authorized Modifications Label.
 - Using a permanent marker, enter the following information on the label:
 - ECM part number [Refer to the **Parts Information** section for the **NEW PART NUMBER**]
 - Calibration ID(s) [Refer to the **Calibration Information** section for the **NEW CALIBRATION**]
 - Dealer Code
 - Repair Date
 - Change Authority [**This bulletin number**]
 - Install the Authorized Modifications Label to the vehicle at the location shown in Figure 1. The Authorized Modifications Label is available through the MDC, P/N 00451-00001-LBL.
- Start the engine and verify the condition is resolved.
- Warm up the engine to normal operating temperature and test-drive the vehicle to confirm proper operation.
