Service

Section Automatic Transmission/Transaxle

YEAR(S)	MODEL(S)	ADDITIONAL INFORMATION	
2016 - 2017	Land Cruiser

TCM Calibration: Transmission Software Enhancements

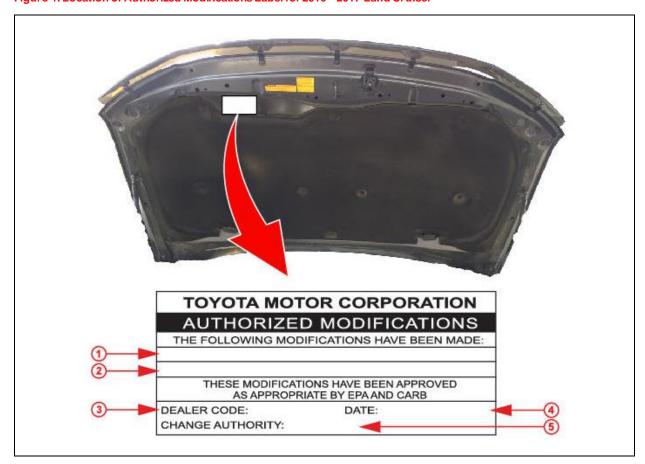
Figure 1. Location of Authorized Modifications Label for 2016 - 2017 Land Cruiser

- 2. Check for the Authorized Modifications Label affixed to the vehicle in the location shown below. Confirm if the TCM calibration has been updated.
 - Is the calibration ID listed the latest TCM calibration?
 - YES This bulletin does NOT apply. Continue diagnosis using the applicable Repair Manual.
 - NO Continue to step 3.

- Install the Authorized Modifications Label.
 - A. Using a permanent marker, enter the following information on the label:
 - TCM part number [Refer to the **Parts Information** section for the **NEW PART NUMBER**]
 - Calibration ID(s) [Refer to the **Calibration Information** section for the **NEW CALIBRATION ID**
 - Dealer Code
 - Repair Date
 - Change Authority [This bulletin number]
 - B. Affix the Authorized Modifications Label to the vehicle at the location shown in Figure 1. The Authorized Modifications Label is available through the MDC, P/N 00451-00001-LBL.
- Perform transmission initialization.
