## Technical Service Bulletin

| <b>Topic</b> | Engine: engine management light on, possible misfire: event entry with 'Camshaft adjuster "A" or "B" ' |
| <b>Transaction No.</b> | 2051769/2 |

### Bentayga W12

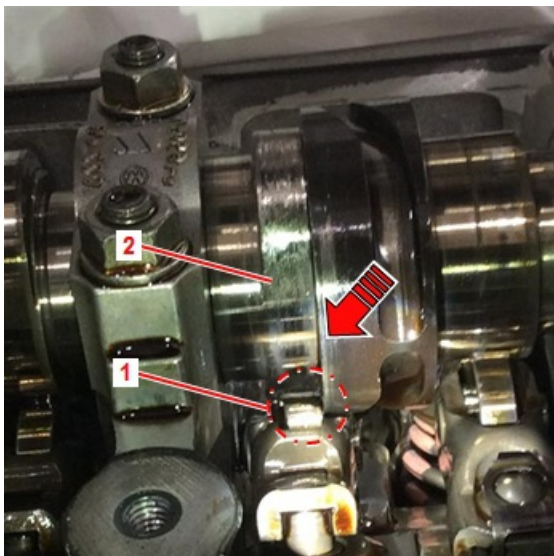
In isolated cases the failure of the roller tappet can lead to the fault code 'Camshaft adjuster "A" or "B" cylinder (X) Self switching" being stored in the event memory of **address 0011**.

Figure 1: Example of roller tappet damage.

1. Complete the event entries with the vehicle tester, checking all circuitry of the CDA system.
2. If the test plan leads to a replacement of the camshaft adjuster, firstly apply **TPI 2051187/1** -providing compressions and cylinder leakages. If no obvious fault can be determined, follow point 3.
3. Remove the camshaft cover for bank 2 and check for damage to the relevant cylinder roller tappet.

If this failure is identified please raise a DISS technical query with your findings-to include attached images and current diagnostic log.
