Technical Service Bulletin

Bentayga

Steering malfunction message displayed on dash, DTC 'C10AC07-Steering mechanical malfunction' stored

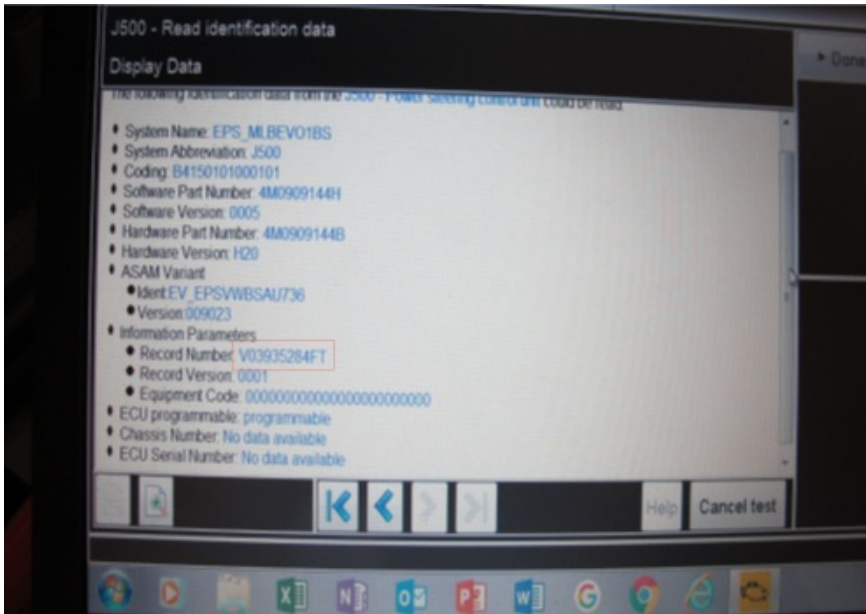
Figure 1

Under the title **Information Parameters**, the **Record Number** should end in suffix **FT**, see *Figure 1*. This confirms the procedure has been successful.
