SIL 14-TR-18  
September, 2018  
Page 1 of 72

**SUBJECT:** Allison Transmission 5th Generation Controls 2018 BC 181 – New/Updated Diagnostic Trouble Codes (DTCs)

**MODELS AFFECTED:** 1000, 2000, 3000 and 4000 Series Product Families (Including B and T Models)

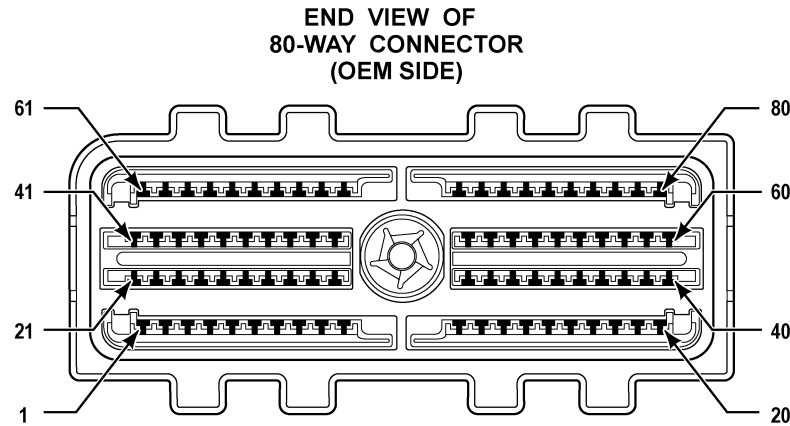
301748

This test counts how many accelerations events occur while the Neutral at Stop input indicates "ON". Failure is when the number of events exceeds 3 acceleration while Neutral at Stop is "ON".

In some applications, this test counts how many deceleration events occur while Neutral At Stop indicates "OFF" and the engine running time while in range. Failure is when the number of event exceeds 20 deceleration events and the engine running time exceeds a calibrated time.

- Short to power or short to another wire for the GPI circuit controlling Neutral at Stop feature, i.e., W143.
- For service brake integrations, defective switch or incorrect wiring, e.g., pressure switches are closed when they should be open. If Neutral at Stop enable switch or door switch integrated in series, all switches would need to be stuck closed or wired on wrong side of switches, e.g., normally closed side vs normally open side.

- For PLC Neutral at Stop integrations, a miswired, misprogrammed, or defective circuit from PLC controlling the TCM GPI signal for Neutral at Stop that is maintaining circuit above 3.4 volts with service brakes released.

- Defective TCM.

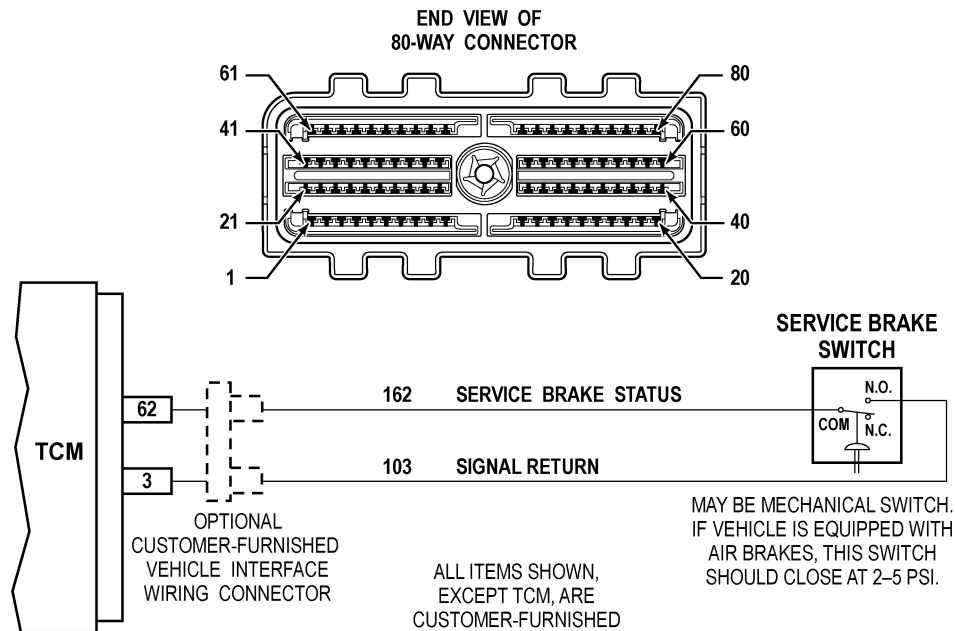
434904

This test counts how many accelerations events occur while the brake switch input indicates "ON". Failure is when the number of events exceeds 3 acceleration while Neutral at Stop is "ON".

In some applications, in addition, this test counts how many deceleration events occur while the brake switch input indicates "OFF" and the engine running time while in range. Failure is reported when the number of events exceeds 20 deceleration events and the engine running time exceeds a calibration.

- Open or short in wire 103 or wire 162.
- Malfunctioning brake system control components such as:
  - Miswired or defective brake system wiring.
  - Defective brake pressure switches.
- Defective TCM.

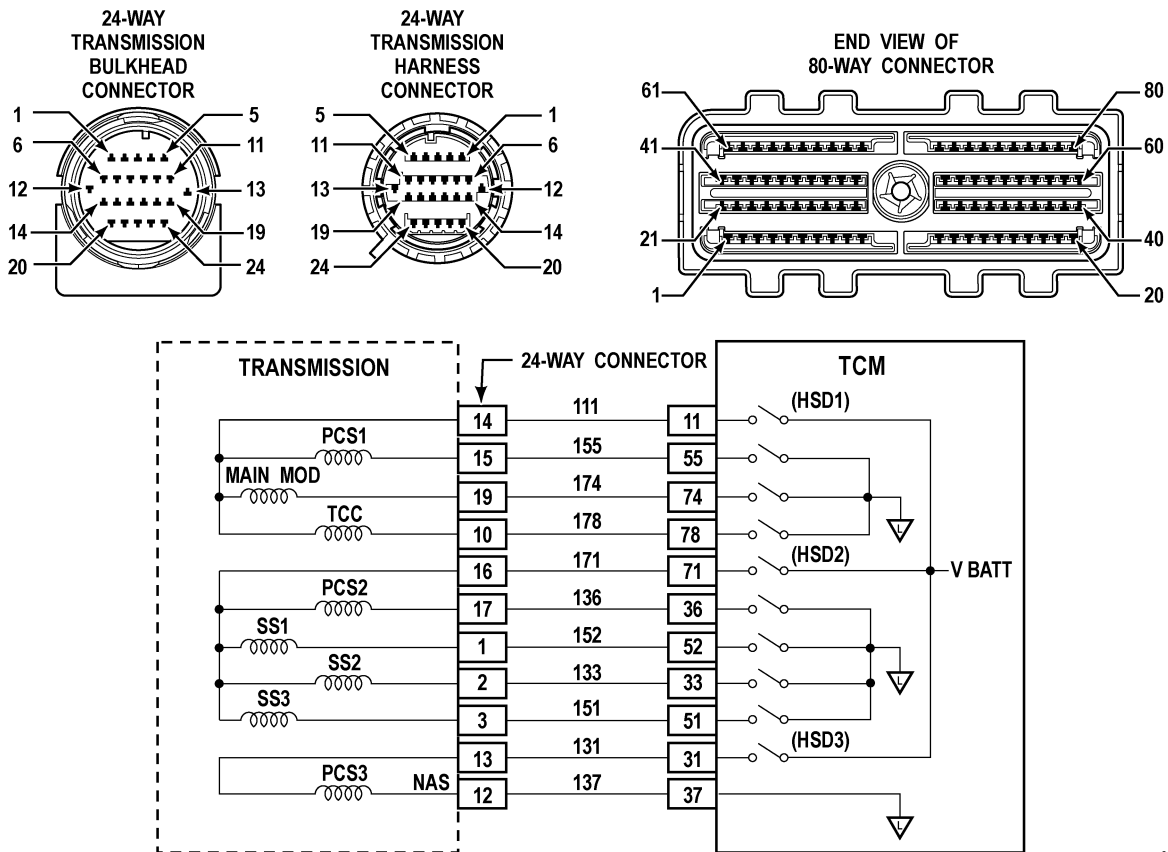
3217237

The TCM sends control current to PCS2 from High Side Driver 2 (HSD2) via wire 171. HSD2 is continuously on unless the TCM detects a fault condition. The TCM regulates the amount of current to PCS2 by switching the low side driver ON and OFF. Wire 136 completes the circuit between PCS2 and its low side driver. DTC P0965 indicates that the TCM processor has detected an open, short to ground, short to power or wire to wire shorts condition in the electrical circuit.

- DTC P0965 indicates an open, short to ground, short to power or wire to wire shorts in the electrical circuit for PCS2.
- Inspect the wiring for poor electrical connections at the TCM and the transmission main connector. Look for the following conditions:
  - A bent terminal
  - A backed-out terminal
  - A damaged terminal
  - Poor terminal tension
  - A chafed wire
  - A broken wire inside the insulation

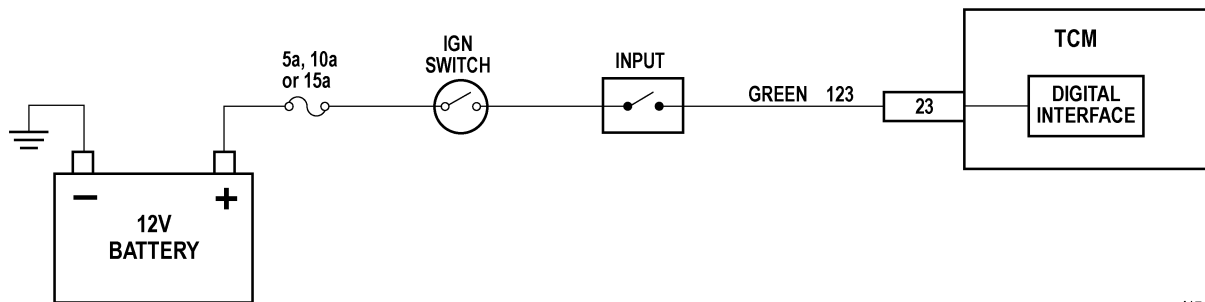
This DTC is set when the TCM detects if the Run/Start wired input to the TCM is low when it is expected to be high.

DTC P2534 indicates that the TCM processor has detected low and open conditions in the ignition switch run/start electrical circuit. Open, short to ground or wire to wire short conditions may exist in the ignition switch run/start circuit (wire 123).

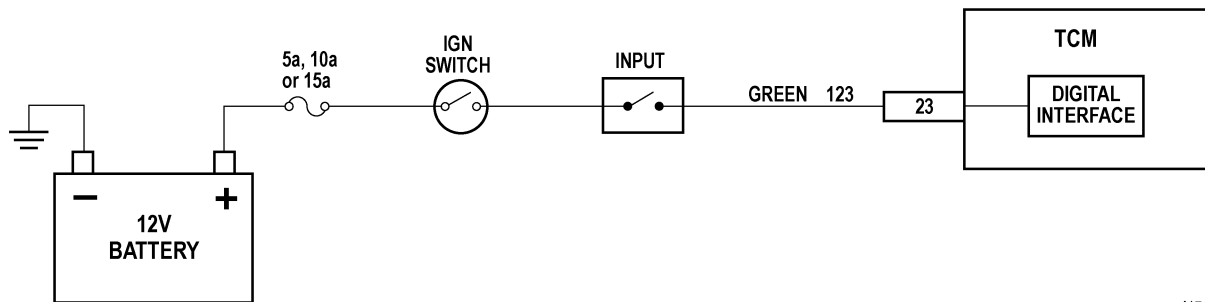
This DTC is set when the TCM detects if the Run/Start wired input to the TCM is high when it is expected to be low.
