FIELD ACTION LETTER

2015FA06, Rev. B  
September, 2018  
Page 1 of 6

SUBJECT: Global Customer Satisfaction Field Action - Torque Converter Backing Plate Bolt (3000 Series™ Product Family).

MODELS AFFECTED: B300, B400, T260, T270, T280, T310, T325, T350, T375, T390, 3000 Series™ Product Family

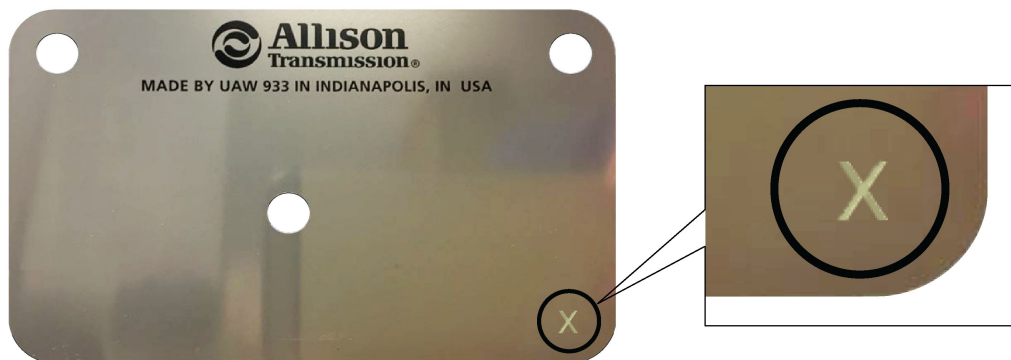
**Figure 1. Identification Mark**

- a. Verify the vehicle's transmission serial number matches the serial number for the authorization number issued.
  - b. Verify the transmission nameplate does not have the "X" Identification Mark indicating Field Action service work has already been completed. Refer to [Figure 1](#).

25. Stamp or etch an "X" identification mark into the transmission nameplate in the location shown in [Figure 1](#).
26. Reinstall transmission into vehicle.
