JAGUAR LAND ROVER

LTB01065NAS3

# TECHNICAL BULLETIN

Tailgate Does Not Open

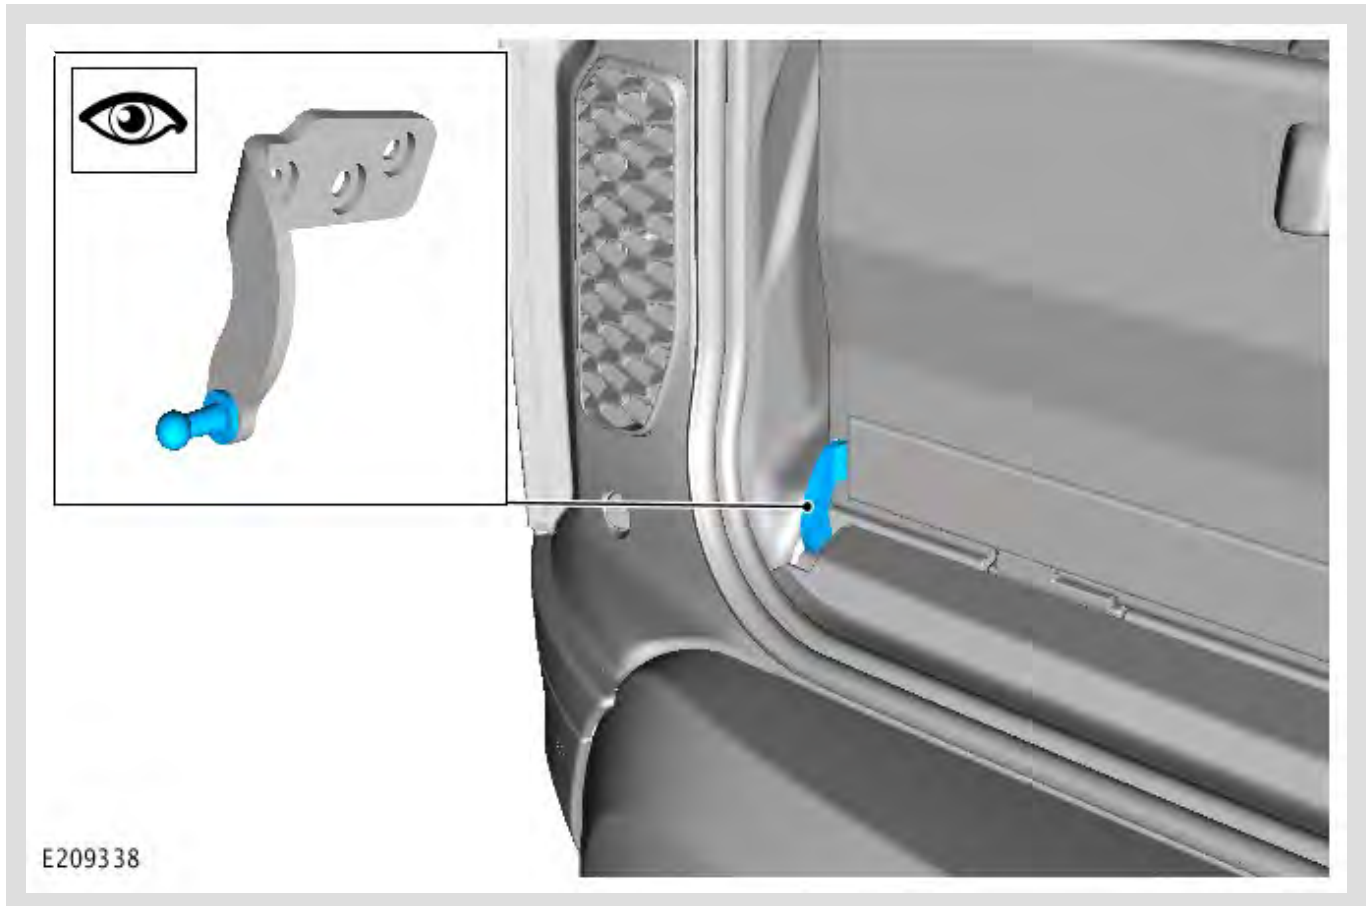
1

Deployable luggage compartment floor operating arm location.

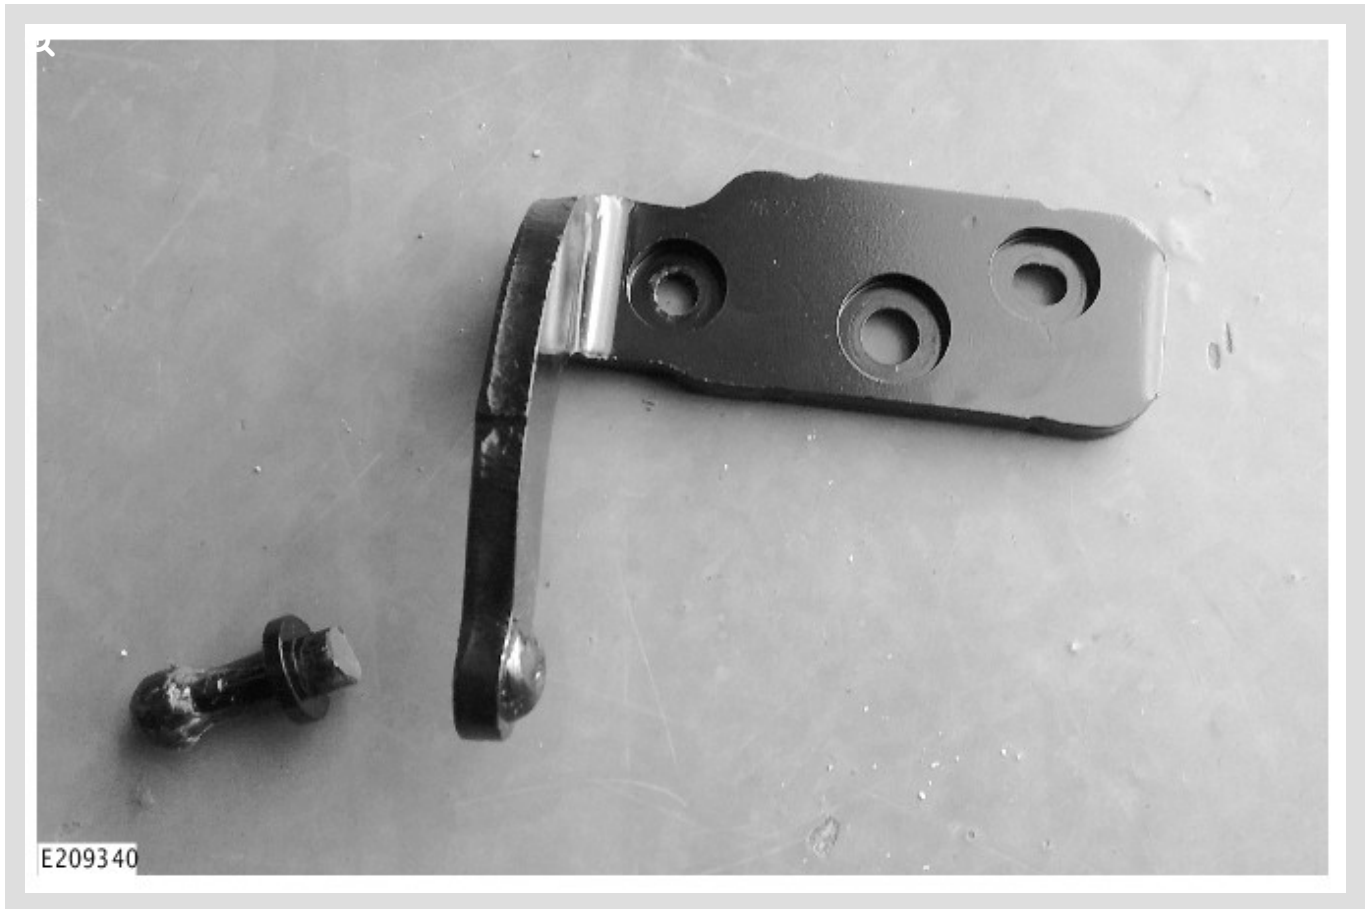
1

Failed condition shown; the deployable luggage compartment floor operating arm may not be as shown.

Example: deployable luggage compartment floor operating arm damage.

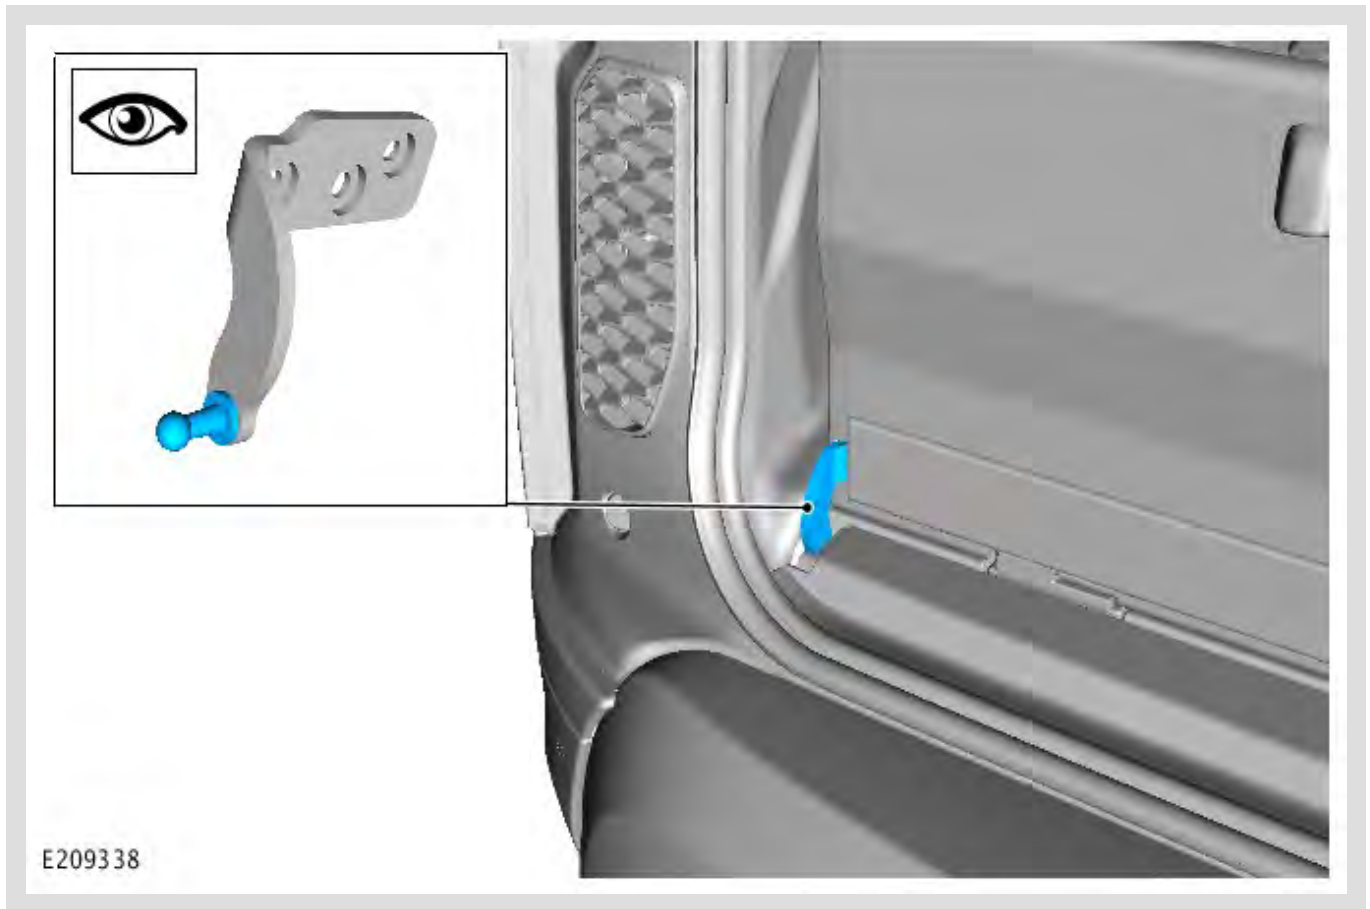
3

Inspect the deployable luggage compartment floor operating arm for damage (cracks/fractures).

- **VIN 011189-017814** - no further action required.
  - Release the vehicle.
- **VIN 000001-011188** - go to WORKSHOP PROCEDURE 'B'.

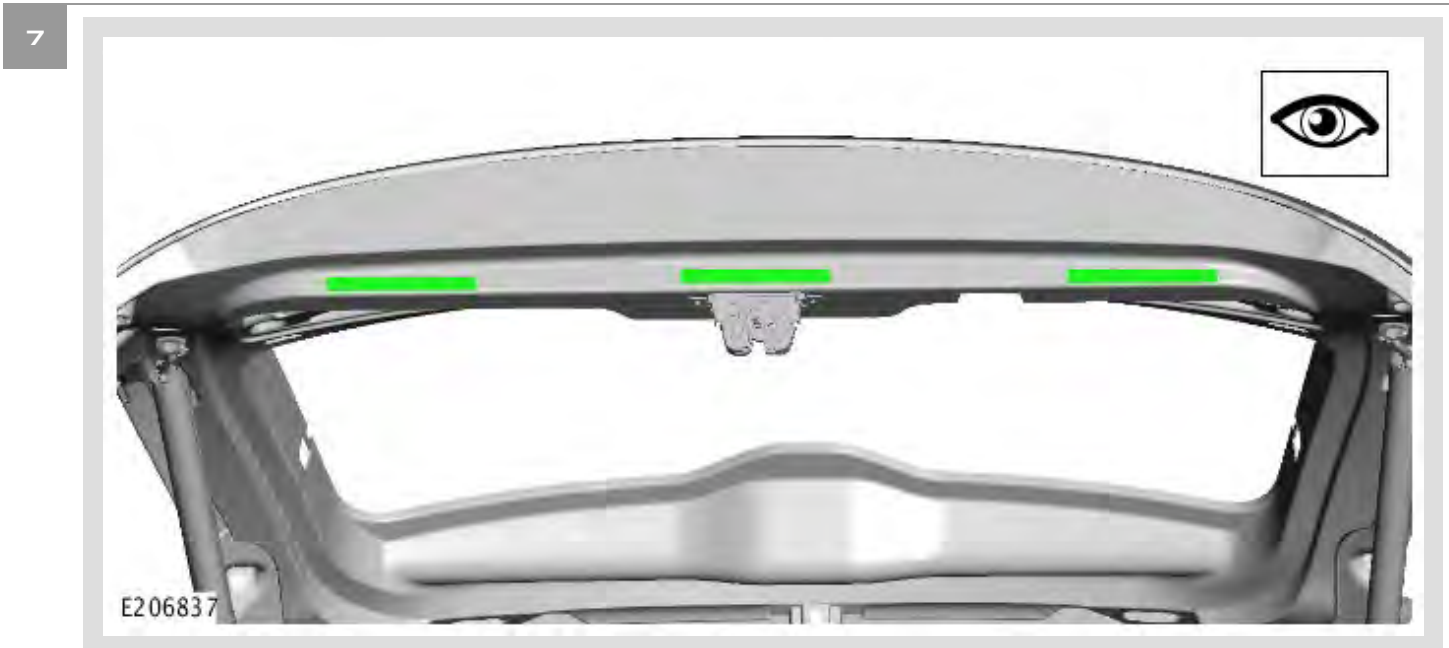
Visually inspect the tailgate.

- If chalk is not visible on the tailgate, go to Step 17.
- If chalk is visible on the tailgate, clean the chalk from the tailgate and go to Step 8.

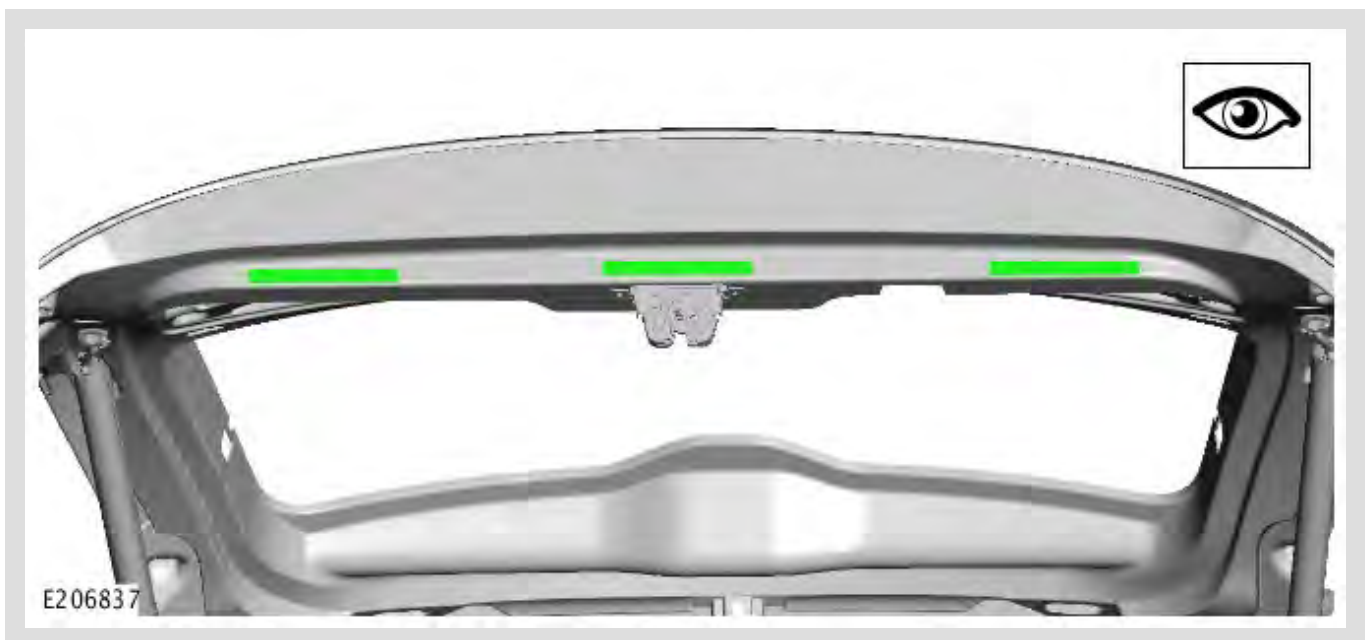
13

Visually inspect the tailgate.

- If chalk is not visible on the tailgate, go to Step 17.
- If chalk is visible on the tailgate, clean the chalk from the tailgate and go to Step 14.

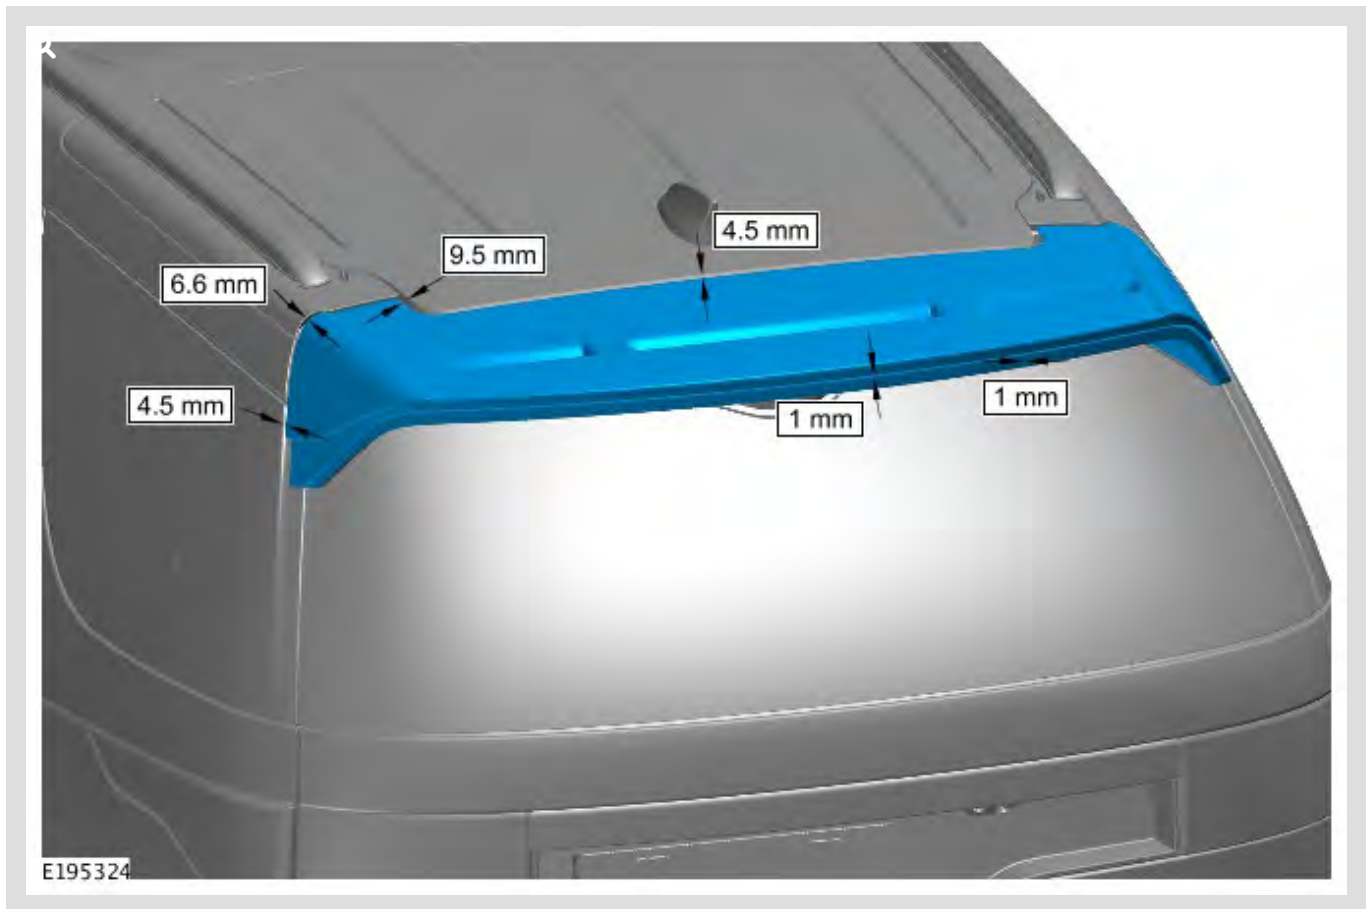
18

Visually inspect the rear spoiler alignment.

- If the rear spoiler alignment is correct, go to Step 19.
- If the rear spoiler alignment is not correct, adjust the rear spoiler alignment (see TOPIx Workshop Manual section 501-03: Exterior Trim and Ornamentation - Rear Spoiler [steps 5-9 of the installation procedure]).
