LTB00814NAS6

# TECHNICAL BULLETIN

Under Hood Lower NVH Pads/Dirty Air Duct Guides Freezing

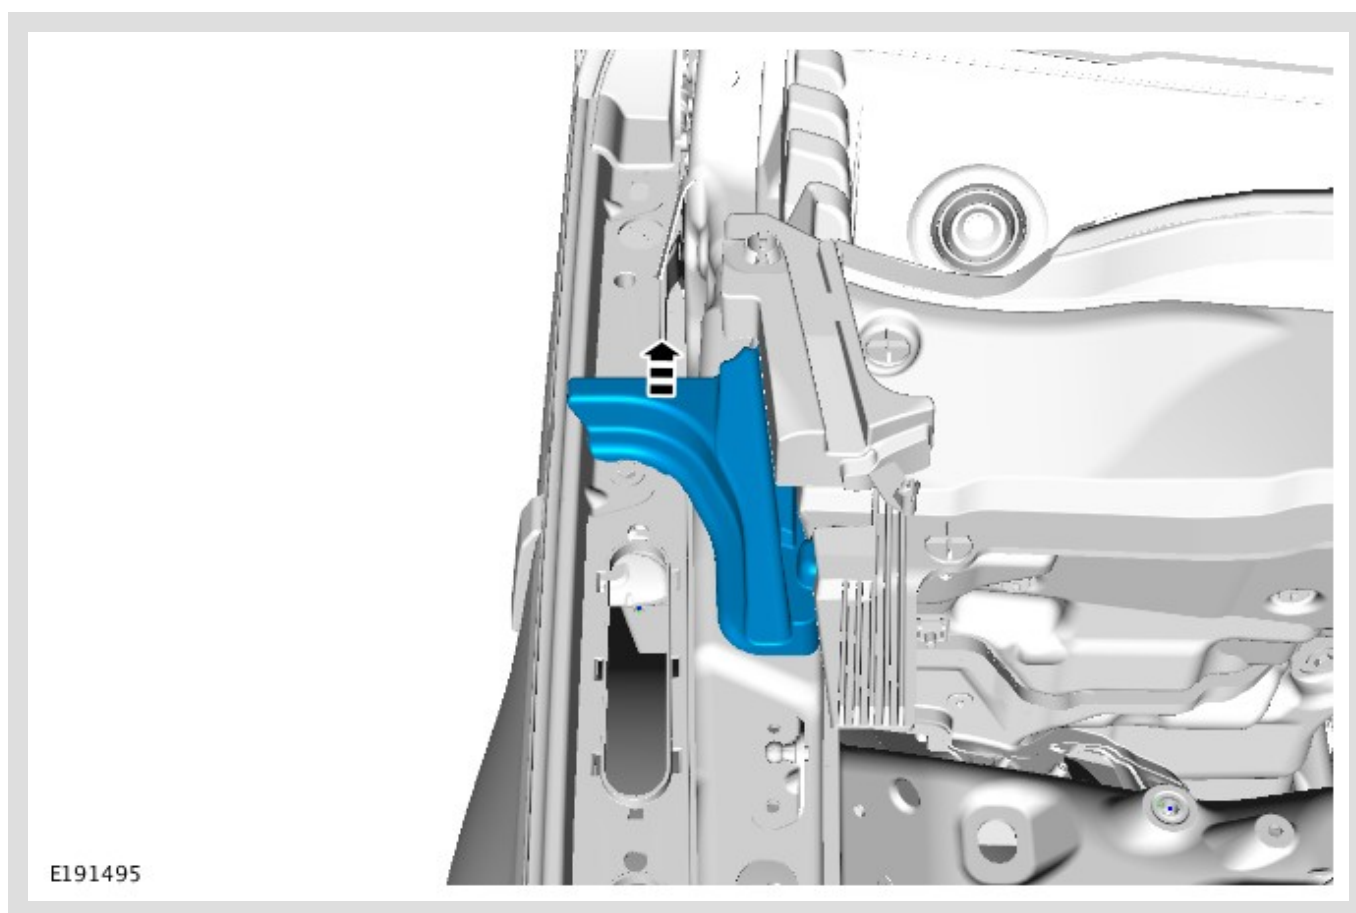
The under hood lower Noise Vibration Harshness (NVH) pads and dirty air duct guides may show signs of ripping, tearing, and/or has a poor finish.

This may be caused by ice build up between the foam surfaces and the hood, causing penetration into the foam.

Remove and discard the under hood lower right-hand Noise Vibration Harshness (NVH) pad.
