Discovery
Sport
RR Evoque
18MY

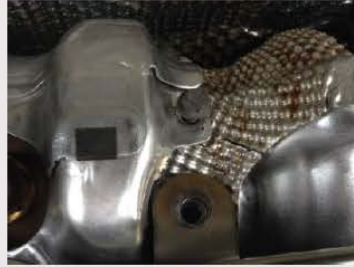
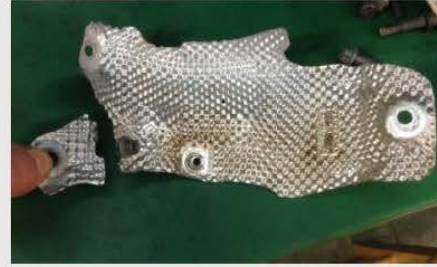
Inspection of the engine bay finds the heat shield mounted to the turbocharger cracked. This condition may also be noted during other repairs. If this condition is observed, regardless if a complaint exists or repair will be made, please raise an EPQR including pictures showing the heat shield.
