RR Velar

A Customer may report that the tail lamp appears to be delaminating or cracking.

LTB01228NAS1  
On Sign-off

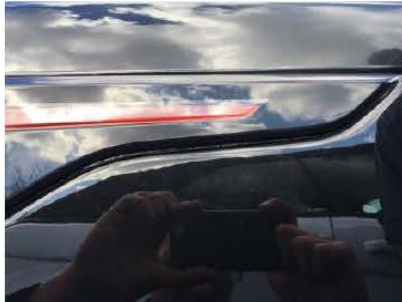
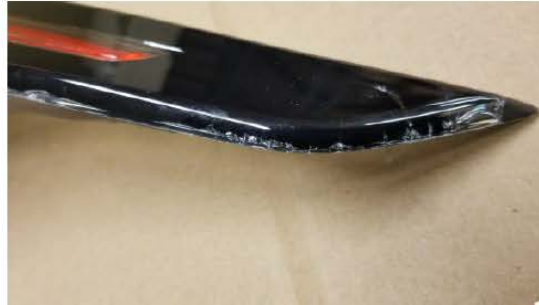
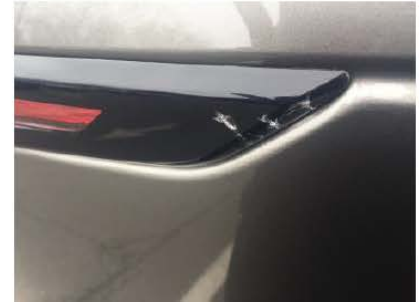
The tail lamps may appear to be cracking or delaminating. This may be caused by a manufacturing defect of the lamp assemblies. Should a customer express a concern, please refer to TSB LTB01228NAS1 and replace the affected tail lamp assembly. Please ensure that the replacement lamp assembly has a manufacturing date stamp of 07/07/2018 or later before installing.
