RR Sport SVR  
18MY

LTB01211NAS1  
On Sign-off

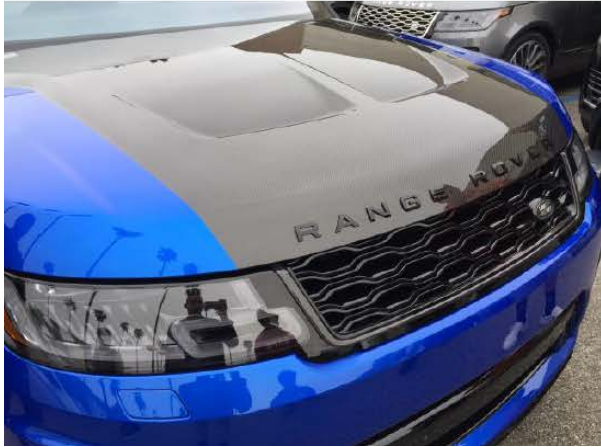
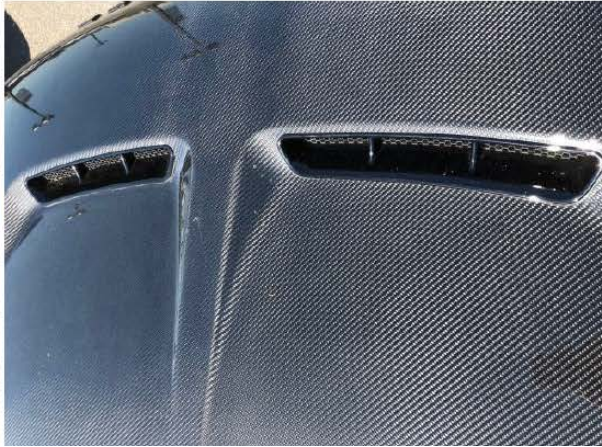
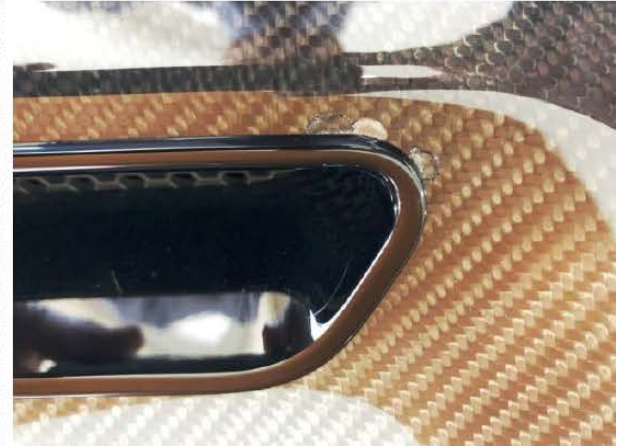
Customers may report the finish on the hood is chipping around the vent inserts.

This may be caused by the ribs designed into the back of the plastic vent flange. Revised vents are being produced to address this concern. TSB LTB01211NAS1 is being published to address customer vehicles. UPS N215 is planned for late August release to proactively replace the vents on unsold vehicles and address any paint damage that may have occurred. Should a customer express a concern, please refer to TSB LTB01211NAS1 for repair guidance.
