LTB00557NAS6

# TECHNICAL BULLETIN

204-06: Ride and Handling Optimization

'Knock' Sound From Front Suspension

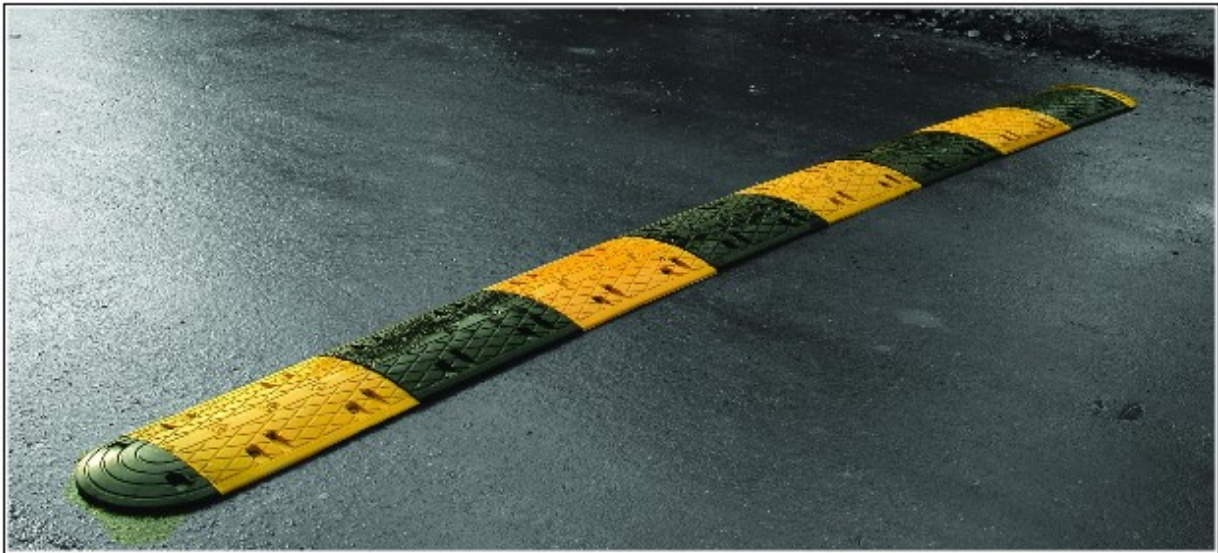
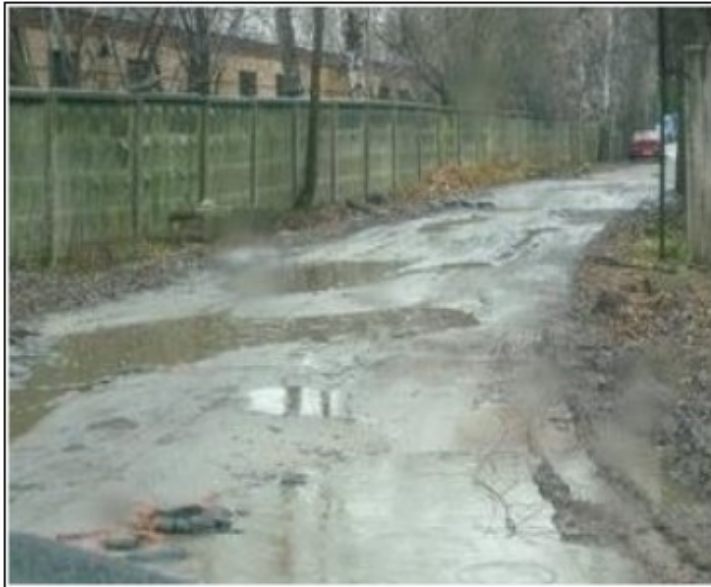
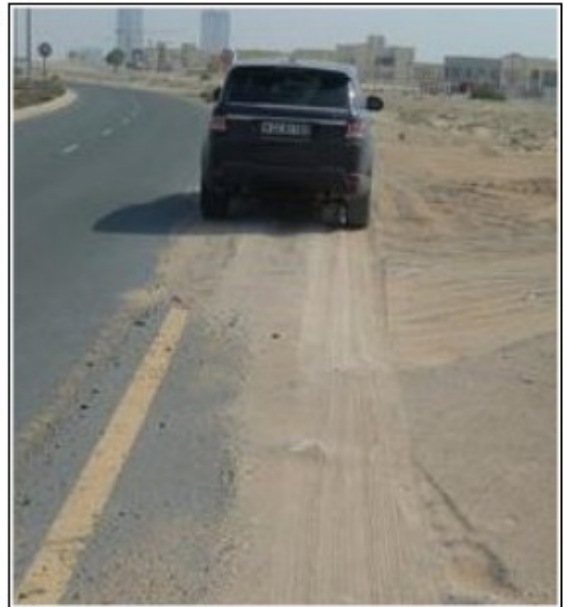
E162272

**SYMPTOM:** single 'knock' OR a series of isolated 'knocks':

- **Drive Cycle / Conditions:** single-wheel and dual-wheel inputs from speed bumps /damaged road surfaces or similar while traveling ONLY forward at speeds of up to 25mph (40kmh).
  - **Action:** perform the SERVICE INSTRUCTION listed below.

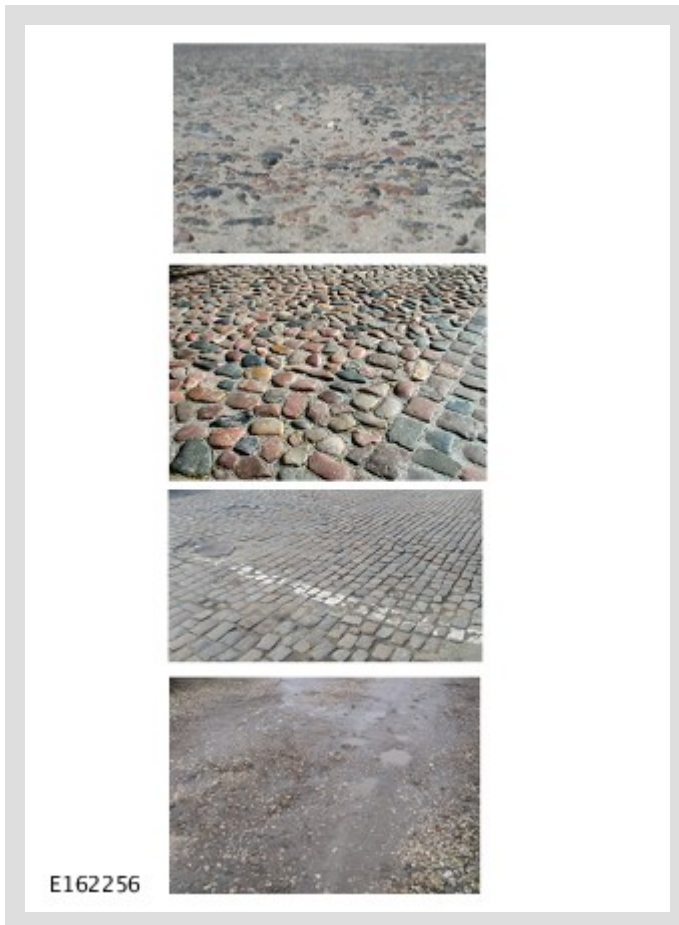
**SYMPTOM:** 'rattle' noise:

- **Drive Cycle / Conditions:** noise occurs while traveling at speeds up to 20mph (32kmh) over road surfaces shown.
  - **Action:** refer to Technical Bulletin LTB00618NAS, 'Click' / 'Rattle' Noise From Engine Compartment When Driving.

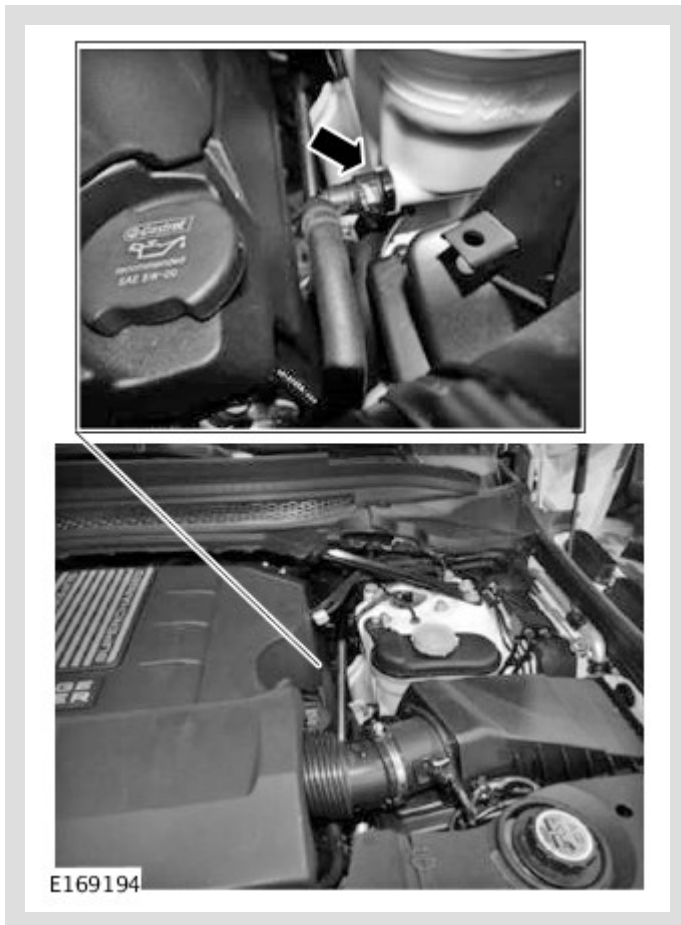
Check the Dynamic Response system fluid reservoir for leaks:

- If a leak is not present, go to the next Step.
- If a leak is present, replace the Dynamic Response system fluid reservoir (see TOPIx Workshop Manual section 204-06: Ride and handling optimization - Removal and installation - Fluid reservoir).

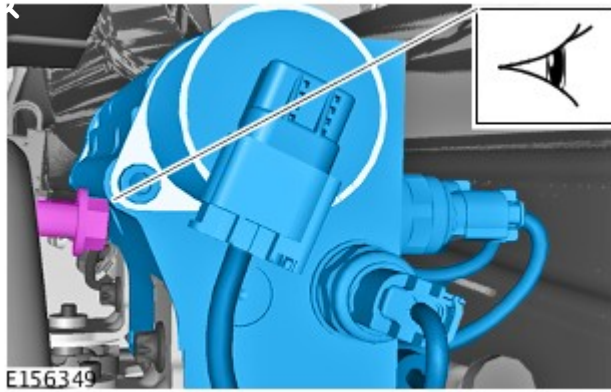
View of the end of hydraulic valve block from front of vehicle.

Check the valve block to body stud clearance.

- If there is sufficient clearance between the valve block body and the plastic body fastener that secures the fuel lines, go to Step 9.
- If there is not sufficient clearance between the valve block body and the plastic body fastener that secures the fuel lines, go to Step 8.

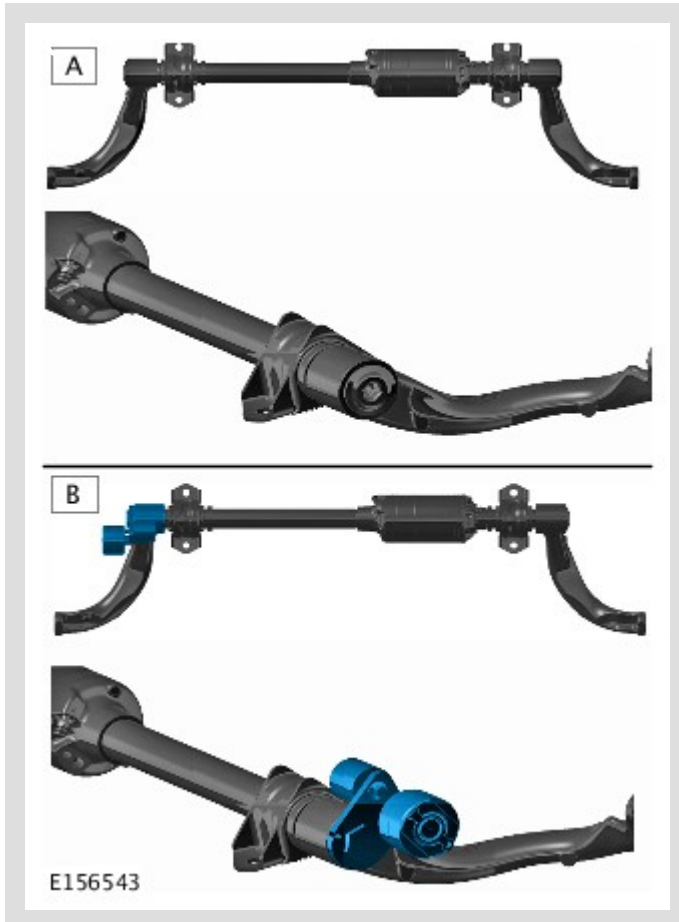
If the latest specification of front actuator bar is installed, only replace it if it is damaged/leaking fluid.

**2013MY Range Rover (L405) vehicles up to VIN 125193 only:** if the knocking noise is still present and considered unacceptable after performing the above steps, replace the Dynamic Response front actuator with part number LR052058 **(B)** (see TOPIx Workshop Manual section 204-06: Ride and Handling Optimisation - Front Stabilizer Bar).

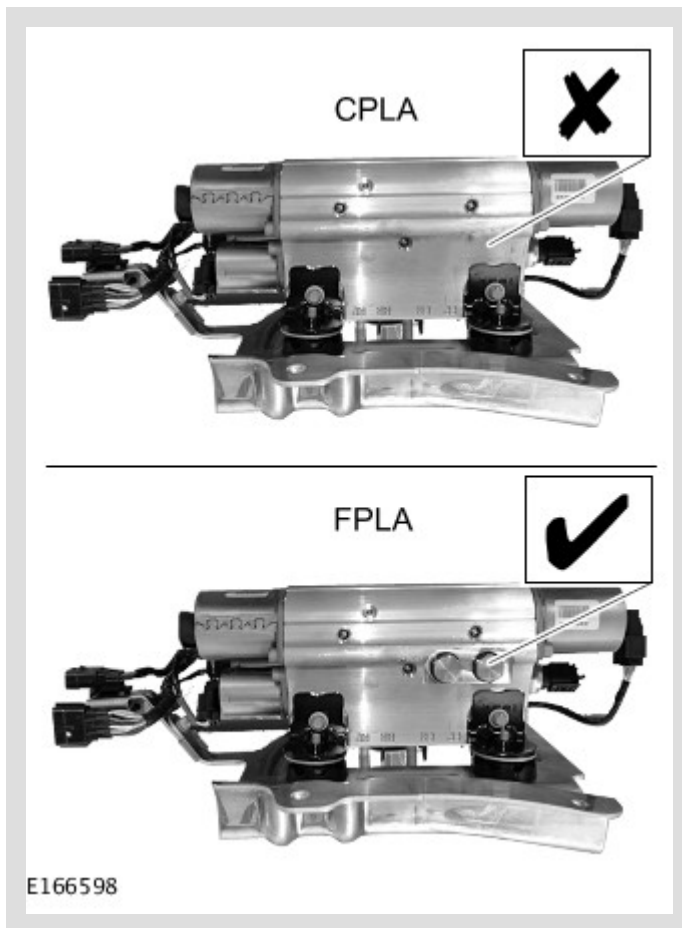
On strong customer complaint, confirm which level of valve block is installed. Valve block shown removed for clarity.

Check the valve block level (**CPLA** or **FPLA**).

- If the vehicle does have the latest level (FPLA) valve block (✓), go to the Step 22.
- If the vehicle does not have the latest level (FPLA) valve block (✗), install a new valve block (see TOPIx Workshop Manual section 204-06: Ride and handling optimization - Removal and installation - Valve block).
  - When all tasks are finished, go to the next Step.
