JTB00539NAS3

TECHNICAL BULLETIN

'Rattle' Noise From Front Overhead Console

MODEL:	MODEL YEAR:	VIN:
XJ Range (X351)	2016-2017	V92474-W05397

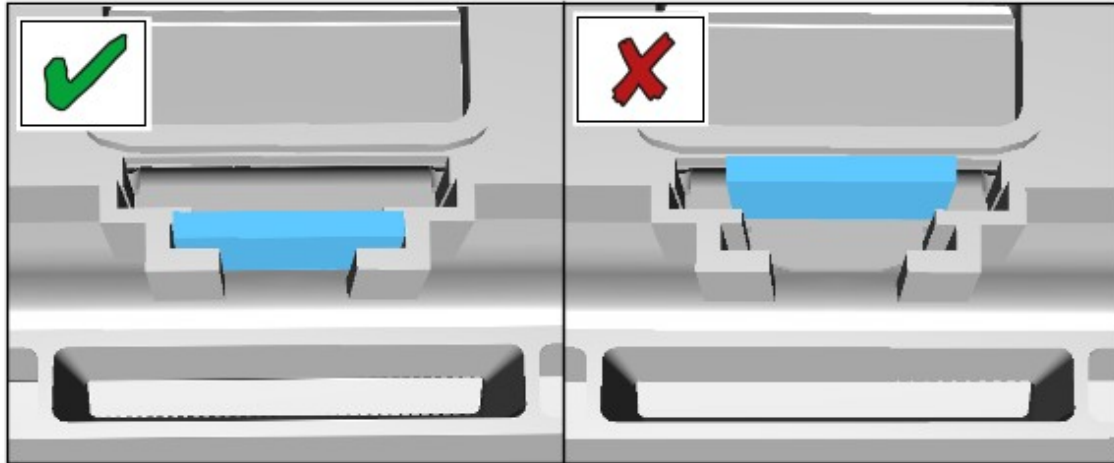
E231107

The black rubber strip should be installed in the center, with the pink rubber strips installed on the outside.

If the conductive rubber strips become loose/dislodged from their original position (X), install them as shown (✓).

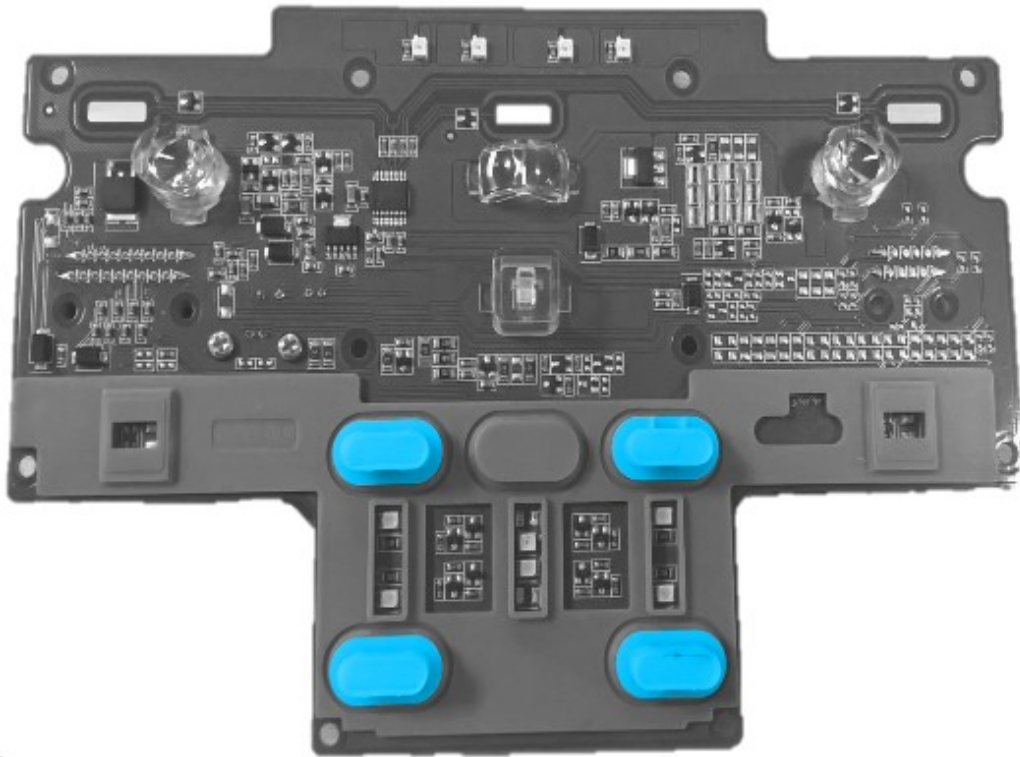
E201555

The front overhead console may have 4 or 5 buttons; 4-button version shown.

White buttons require modification; gray buttons do not require modification.

Visually inspect the color of the 4 or 5 front overhead console buttons.

- If all the buttons are gray, this is not the cause of the Customers concern.
 - Go to step 11.
- If any of the buttons are white, go to Step 7.
