JTB00591NAS2

# TECHNICAL BULLETIN

501-10

Front Seat Bolster Wear - Light Oyster Leather Only

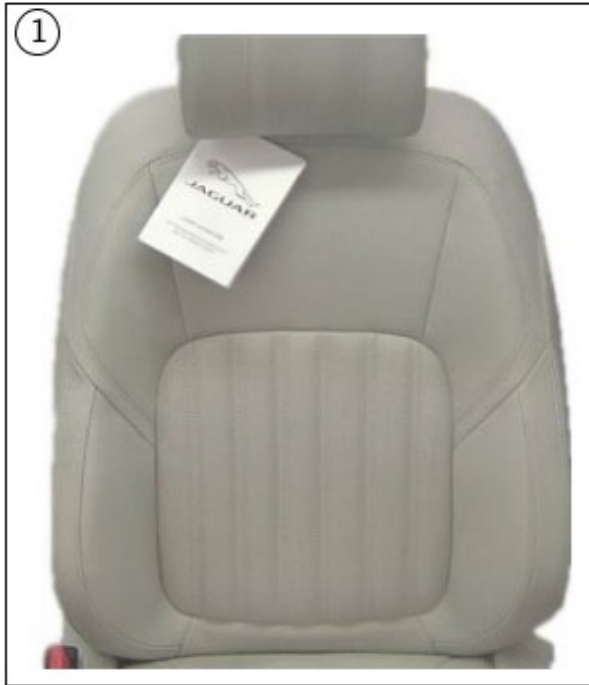
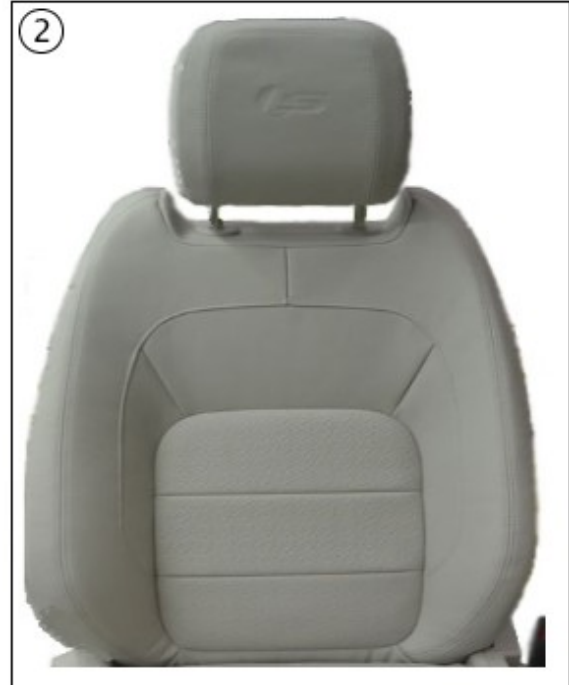
E230171

The front row seat backrest cover(s) and/or cushion cover(s) may exhibit premature cosmetic wear. This affects only vehicles with Light Oyster color seat trim.

This may be caused by poor durability of the leather coating.

Oyster Windsor **(1)**; Oyster Houndstooth **(2)**.

Inspect the front row seat cushion and backrest covers for premature cosmetic wear.

If premature cosmetic wear is visible on any of the front row seat cushion and/or backrest covers, the front row seat cushion and backrest covers **must** be renewed on **both** front row seats.

- If there is any premature cosmetic wear visible on any of the front row seat cushion covers and/or front row seat backrest covers, continue to the Workshop Procedure below.
- If there is not any premature cosmetic wear visible on any of the front row seat cushion covers and/or front row seat backrest covers, do not continue with this Technical Bulletin; the customer concern does not relate to its content.
