JTB00527NAS4

TECHNICAL BULLETIN

Disc Does Not Eject From The Digital Disc Player

MODEL:	MODEL YEAR:	VIN:	APPLICABILITY:
F-PACE (X761)	2017	045000-887416	Vehicles With: InControl Touch Pro

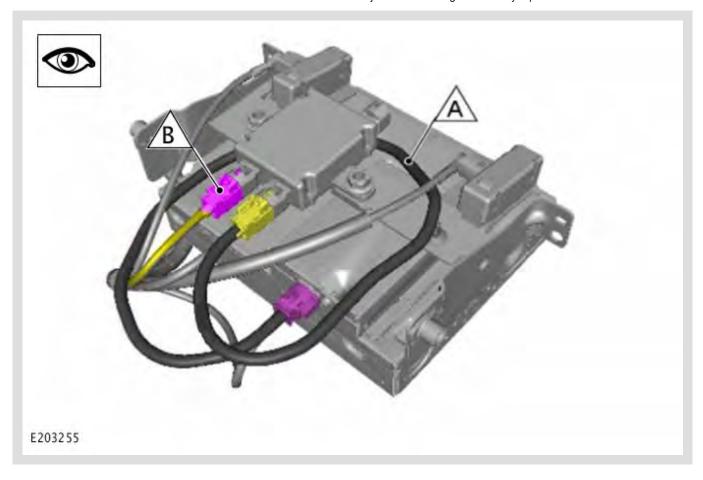
Visually inspect the wiring harness A.

- If the wiring harness is routed as shown, do not replace the harness.
 - Unplug connector 'B' and go to Step 39.
- If the wiring harness is not routed as shown, go to Step 29.
