LTB01198NAS1

# TECHNICAL BULLETIN

Hands-Free Tailgate Unintentionally Opening

MODEL:	MODEL YEAR:	VIN:	ASSEMBLY PLANT:
Discovery Sport (LC)	2016 Onwards	544577 Onwards	Halewood

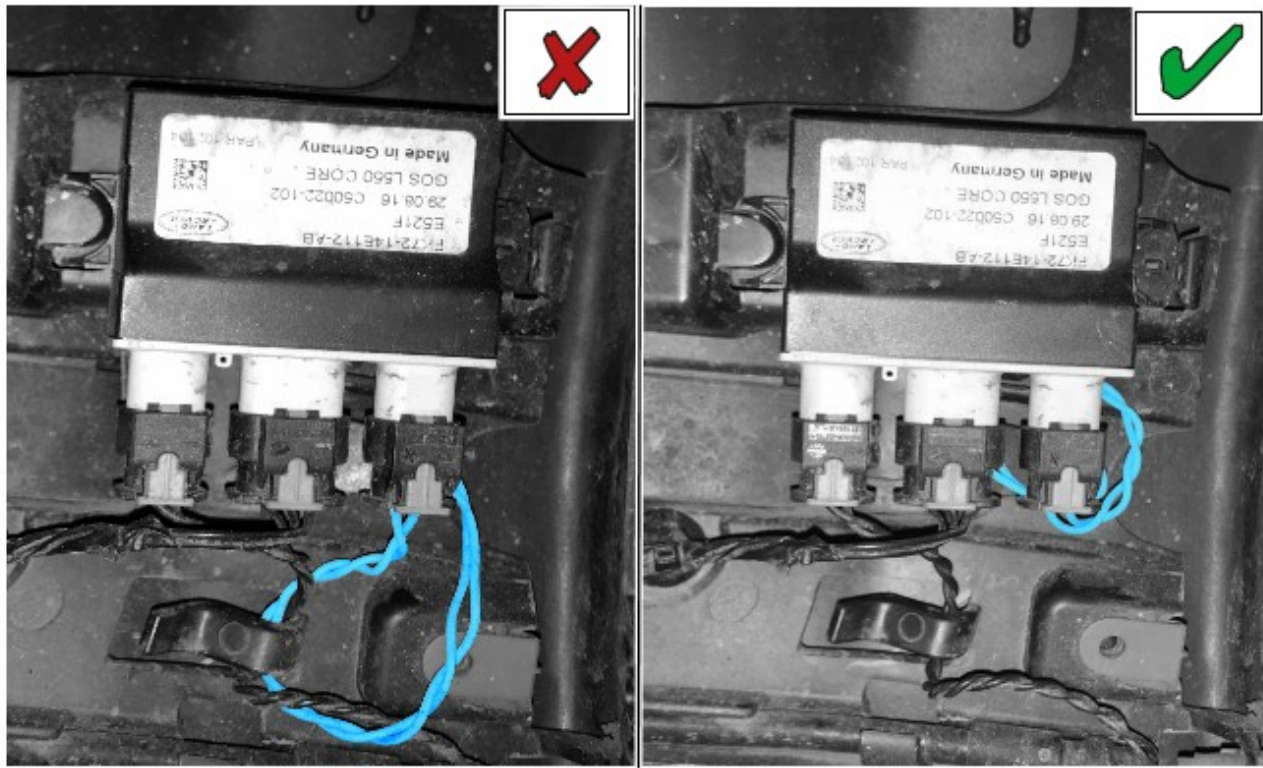
4

This may be caused by incorrectly routed Hands-Free Tailgate module wiring.

Inspect the left Hands-Free Tailgate module wiring.

- If the wiring is routed correctly [✓] as shown, go to Step 7.
- If the wiring is not routed correctly [✗] as shown, go to Step 5.
