LTB01009NAS6

# TECHNICAL BULLETIN

27 JUN 2018

InControl® Touch Pro™ Features May Not Function As Expected; Phase 4 Updates

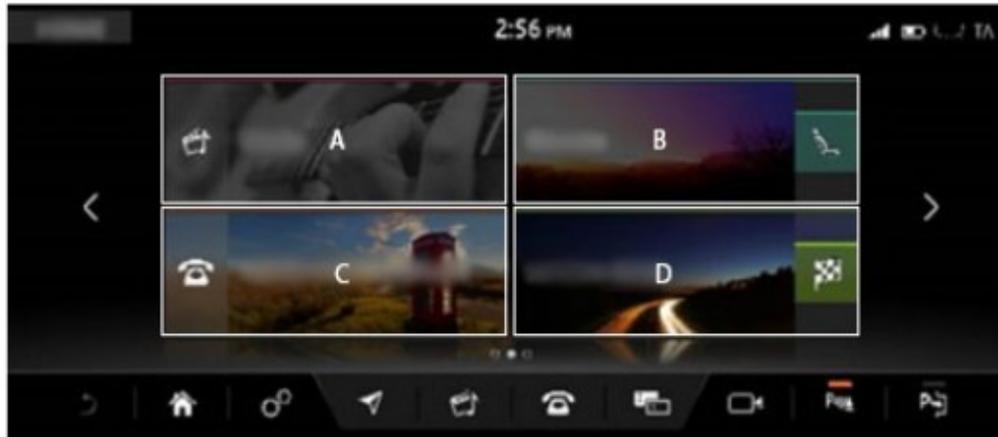
E229092

**Vehicles with Single-Screen System** - current 4-tile look & feel home screen:

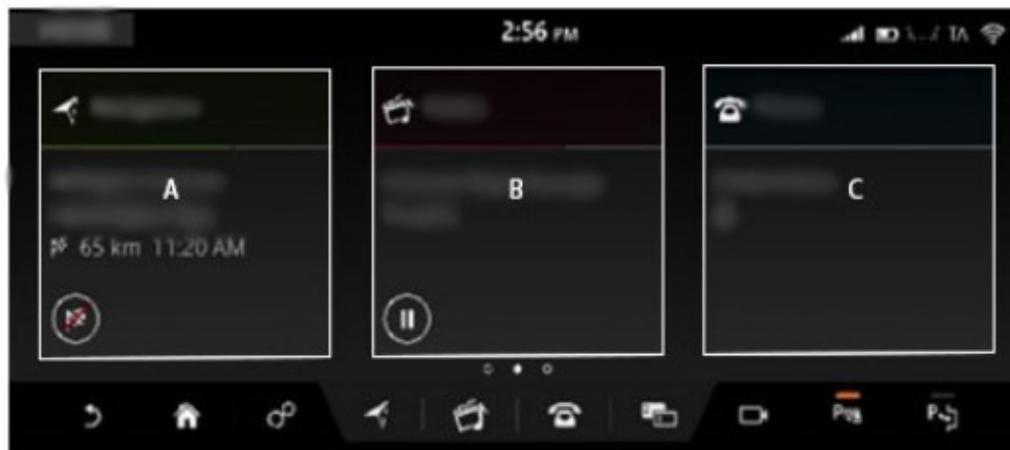
E229093

**Vehicles with Single-Screen System** - updated 3-tile look & feel home screen:
