March 2018  
FL751A  
NHTSA #17V-628  
Transport Canada #17-488

## Subject: Dana Front Steer Axles

**Models Affected: Specific Freightliner Cascadia and Western Star 4900 model vehicles manufactured March 17, 2015, through September 29, 2015, and built with Dana steer axles.**

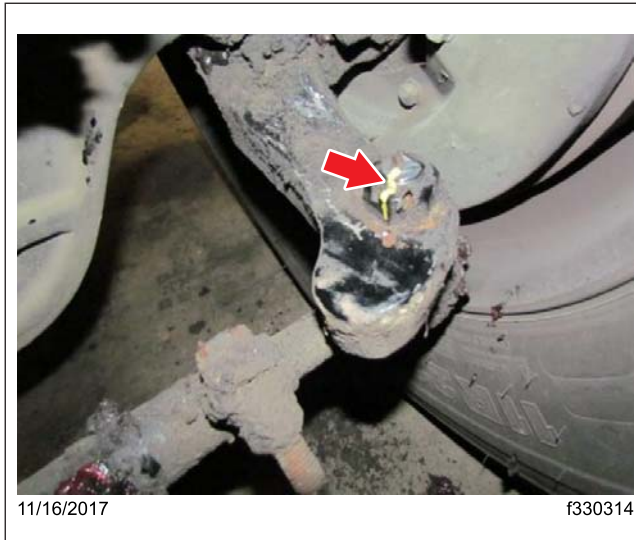
**Fig. 3, Paint Mark to Identify Nut Rotation**

- Remove the cotter pins and check for proper nut torque. Put a paint mark across one side of the nut and the top of the stud. With a torque wrench and a 1-1/4-inch socket, torque the nut in a clockwise (tighten) direction until the nut just starts to rotate or you reach 130 lbf-ft (175 N·m). Record your findings in Step 2 of the inspection form. See [Fig. 3](#) and [Fig. 4](#).

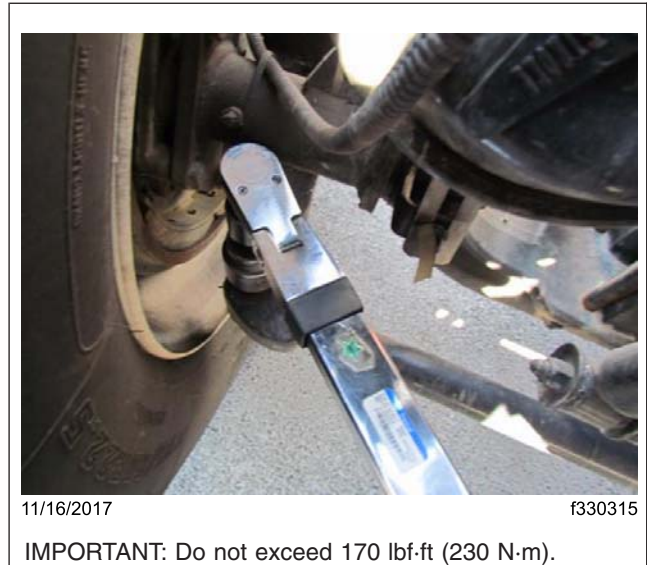
**Fig. 4, Check Nut Torque**

- If there is no rotation of the nut at 130 lbf-ft (175 N·m), install a new cotter pin and the repair is complete. Clean a spot on the base label (Form WAR259). Write the campaign number, FL751, on a blank red completion sticker (Form WAR260) to indicate the work has been completed and attach it to the base label.

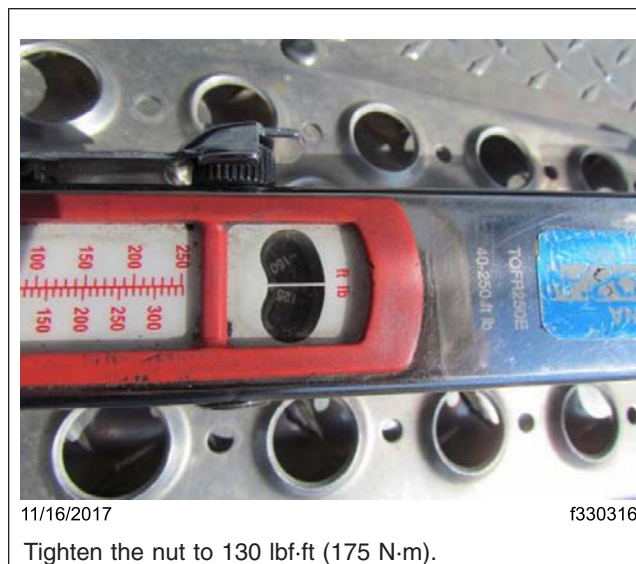
**Fig. 5, Tightening the Nut**

- If you found rotation of the nut before you reached 130 lbf-ft (175 N·m), now tighten the nut to 130 lbf-ft (175 N·m). Using the paint mark, record the rotation of the nut in Step 2 of the inspection form. Example: Using the paint mark as the 12:00 position, if the nut rotates 1/4 turn to reach 130 lbf-ft (175 N·m), document the nut rotation at the 3:00 position. See [Fig. 5](#) and [Fig. 6](#).

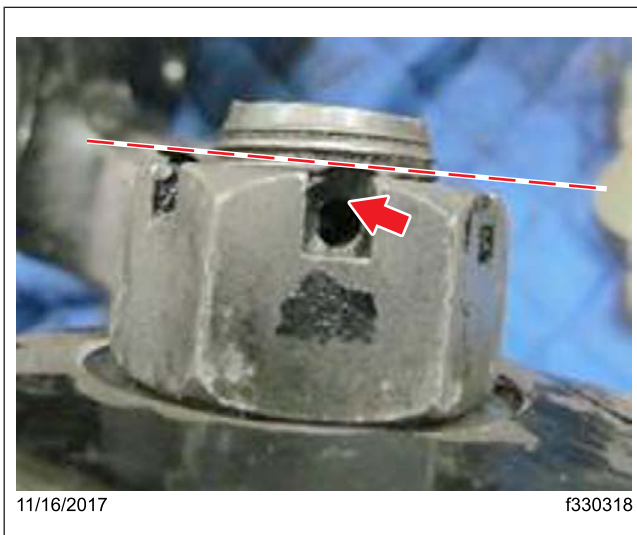
**Fig. 7, Good Cotter Pin Hole Position**

**IMPORTANT:** Never back the nut off to align the cotter pin hole to the nut slot. Torque may reach 170 lbf-ft (230 N-m) to obtain proper alignment. After the nut has been aligned with a slot in the nut, the cotter pin hole **CAN NOT** be above the top of the nut as shown below. Any cotter pin hole that is above the top of the nut surface will require the replacement of the knuckle and tie-rod end. See [Fig. 7](#) and [Fig. 8](#).

**NOTE:** Any tie-rod stud with movement after proper nut torque and alignment will require the replacement of that knuckle and tie rod.

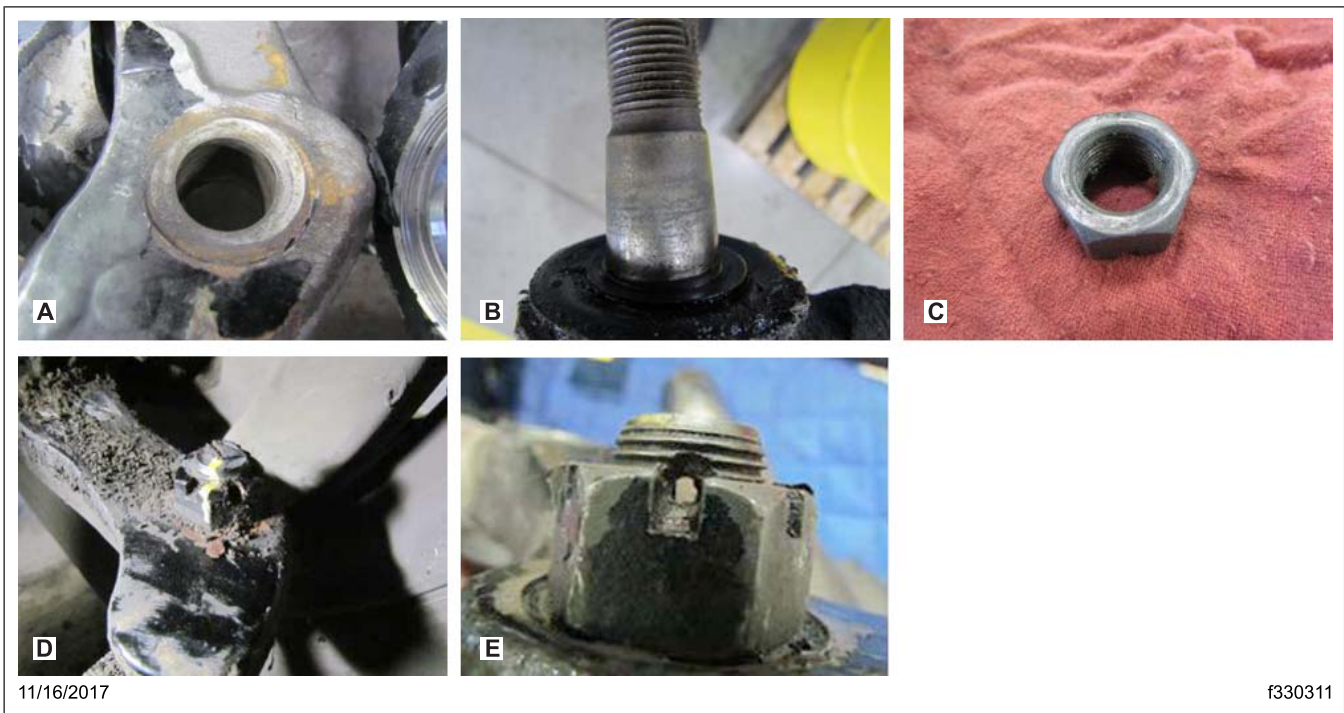
**Fig. 10, Sample Photos**

12. Take clear photos of the damaged parts and the position of the cotter pin.

If the photos are out of focus, too light, too dark, too far away, or too close up, the process will be delayed until new photos are submitted. Use the examples in **Fig. 10** as a guide.
