# SS 1033351 New Cascadia Fault Code SA 33 SPN 520197 FMI 31 MQ Switch Bus – Malfunction

Any new Cascadia with 17.48 or newer SSAM software

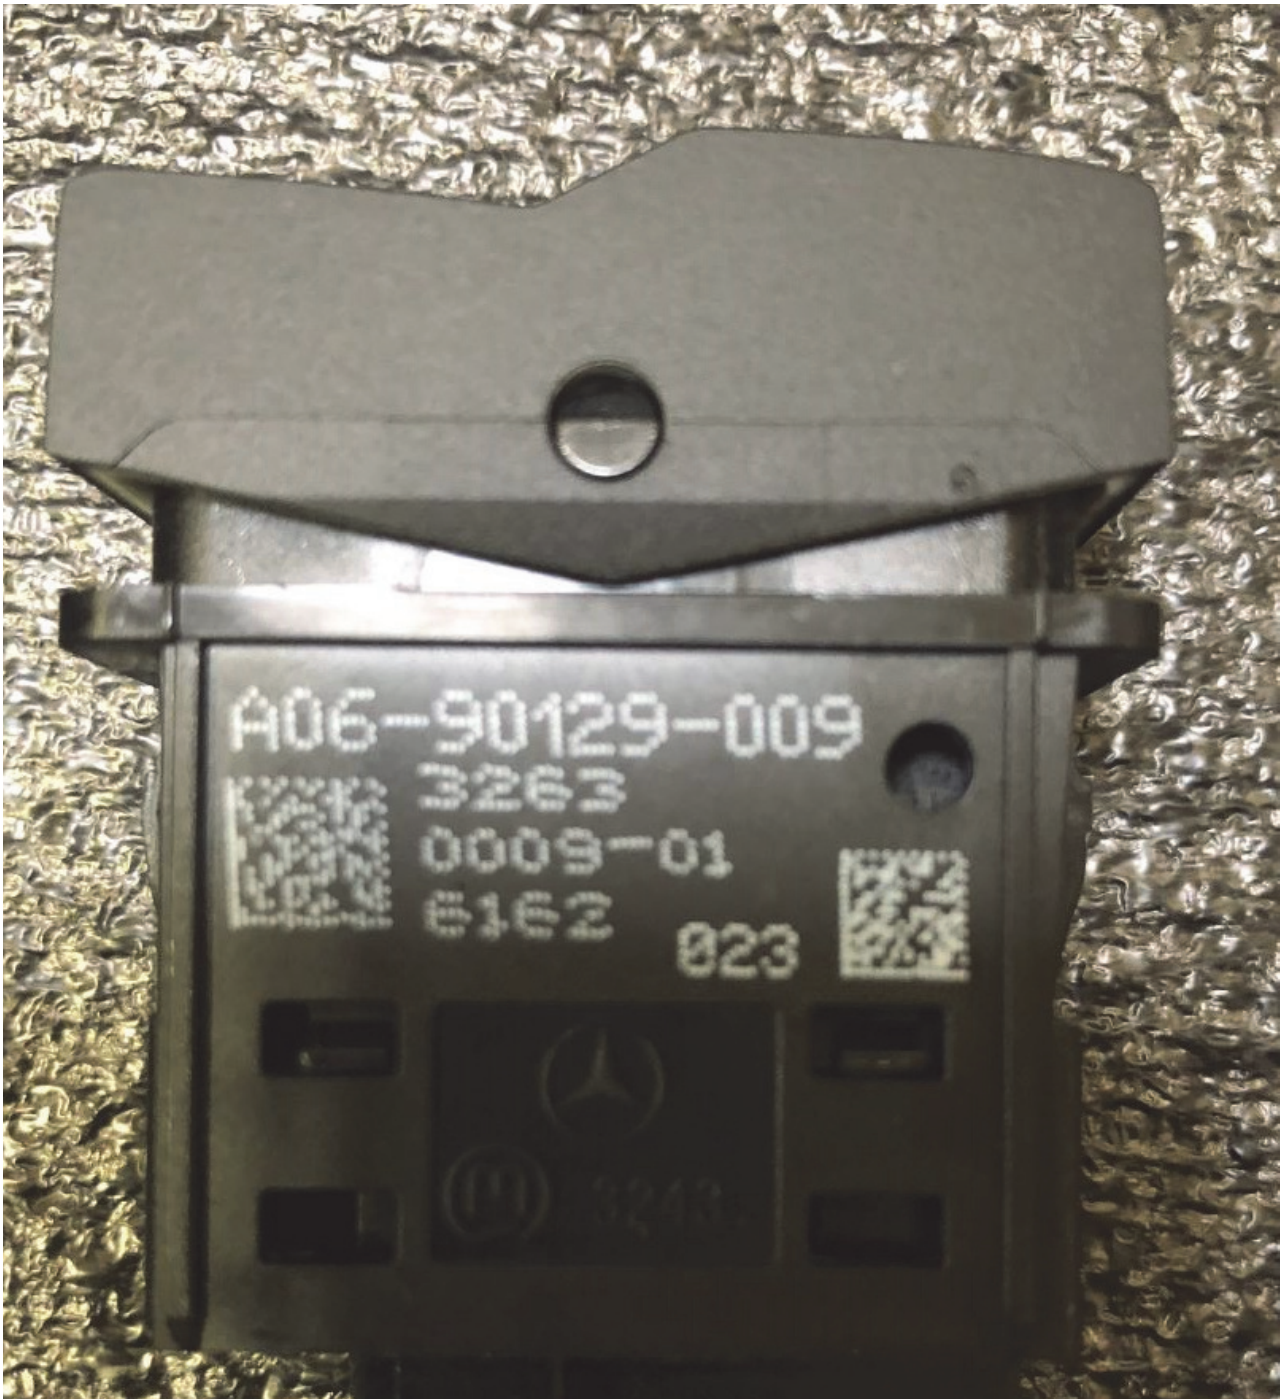
There can be switches that are communicating on the bus, but do not show on the panel. These switches have switch IDs 501 thru 508. These switches can be identified by the base P/N A06-90129-XXX. Use EZWiring to obtain the switch address (ID) documented on the print. Verify that all 501 thru 508 switches that are installed have matching switch parameters.
