# SS-1033353 FCCC S2G Cab Lean

**Applicable Vehicles** - Certain 2013 thru 2015 FCCC S2G cab/chassis vehicles.

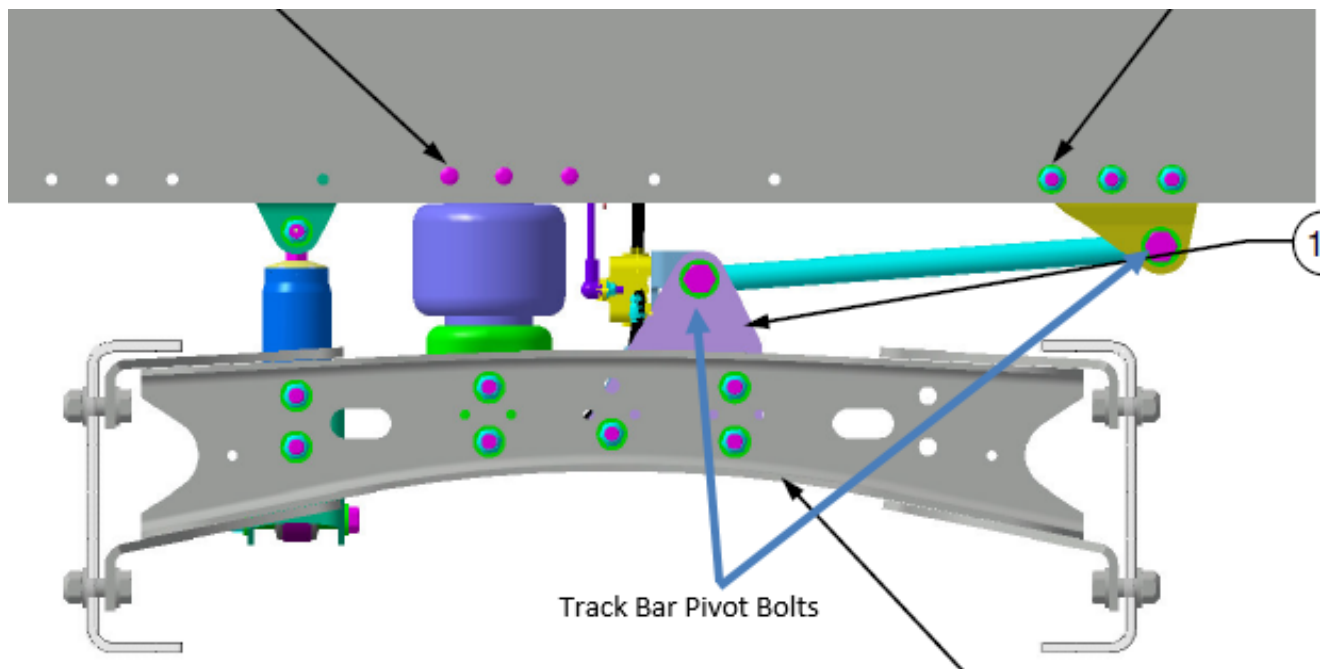
**Symptoms** - May have a cab lean or cab squeak around the track bar area

**Issue** - Certain Freightliner Custom Chassis Corporation's S2G models may have a cab lean or squeak. Use this solution to help determine if the issue is caused by the cab track bar hardware.

**Solution** - If a vehicle is exhibiting either an unexplained cab lean or cab squeak in the track bar mounting bushings, verify the pivot bolts size. The correct hardware should be 5/8" (5/8" bolt has a 15/16" hex head -1/2" bolt will have a 3/4" hex head bolt), If found to have 1/2" hardware replace it with 5/8" : 23-11755-350 - bolt, 23-09114-000 - washer, 23-13179-110 - lock nut. Torque this hardware to 40 - 50 ftlbs. Either end of the track bar could be effected.
