Business Class M2
Cascadia
108SD/114SD
> New Cascadia

**Freightliner
Service Bulletin**

General Information

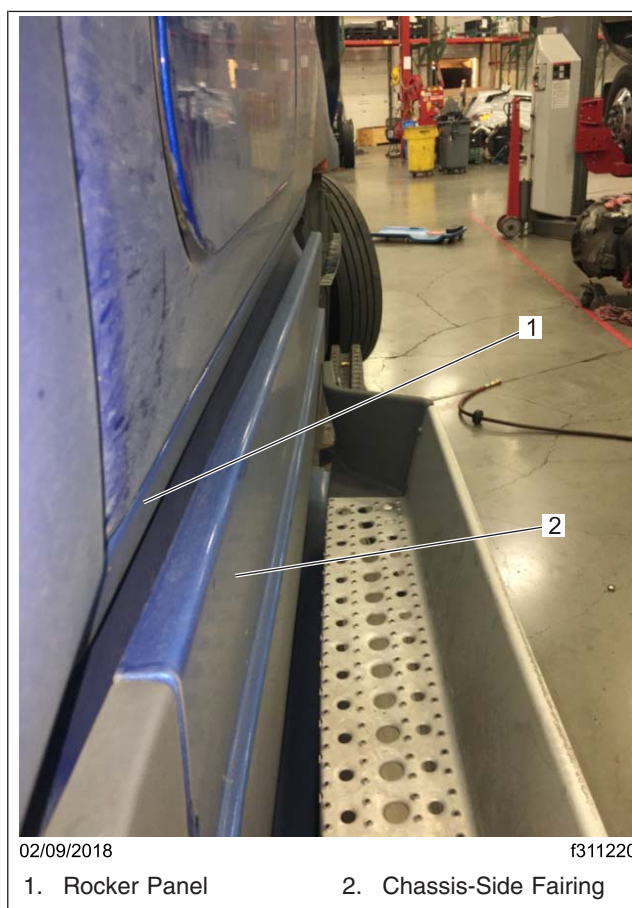
Fig. 1, Location of the Rocker Panel and Chassis-Side Fairing

The right-hand cab rocker panel on New Cascadia vehicles can come into contact with the right-hand chassis-side fairing when making a left turn. This contact can result in an audible popping noise, paint damage to the rocker panel and damage to the back-side of the chassis-side fairing. See [Fig. 1](#). Beginning February 5, 2018, production added spacers between the track rod bracket and the rail. This will shift the aft of the cab to the left by 6 mm to provide clearance.

For vehicles built through February 4, 2018, follow the steps below to add shims and provide clearance. For vehicles built from February 5, 2018 with shims installed but still experiencing clearance issues, adjusting the fairing is all that is needed for clearance.

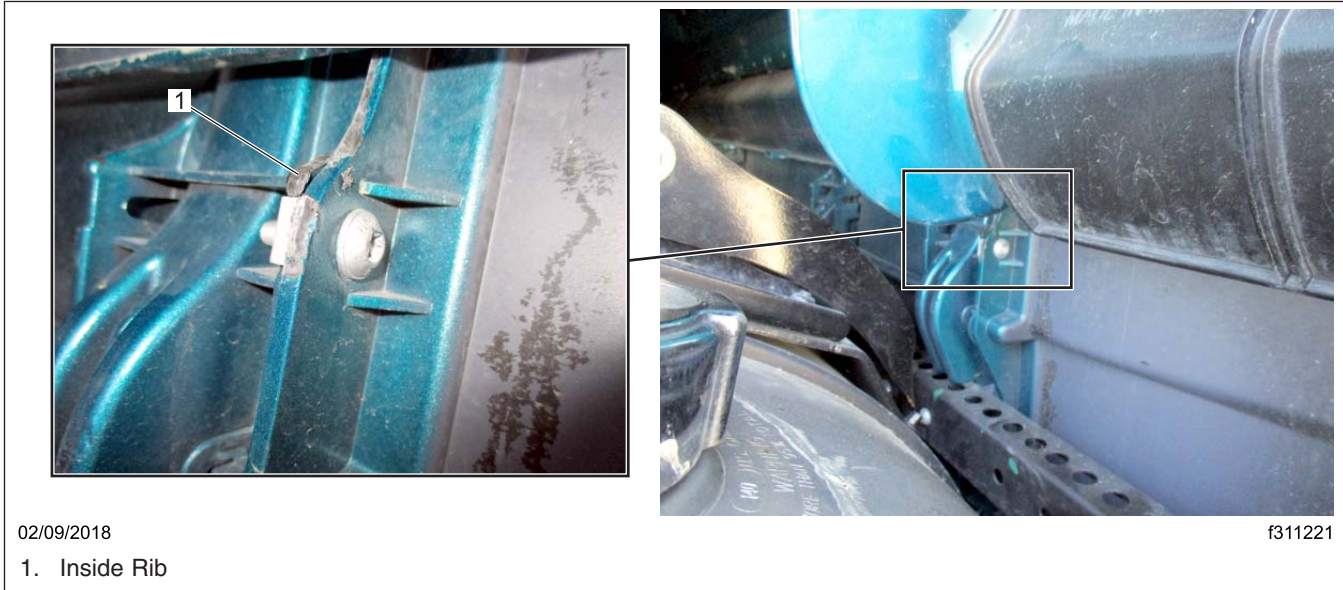
Fig. 2, Checking if the Inside Rib Contacts the Chassis-Side Fairing (fuel tank mounting shown)

1. To determine if this problem exists, check for an indication of contact on the inside rib on the chassis-side fairing. See [Fig. 2](#).
