# SS 1033315 - WST 5700 Exhaust Pipe Installation Bracket Improvements

## **WST 5700 Exhaust Pipe Installation Bracket Improvements**

WST 5700

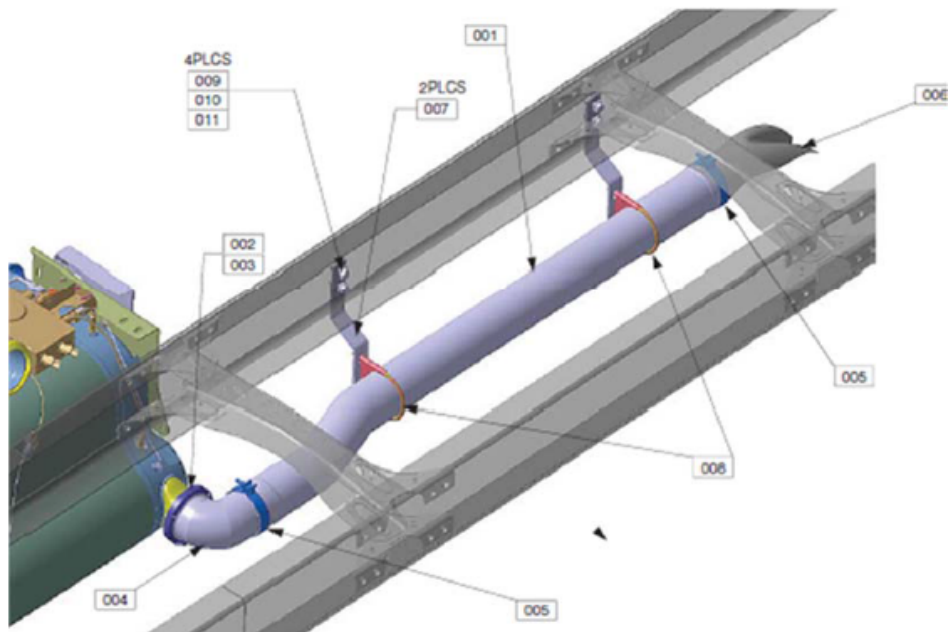
001 – INSTL. EXHAUST, 016-1C3, 2 BRKT, DD15/3

Current installation shows items 7, 04-31835-00 (2Plcs) that need to be updated with new bracket 04-32929-000:
