SS 1033417: WST 4900 Low Max w/Disc Brakes Front Brake Hose rubbing Hood fender

WST 4900EX and 4900 Low Max with Disc Brakes built since February 2015 thru March 2018

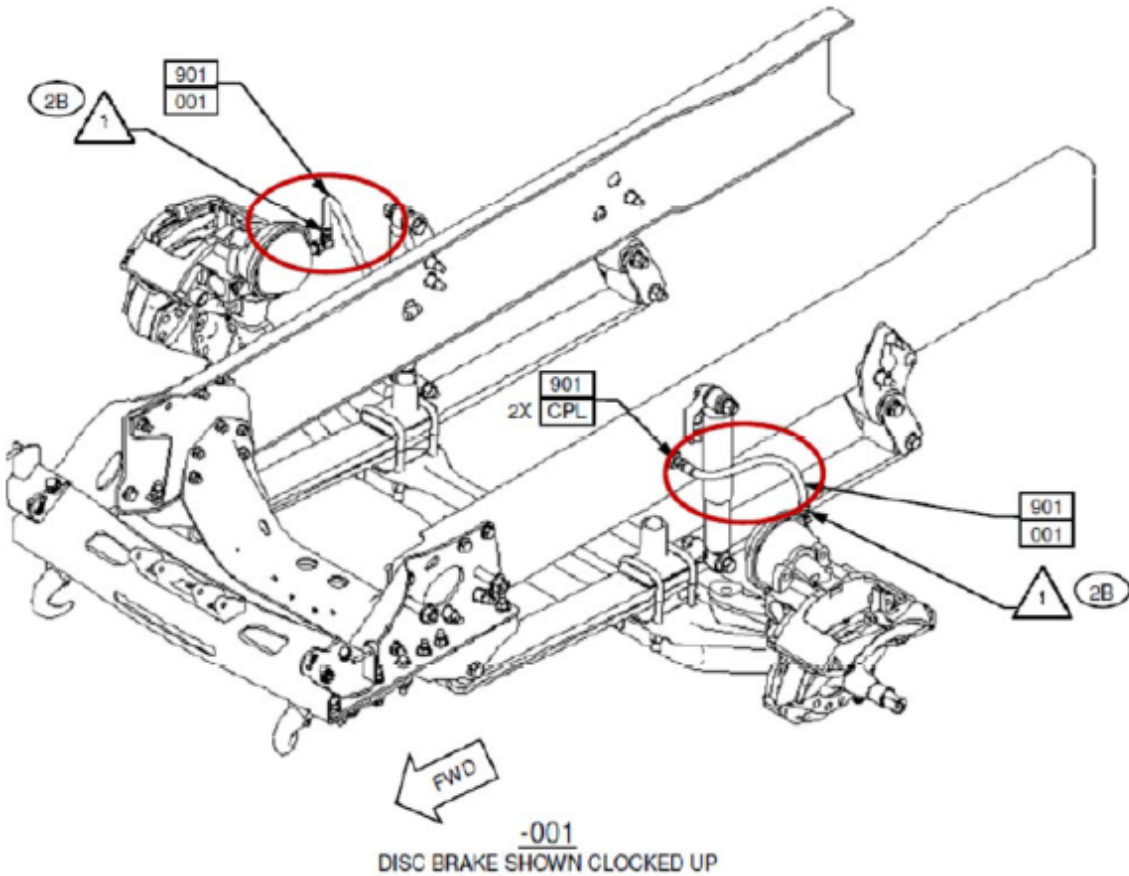
Front brake hose routing with loop up causes interference/rubbing issues between Hoses and Hood fender in 4900EX and 4900 Low Max vehicles equipped with disc brakes.

Reports from the field indicate that Front Brake Hose routing is causing rubbing / interference with 4900EX Hood and 4900 Low Max Hood resulting in damaged brake hoses. Current installation has Hoses routed with loop going up as shown:
