SSM73995 - Dynamic Response high pressure pipe fluid leak | TOPIx

Reference	SSM73995
Models	Range Rover / L405
	Range Rover Sport / L494
Title	Dynamic Response high pressure pipe fluid leak
Category	Chassis
Last modified	03-Aug-2018 00:00:00
Symptom	304000 Suspension System
Attachments	Picture 1.JPG
Content	Issue:
	Customer reports red warning lamp illuminated with a message
	"SUSPENSION FAULT"
	"STOP SAFELY"
	"STOP ENGINE"
	Cause:
	Dynamic Response high pressure pipe has a fluid leak due to hose

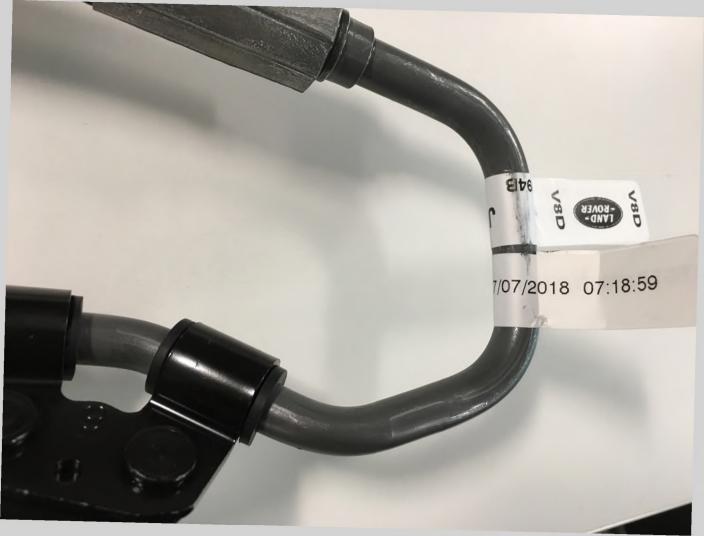
- 1. Provide close up photographs that identify where the leak is coming from, and the whole pipe to show which connection is leaking
- 2. Provide a photograph showing the Test Passed time and date label (not part number label). This is located next to the part number label – see picture attached
- 3. Any other information and observations as to why this leak has occurred
- 4. Replace appropriate part and hold ready for part return request (PRR)
