LTB01133NAS1

TECHNICAL BULLETIN

415-01: Information and Entertainment System

Voice Echo During In-Vehicle Hands-Free Call

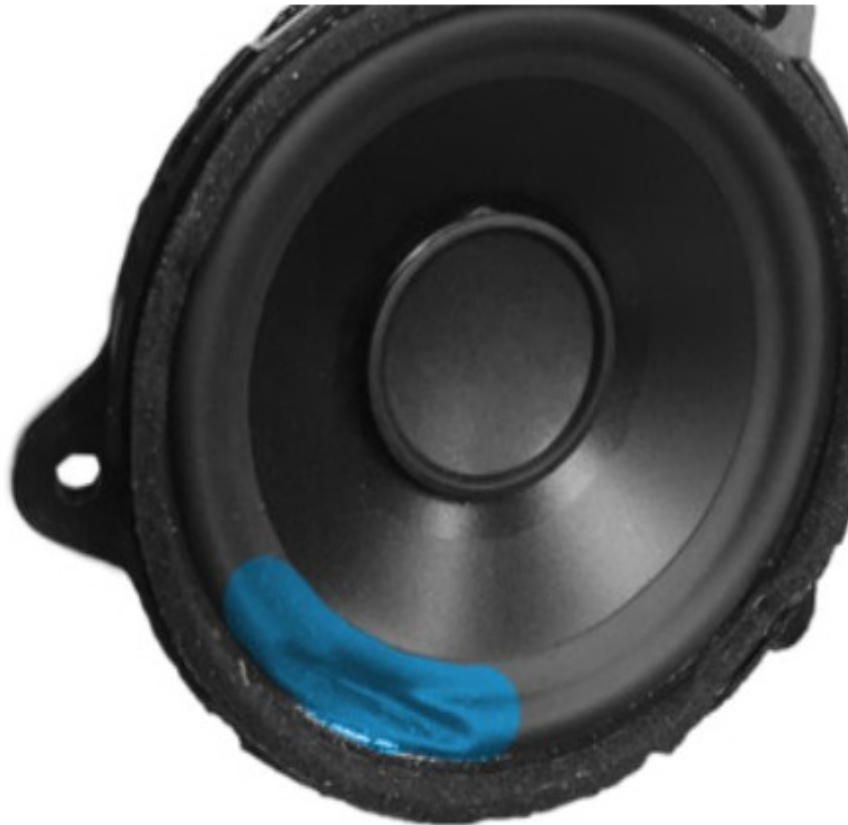
E217793

This may be caused by incorrect installation of the speaker grille to the door trim causing consequential damage to the mid-range speaker.

Possible damage to the mid-range speaker due to a weld tower present on the mid-range speaker grille.

Renew the speaker only if damaged as shown in the Service Information section.

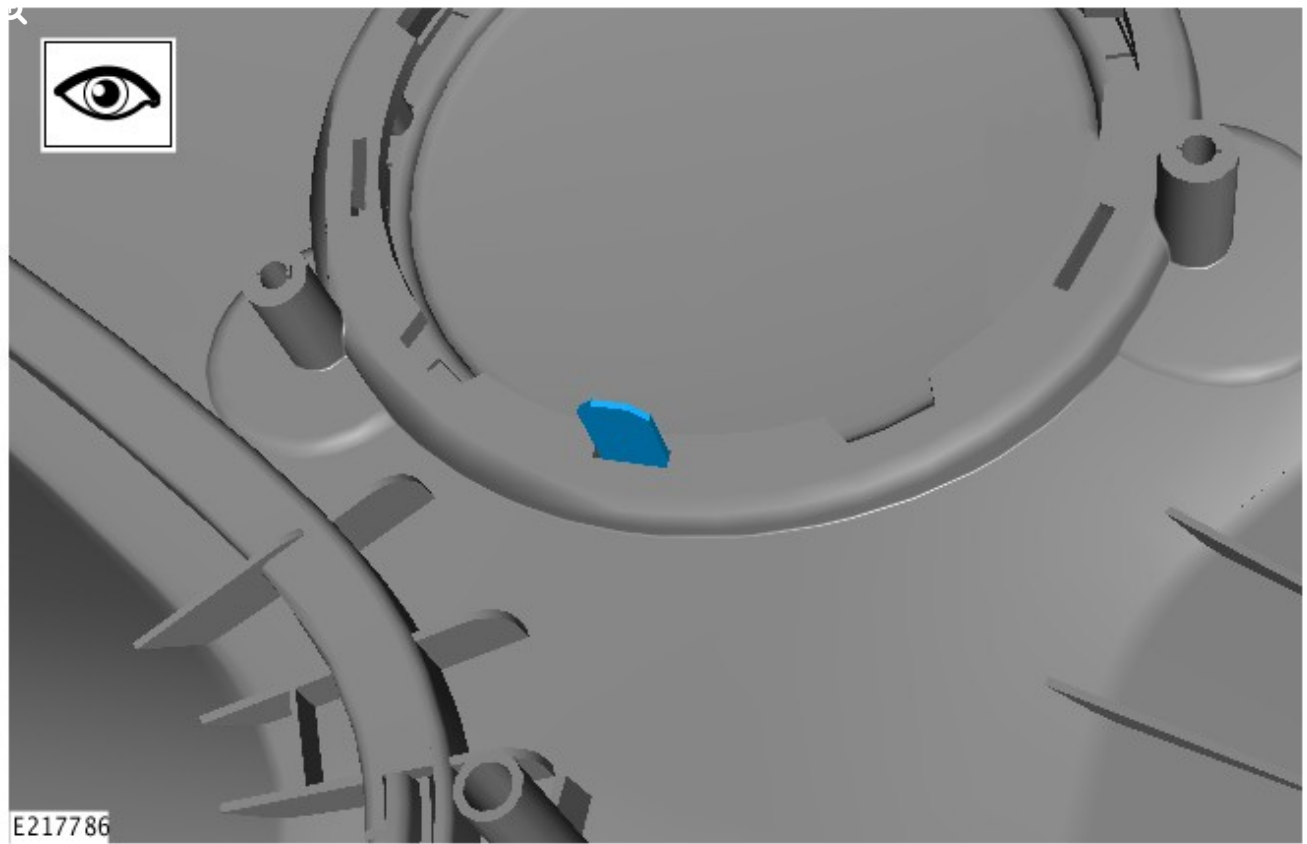
4

Inspect the mid-range speaker grille for the presence of a weld tower.

- If a weld tower is present, go to Step 6.
- If a weld tower is not present, go to Step 5.
