LTB01228NAS1

TECHNICAL BULLETIN

Rear Lamp Cracked And/Or Delaminated

MODEL:	MODEL YEAR:	VIN:
Range Rover Velar (LY)	2018-2019	700125-786268

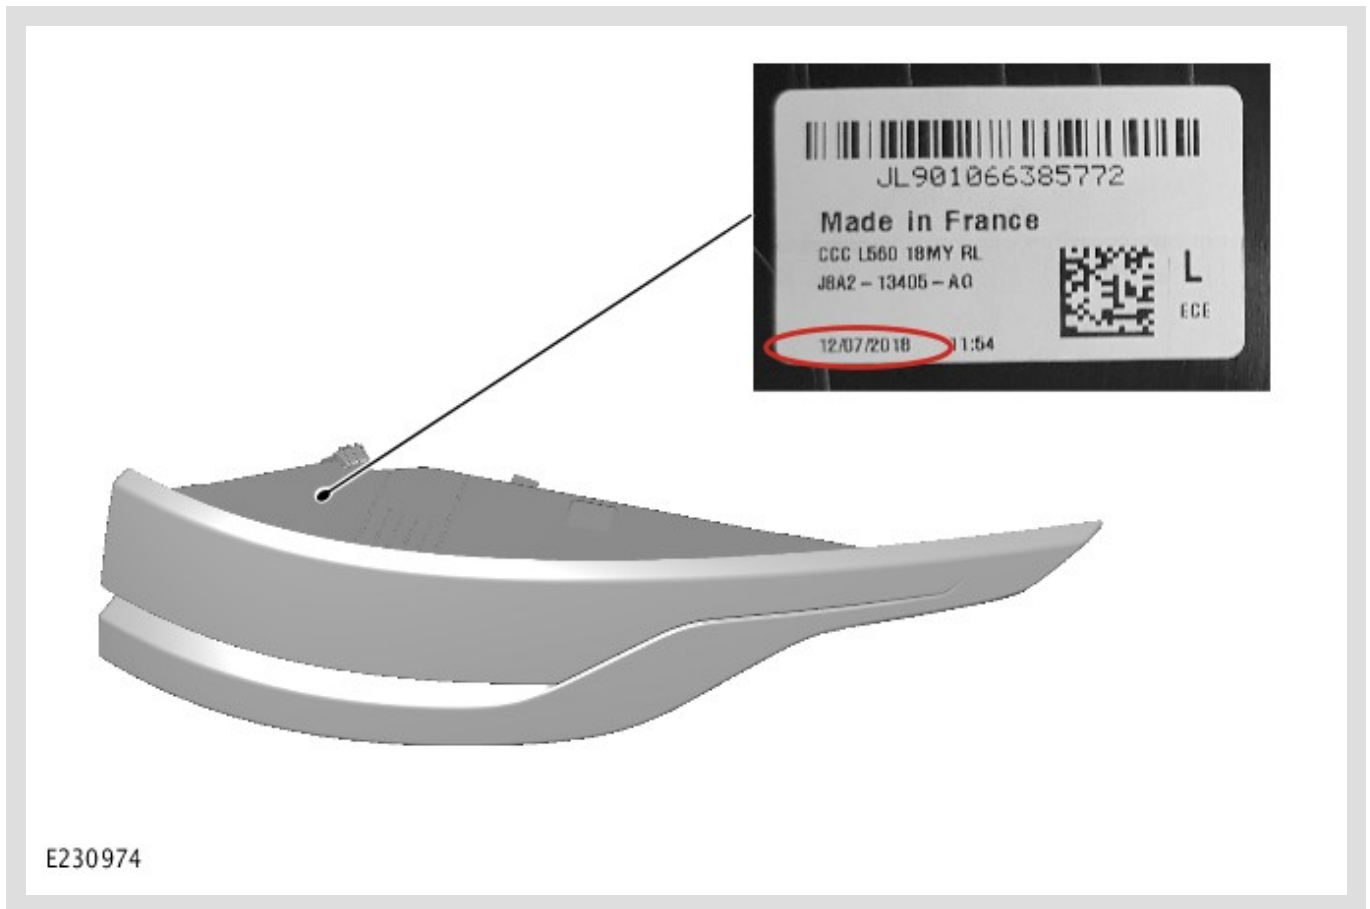
The new rear lamp assembly must have a date stamp of **07/07/2018 or later.**

Inspect and record the date stamp on the **new** rear lamp assembly.
