LTB01149NAS3 TECHNICAL BULLETIN 16 AUG 2018

501-14

'Hood open' Warning Message Displayed On Instrument Cluster

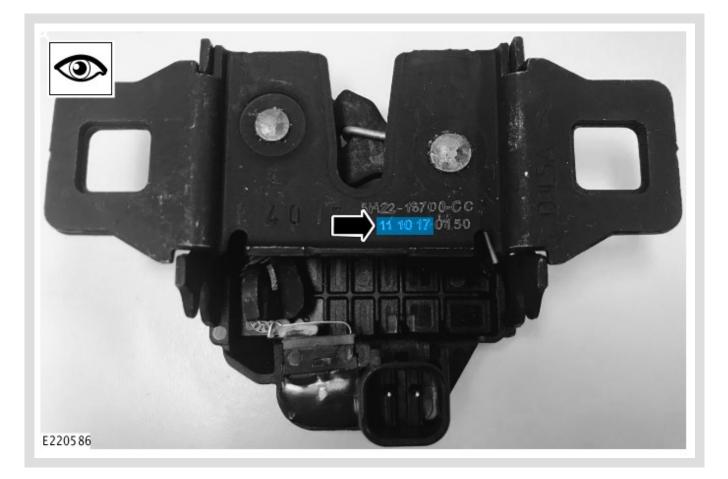
This may be caused by water ingress into the hood latch micro switch.

Date shown, **11 10 17** (11 October 2017), for reference only.

The date code (DD MM YY) of the new hood latch must be 27 04 18 (27 April 2018) or later.

Only replace the hood latch that has the microswitch installed.

Renew the hood latch (see TOPIx Workshop Manual section 501-14: Handles, Locks, Latches and Entry Systems - Hood Latch).
