LTB01211NAS1

# TECHNICAL BULLETIN

Carbon Fiber Hood Delamination

MODEL:	MODEL YEAR:	VIN:	APPLICABILITY:
Range Rover Sport (LW)	2018 Onwards	181339 Onwards	Vehicles With: SVR

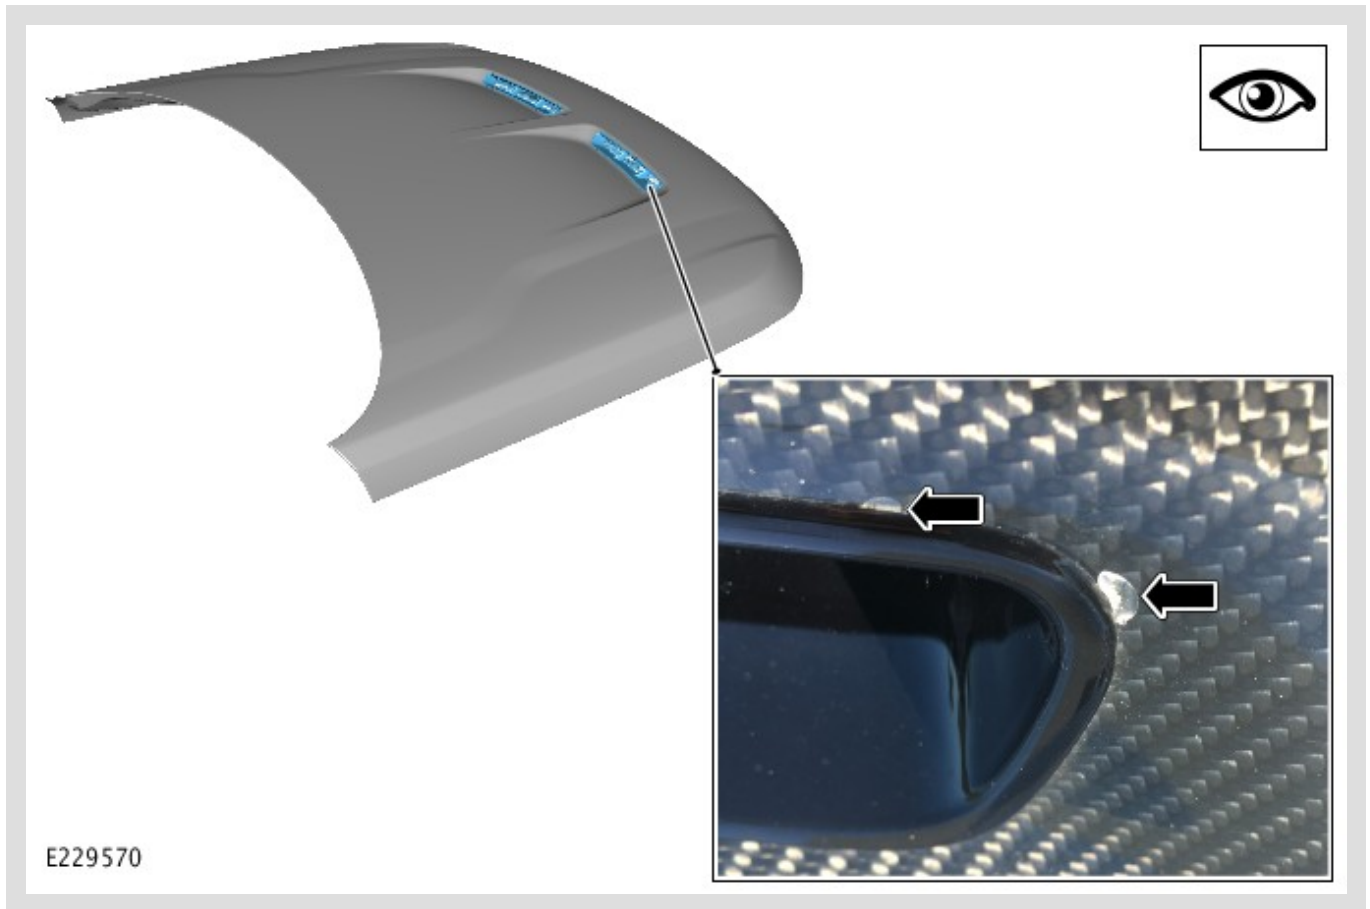
1

On vehicles with an exposed carbon fiber hood, the area surrounding the hood vents on the carbon fiber hood may be delaminating.

This may be caused during hood vent installation where the hood vents lift the laminate away from the hood.

Inspect the hood for delamination in the area surrounding the hood vents.

- If similar delamination on the hood in the area surrounding the hood vents is not evident, do not continue with this Technical Bulletin; the customer concern does not relate to its content.
- If similar delamination on the hood in the area surrounding the hood vents is evident, go to the Body Shop Procedure below.
