Technical Journal

Vibrations due to wheel / tire

REF NO:
TJ 32161.6.1

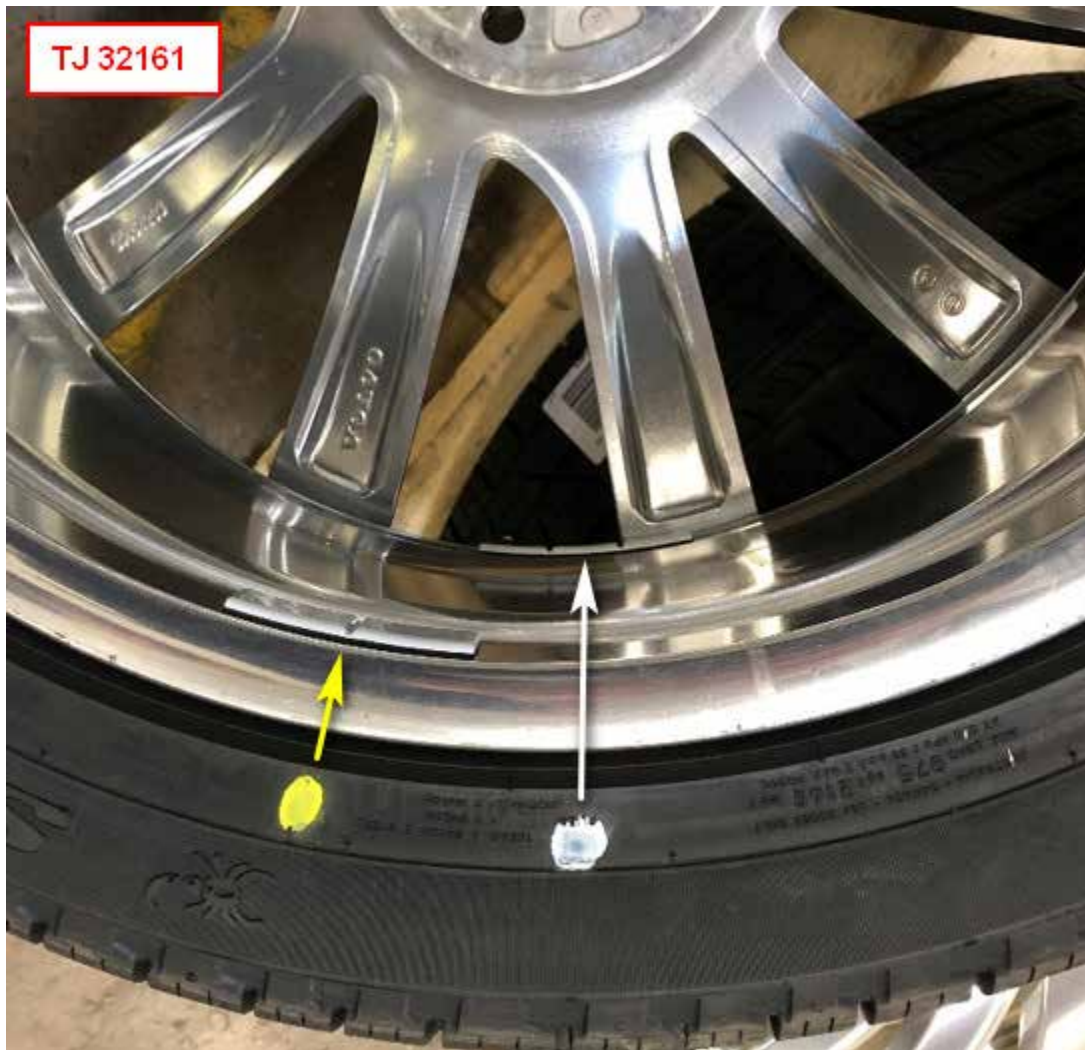
Check that the rim is equipped with balancing weights. For newer wheels there should be visible white and yellow dots printed on tire (inner side) indicating the location of the balancing weights, yellow for inner side, white for outer side (see photo). If balancing weights are missing but there are white and yellow dots on the tire, then it is likely that the weights has been lost and it is then needed to rebalance the tire.
