## SERVICE BULLETIN

**APPLICABILITY:** 2017-2019MY Impreza  
 2018-19MY Crosstrek  
 2018-19MY Legacy and Outback  
 2019MY WRX and WRX STI  
 2019MY Ascent  
 2018-19MY BRZ

**NUMBER:** 15-221-18R  
**DATE:** 04/11/18  
**REVISED:** 09/05/18

**SUBJECT:** Harman Audio / Infotainment: Harman Generation 3.0 and 3.1 Operating Tips

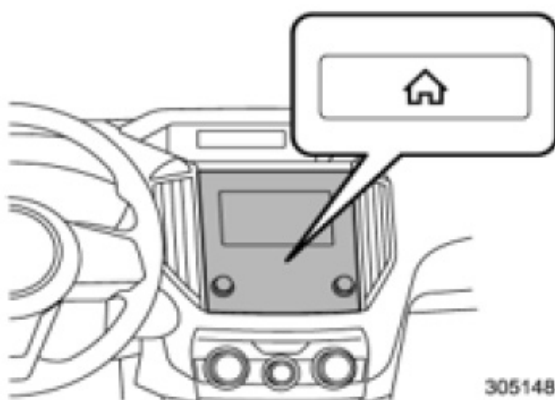
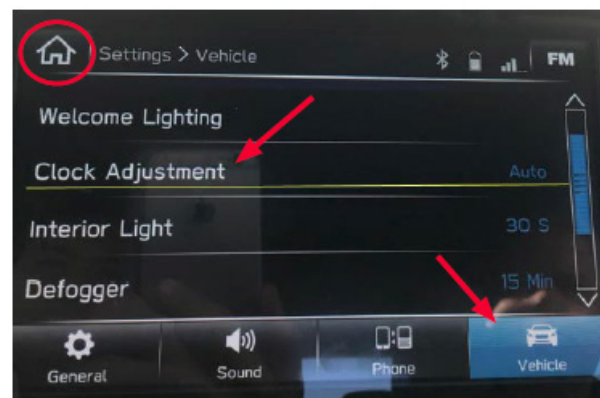
**CONDITION# 2:** Display Audio (non-navigation units), clock not synchronized with paired iPhone. (December 2016 TechTIPS).

**CAUSE: NOTE:** This information is applicable to iPhone (iOS) users only. If a customer states the time displayed on their iPhone is not synchronized with the instrument panel clock display, the information below provides an easy solution. Always ensure the latest software version is installed.

**RECOMMENDATIONS:** First, select the setting mode for the clock by following these steps:

- Press the “Home” button on the audio unit display.
- Press “Settings”.
- Press “Vehicle”.
- Select “Clock Adjustment”.
- Select “Auto”.

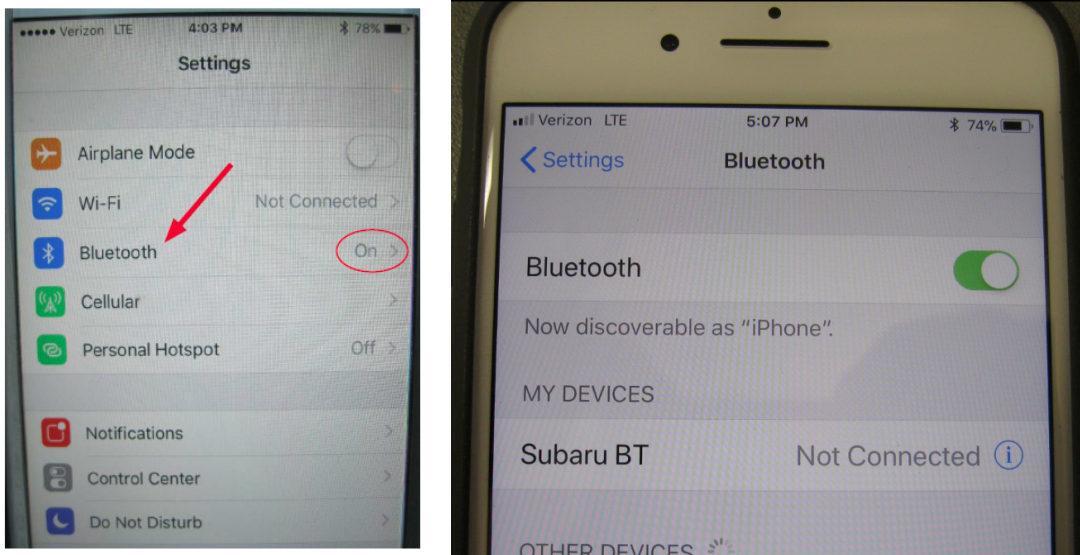
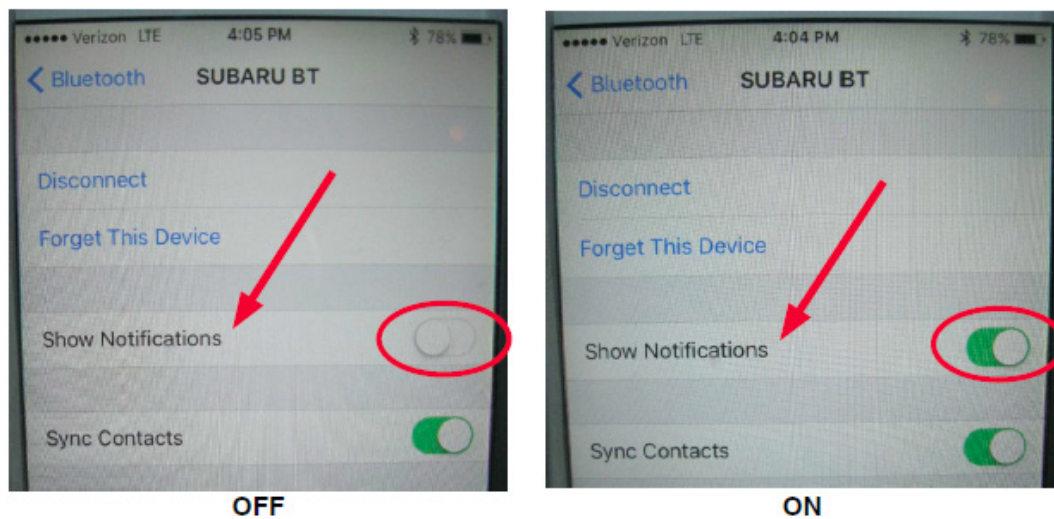
Once “Clock Adjustment” is set to “Auto”, the iPhone “Show Notifications” setting must also be confirmed as set to ON following the steps below:

- From the iPhone Home screen, tap “Settings”.
- From the Settings menu, tap “Bluetooth” and make sure it is set to “On”.
- Select the device being used (in this case, SUBARU BT) then tap on the blue i icon to display the device options list.

- Once “Show Notifications” is switched on, the device and vehicle clocks will synchronize automatically.

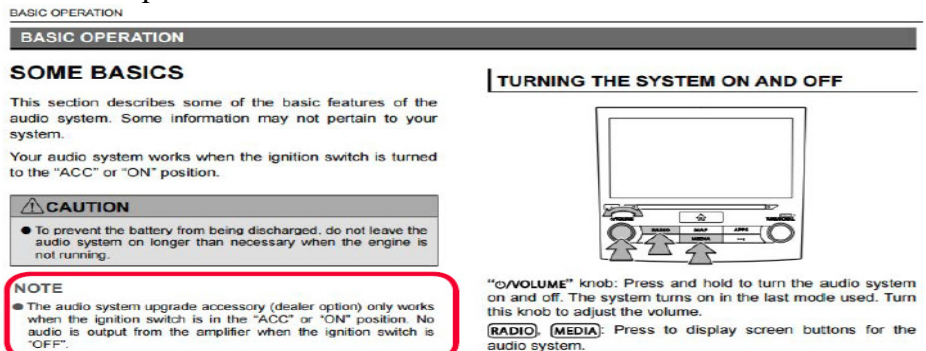
**CONDITION# 4:** Audio unit stays powered up after ignition switched to Off (February 2017 TechTIPS).

**CAUSE:** All the new 2017MY Impreza audio systems include a feature where the audio system stays powered for a period of time after the ignition is switched OFF. If the vehicle has been equipped with the accessory Rockford Fosgate audio amplifier, some confusion may arise when comparing audio unit operation of one Impreza to another. Although the audio unit will continue to operate after the ignition is switched OFF on all models, the power supply for the accessory amplifier is switched off along with the ignition resulting in the loss of audio output. This may cause confusion for customers when seeing the audio unit appear to be operating but not hearing any audio output.

Be advised, this is a normal operating characteristic and no attempt should be made to repair or replace any of the system components. **This operating characteristic is also briefly described on pg. 118 of the Multimedia System guide contained in the Owner Information Kit as shown here.**

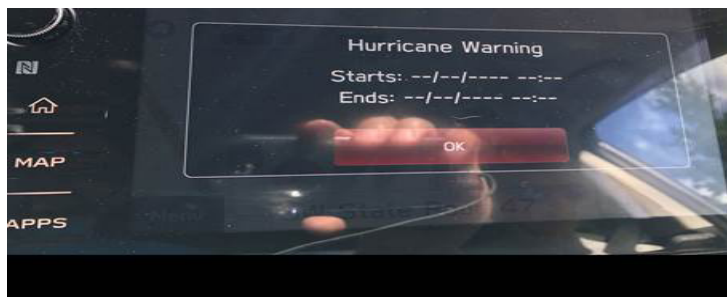
**CONDITION# 10:** Hurricane or Severe Weather warning message is displayed.

**CAUSE:** The head unit receives information from SXM and displays the message whenever there is a signal from SXM. If there is no date information from SXM, the details (dates) will not show.

**RECOMMENDATION:** The display matches data supplied by SXM. **NOTE:** If the concern is the frequency the message is displayed, the frequency was reduced effective with Version 3 software update release.

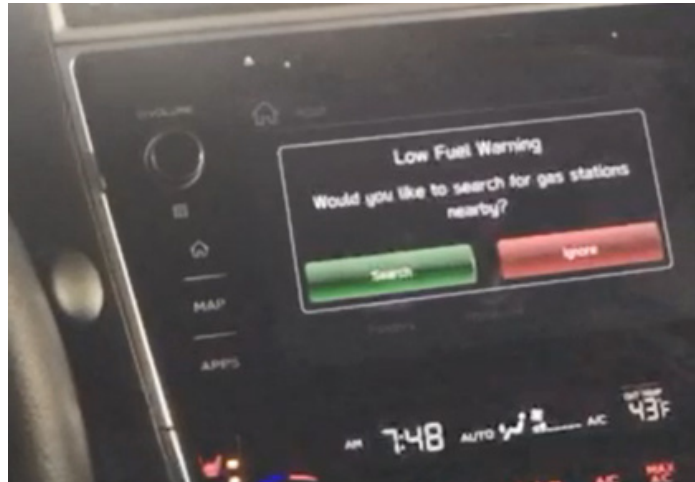
**CONDITION# 15:** Low Fuel Warning advisory message appears on display.

**CAUSE:** The head unit only displays fuel level information sent to it from the combination meter.

**RECOMMENDATIONS:** Confirm combination meter and sender functions are operating properly. Confirm the trip meter is reset following refueling. Confirm ignition key is not being left in the ON / RUN positions during refueling.

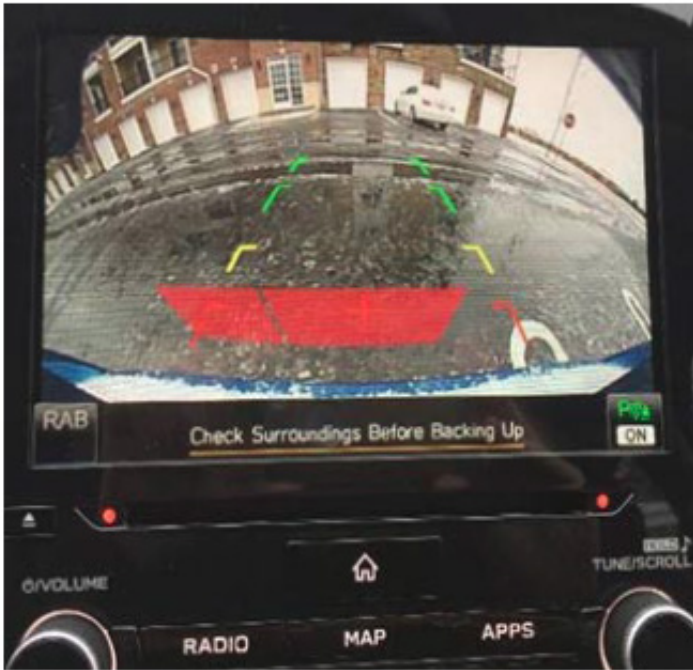
**CONDITION# 19:** On vehicles equipped with reverse automatic braking (RAB), a red area appears in backup camera display.

**CAUSE:** If a customer states they see a red box or area in their backup camera display, the system is most likely operating as designed. Always perform a visual check of the sensors on the rear bumper first. If any of the sensors are covered over or obstructed by ice and / or snow, the RAB system may not function properly and the red area shown in the example photo below will most likely appear.

**RECOMMENDATIONS:** When this condition occurs, the RAB system is unable to properly differentiate between what really is an obstacle and what is not. In the image below, the sensor is iced over and the red area is displayed with no obstacle present. The Owner's Manual provides a list of other potential causes for this condition to occur.
