SERVICE BULLETIN

APPLICABILITY: 2017-2019MY Impreza
 2018-19MY Crosstrek
 2018-19MY Legacy and Outback
 2019MY WRX and WRX STI
 2019MY Ascent
 2018-19MY BRZ

NUMBER: 15-229-18R
DATE: 08/21/18
REVISED: 09/05/18

SUBJECT: Harman Audio / Infotainment: Troubleshooting
 Clock-Related Concerns

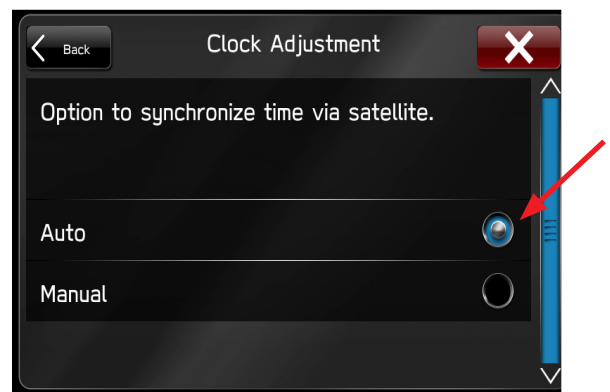
- a. What is the clock adjustment setting, Manual or Auto? (Clock setting information can be found under Settings > Vehicle > Clock Adjustment as shown below.)

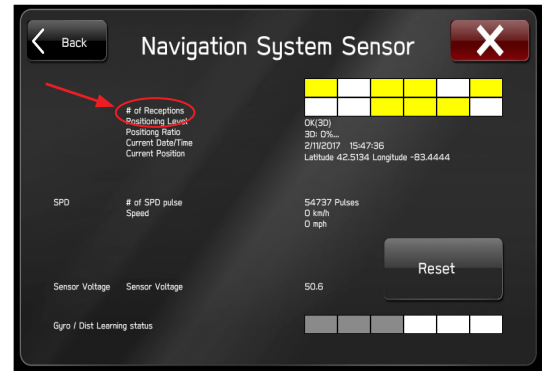
i. Open the Navigation System Sensor screen. Press and hold the Home hard key and press the Tune knob 6 times, then release the Home button. In the Dealer menu, select “Function check” > “Navi System Sensor” (See screenshot to the right.)

ii. Does the screen show the correct date and GMT time?

iii. Note the number of satellites acquired. If none, move vehicle to an area with open sky.

iv. If system does not show the correct time while in open sky, investigate the GPS antenna:
