## ARTICLES CONTAINED IN THIS ISSUE

SUBARU OF AMERICA

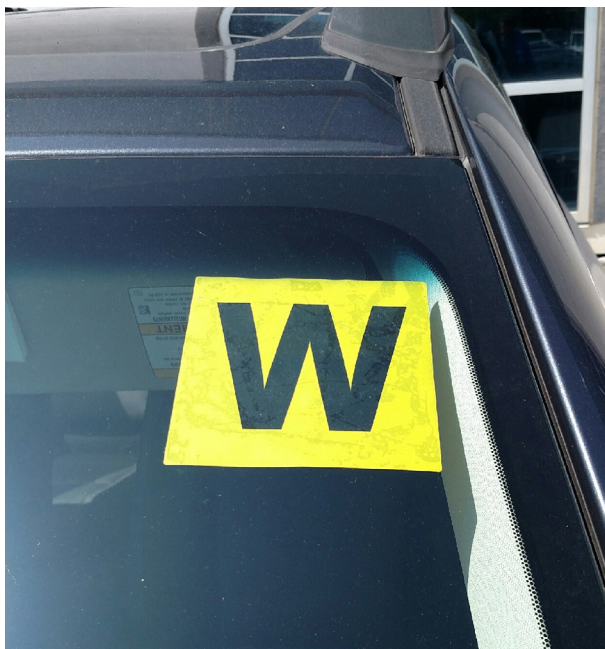
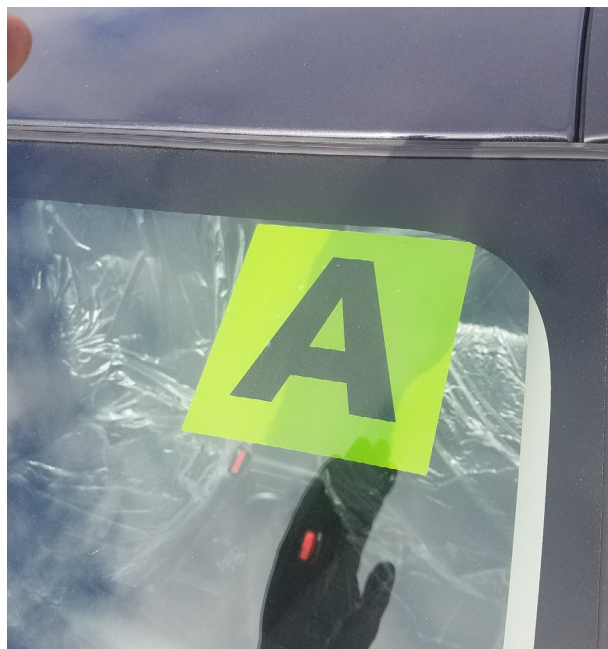
If you receive a vehicle which has a sticker in the windshield that has a black “A” with a green background or a black “W” with a yellow background, be advised the vehicle had an issue discovered at the plant or port of entry. Generally, the “W” is used for a mechanical or electrical type repair which needs to be addressed before delivering the vehicle to a customer. Your Service Manager will receive a message via Subarunet describing the issue in detail. The “A” is used for body repairs such as a dent, scratch or stain type repair. The following text is copied directly from the Policy and Procedures Manual and the photos show these stickers.
