**NUMBER:** 06-65-18

### SERVICE BULLETIN

APPLICABILITY: 2017MY Impreza

SUBJECT: "Clicking" or "Ticking" Sound from VDC

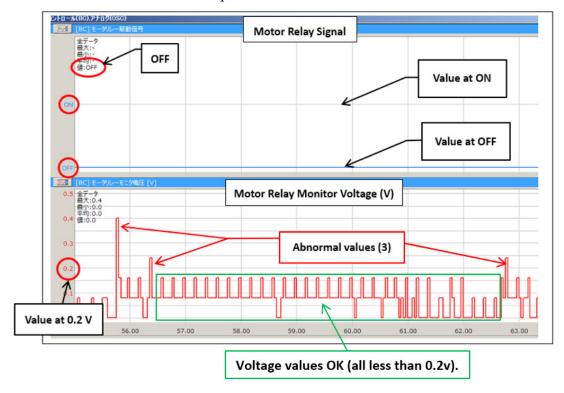
**Step 2:** Connect the SM4 and access data monitoring for the Brake Control system. Select the data for Motor Relay Signal and Motor Relay Monitor Voltage (V) as shown in the image below.

• Scenario 2: Inspect the value for Motor Relay Monitor Voltage. If any "spikes" of voltage exceeding 0.2v are identified while the Motor Relay Signal shows either ON or OFF, the VDCCM&HCU must be replaced.

**Step 3:** If either **Scenario 1** or **2** described above is confirmed, the VDCCM&HCU must be replaced.
